DPF Pressure Hose

febi no. 45777

Ford Mondeo 07 / S-Max 06 /

Galaxy 06 with 2.0 TDCi engine

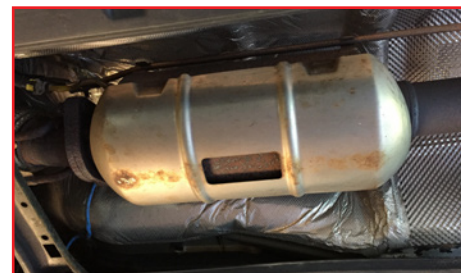
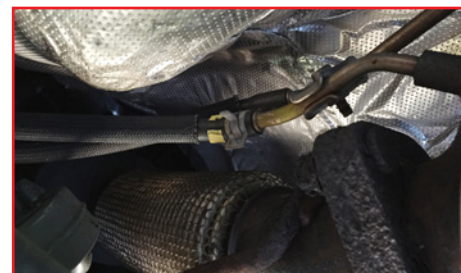
In the Ford models mentioned above, a pressure hose which routes the exhaust gas pressure to a differential pressure sensor is located on the DPF. If the differential pressure upstream and downstream of the filter is too high, this is a sign that the filter is saturated and needs replacing.

It may be that the pressure hose is blocked or has been scorched by the high temperatures, causing it to leak. As a result, the pressure actually prevailing at the differential pressure sensor is transmitted incorrectly or not at all. In this case, the engine control unit receives incorrect information and passes it on to the driver via the warning light.

Check the lines and hoses of the diesel particulate filter or sensor before carrying out a costly replacement.

The problem is often remedied simply by replacing the pressure hose. This saves the vehicle owner an expensive repair.
