## Always connected - With electrical coils by febi bilstein

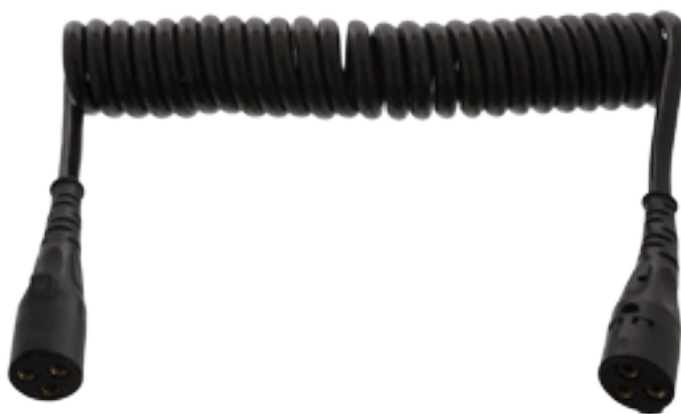
febi no. 44652

24V, 3-Core, Working length 3m
