All you need for professional repairs

Windscreen wiper motor with fitting materials

febi no. 38800

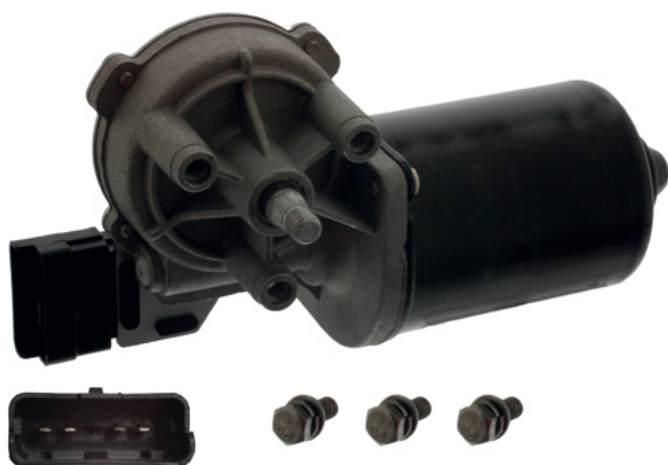
The most frequent cause for windscreen wiper motors to fail is the motor overheating or rotating too much. Also, age-related wear can lead to the wiper linkage binding.

Since the wiper motor has no threaded holes, in order to replace it, usually additional self-tapping screws have to be sourced.

febi bilstein recommends testing the ease of movement of the wiper linkage before fitting. This can help prevent the windscreen wiper motor from failing prematurely.

On febi bilstein wiper motors there are already threaded holes so that, using the supplied screws, mounting is trouble-free.
