801502 - Fitting Instruction

Part Number: 801502

For Vehicle: Avensis, Carina, Celica, Corolla, MR2 Mk3, Rav 4, Yaris.

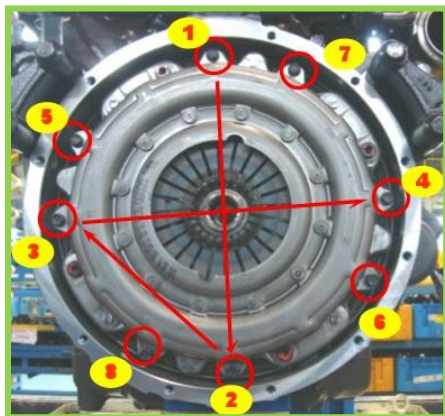
Please see below for the correct tightening sequence provided by our factory of manufacturing. For the specific torque please refer to manufacturing specification.

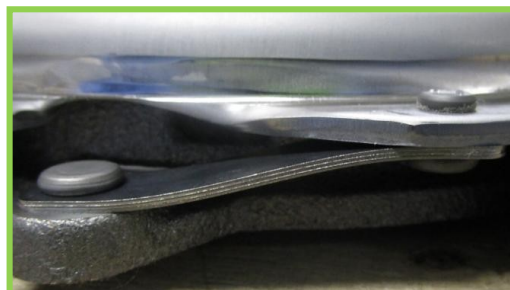
New part taken from Valeo stock; shows no deformation/damage to the straps

Please check each of the drive straps prior to fitment to ensure the cover plate has not suffered any trauma. There should be no air gaps or space between the metallic strips that make up each strap and each strap should have the same profile (shape).

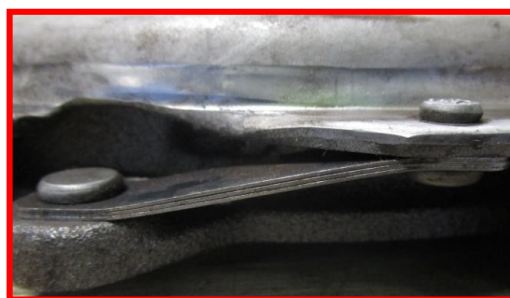
The Valeo Service UK warranty department have received returns of 801502 clutch kits with a fault description of "light pedal, difficulty in changing gears and not clearing gears". After analysis of the returned parts, it was discovered that the cover plates had deformed drive straps. The effect of a deformed strap means the pressure plate will not lift correctly when the diaphragm spring (fingers) is actuated therefore reducing the drive plate clearance and making it difficult to select gear. Due to the reduced load on the diaphragm spring, the clutch pedal can feel lighter than normal.

The cause of a deformed drive strap is often one of the following: dropping the cover plate, excessive trauma during transport or an incorrect tightening sequence used when fixing the cover plate to the flywheel.

Fitted part returned as warranty; shows deformation/damage to the drive strap
