Mitsubishi & Volvo 1.8 16V / Synchronous Drive / Tensioner Info.

GATES REFERENCE:	5514XS & related kits.	
MAKE:	MITSUBISHI / VOLVO.	
MODEL:	Carisma, IO, Montero, Pajero, Shogun, Space Star, S40, V40.	
MOTOR:	1.8, 1.8 GDI.	
MOTOR CODE:	4G93DOHC, B4184SJ, B4184SM.

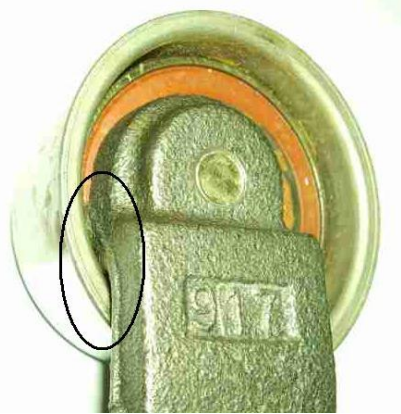
Fig. 2

- 1) Following the recommended tension setting procedure.
- 2) Turning the tensioner in correct direction = anti-clockwise. If not this leads to incorrect tension and very often tensioner seizure. The tensioner bracket touches the pulley, obstructing it to rotate freely (Fig. 2).

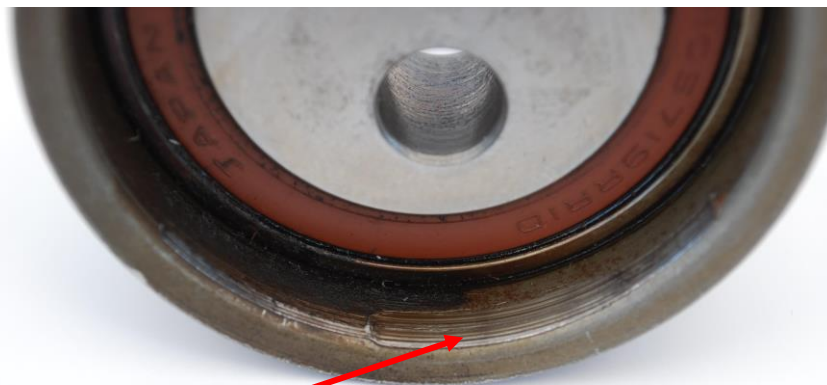
Fig. 3

Evidence of this can be found on the back inner side of the tensioner pulley (Fig. 3).

Rubbing mark

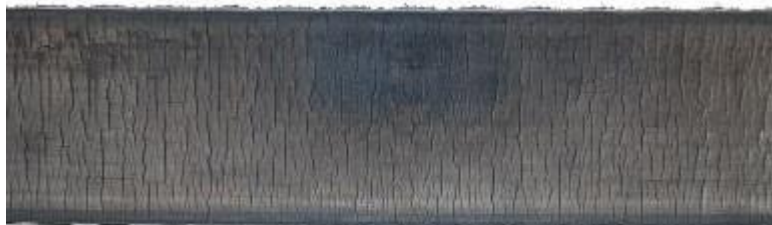
Fig. 4

Since the pulley cannot rotate anymore, the belt back - constantly rubbing against the pulley surface - will start to overheat and crack (Fig. 4).

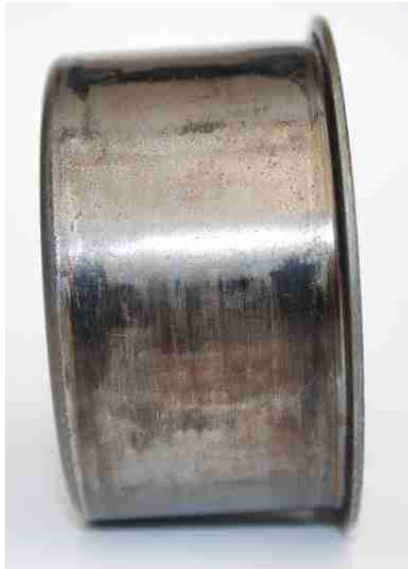
Fig. 5

This excessive temperature is further transmitted to the tensioner and idler pulleys, leaving a blue heat mark on the pulleys (Fig. 5), and possibly even traces of melted rubber (Fig. 6).

In general it is strongly recommended to replace the tensioner and idler pulleys together with the belt, as these parts obviously also wear out. A worn bearing (loss of grease, seizure, misalignment ...) is just as bad as a worn belt, and will lead to premature drive failure, resulting in serious engine damage.

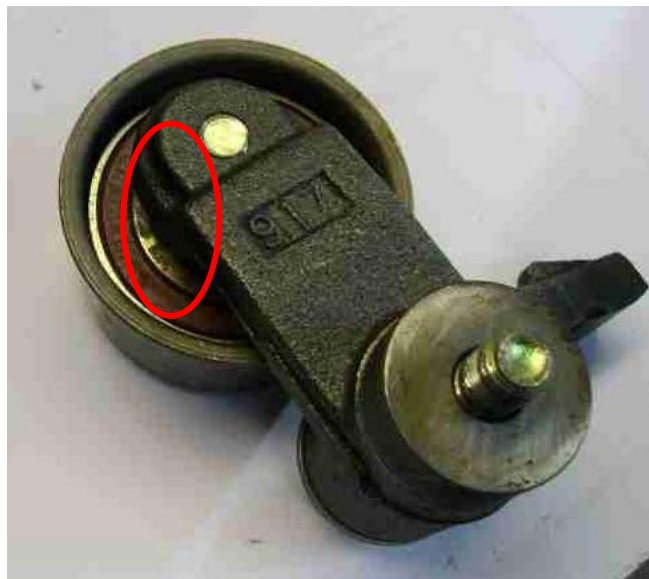
Fig.7

If the tensioner pulley is turned in the correct – anti clockwise - direction, it will not be able to come into contact with the bracket (Fig. 7).

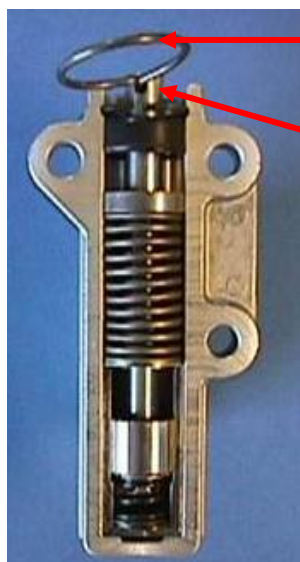
Fig. 9

By now, the piston rod of the hydraulic tensioner has come out of the tensioner body by 10.5 to 11.5 mm. If not, or leakage is present, replace the tensioner.

Apply a pressure of 10 to 20 Kg on this rod; movement of the rod should be maximum 1 mm. If more, replace the tensioner.

Retaining pin

Piston rod

Push the rod slowly down (vertically) until the holes of the rod and the tensioner body are in line. Insert a 2 mm retaining pin (can be found in GAT4657) (Fig. 9).

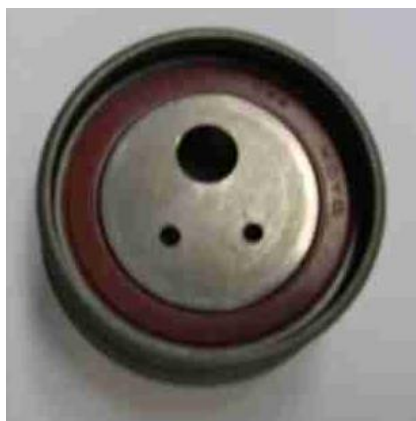
Fig. 10

The engine needs to be at TDC (Top Dead Center)!
 (Re)install the (new) hydraulic tensioner (2 bolts at 13 Nm).
 Install the new tensioner and idler pulleys (tensioner pulley with eccentric hole at the top, 2 small adjusting holes at the bottom) (Fig. 10).
 Rotate the crankshaft pulley ½ tooth anti clockwise.
 Install new belt in this order: crankshaft, water pump, idler, outlet camshaft, inlet camshaft, tensioner.
 Turn the tensioner pulley (using adjuster GAT4577 included in GAT4657) ANTICLOCKWISE into the belt and tighten the bolt (Fig. 11).
