**Tensioner/kit installation on PSA diesel engines**

<b>GATES REFERENCE:</b>	T41139, T41140 & related kits.

<b>MAKE:</b>	CITROEN / FIAT / LANCIA / PEUGEOT / SUZUKI / TOYOTA.	
<b>MODEL:</b>	Various.	
<b>MOTOR:</b>	1.9D, 1.9HDI, 2.0HDI, 2.0JTD, 2.0TDI, 2.2 HDi, 2.2JTD.	
<b>MOTOR CODE:</b>	Various.

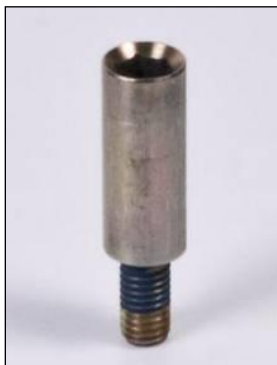
Fig. 1

We've found several cases where the tensioner pulley was not positioned correctly over the mounting stud (Fig. 1).

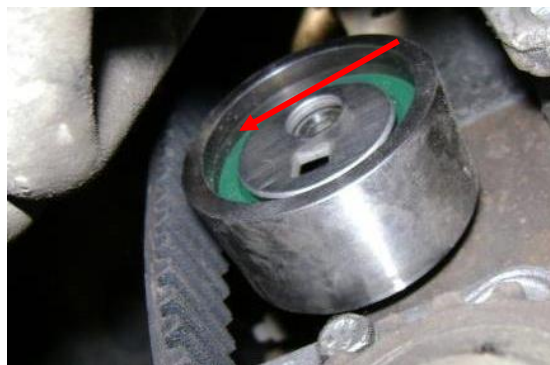
Fig. 2

If the inside of the tensioner front plate rests against the front edge of the mounting stud (Fig. 2 and 3), this results in the tensioner pulley not sitting straight over the stud even after the fixing bolt (Fig. 4) is installed with the correct torque. This will lead to belt misalignment, resulting in a premature failure.
