Technical Bulletin

Toyota - CV Joints Removal

Applications: Toyota various models

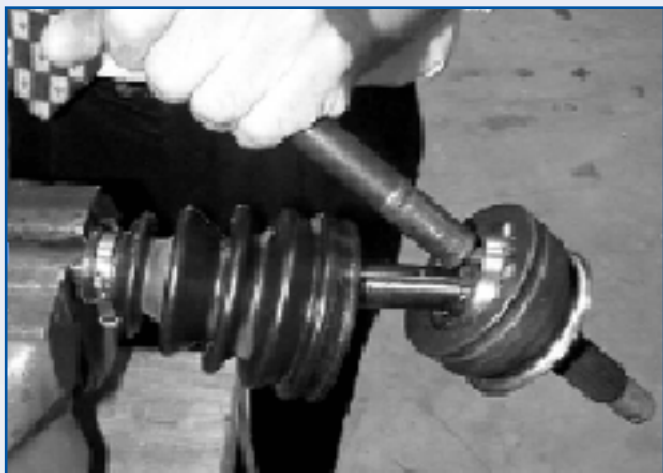
Removal of the original joint

Difficulty is often encountered removing the original CV joint from the driveshaft on the above application. This is because the manufacturer uses a 'heavy duty' type internal circlip to retain the joint. It is sometimes necessary to cut or grind the original joint from the shaft, taking great care not to damage the shaft splines. If a disc grinder is used, the grease must be cleaned out to prevent the likelihood of fire.

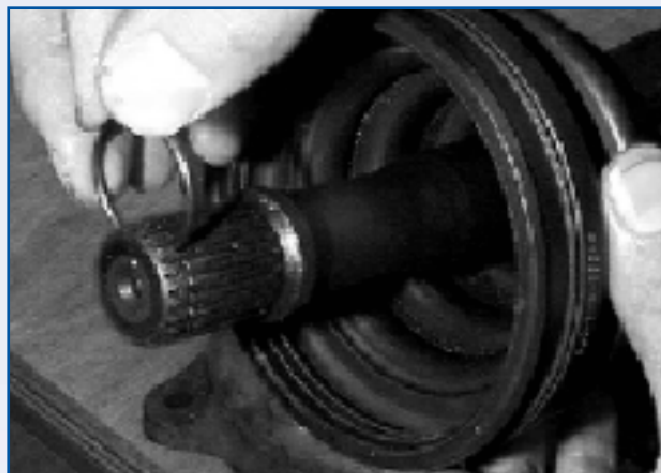
Fitment of new Blue Print CV Joint (using new internal clip supplied)

To assist you with the replacement, Blue Print CV Joints are supplied with the internal clip, high specification boot, two steel boot clips, retaining nut and locking pin plus 100gm of the correct specification grease.
