Technical Bulletin

Land Rover Freelander 1 – Tailgate Window Regulator Calibration

Applicable References: ADJ131301

Applications: 1.8i, 2.0DT, 2.0DT - TD4, 2.5i - V6, 1996>2006, Chassis Ref: LN

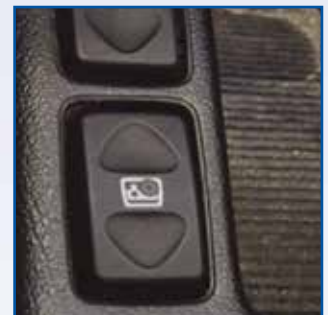
The tailgate window switch is located in the centre console near the handbrake.
