# Technical Bulletin

## Chrysler Voyager, Grand Voyager - Clock Spring Diagnosis and Replacement

**Applicable References:** ADA101413

**Applications:** Chrysler Voyager 2.0i 1996>2001, 2.5DT 1997>2001, 3.3i 1996>2001 / Grand Voyager 2.5DT 1997>2000, 3.3i 1996>2000

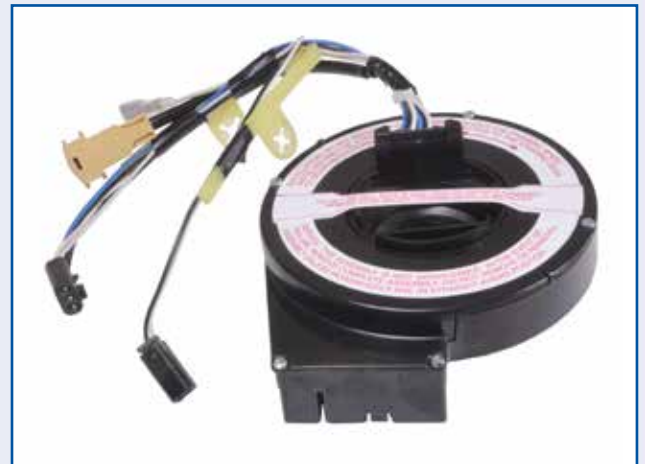
A clock spring allows a constant contact to be made between the stationary wiring loom on the steering column to the moving components on the centre of the steering wheel. This is done via coiled strip cables inside the clock spring that can fail through fatigue, rendering the steering wheel-mounted controls inoperable.

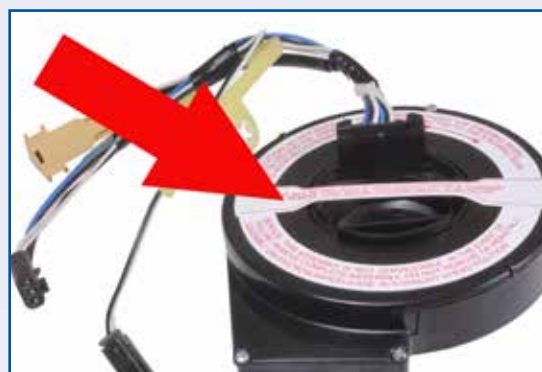
- The new clock spring has a taped seal across its centre to prevent it from being turned prior to installation. This is necessary as the centre has a limited number of turns from side to side and if it were installed whilst on full lock it would break the first time you attempt to turn the steering wheel.
- On fitting, release the clock spring locking pins to engage the mechanism.
- Refit the steering wheel, taking care that the wheel and shaft are correctly aligned. Feed the wires from the clock spring through the wheel openings, ensuring the flats on wheel align to flats on clock spring inside.
- Tighten the steering wheel nut to 61Nm or 45ft/lbs
- Refit and reconnect the steering wheel controls and air bag.
- Reconnect the battery.
- Clear all fault codes from the ECU and rescan.

Note: It is strongly advised to add a small amount of dielectric grease to all connections of the clock spring to ensure the correct levels of resistance are maintained.
