Ford Transit 2.4 Di 2000> Starter Motor issues

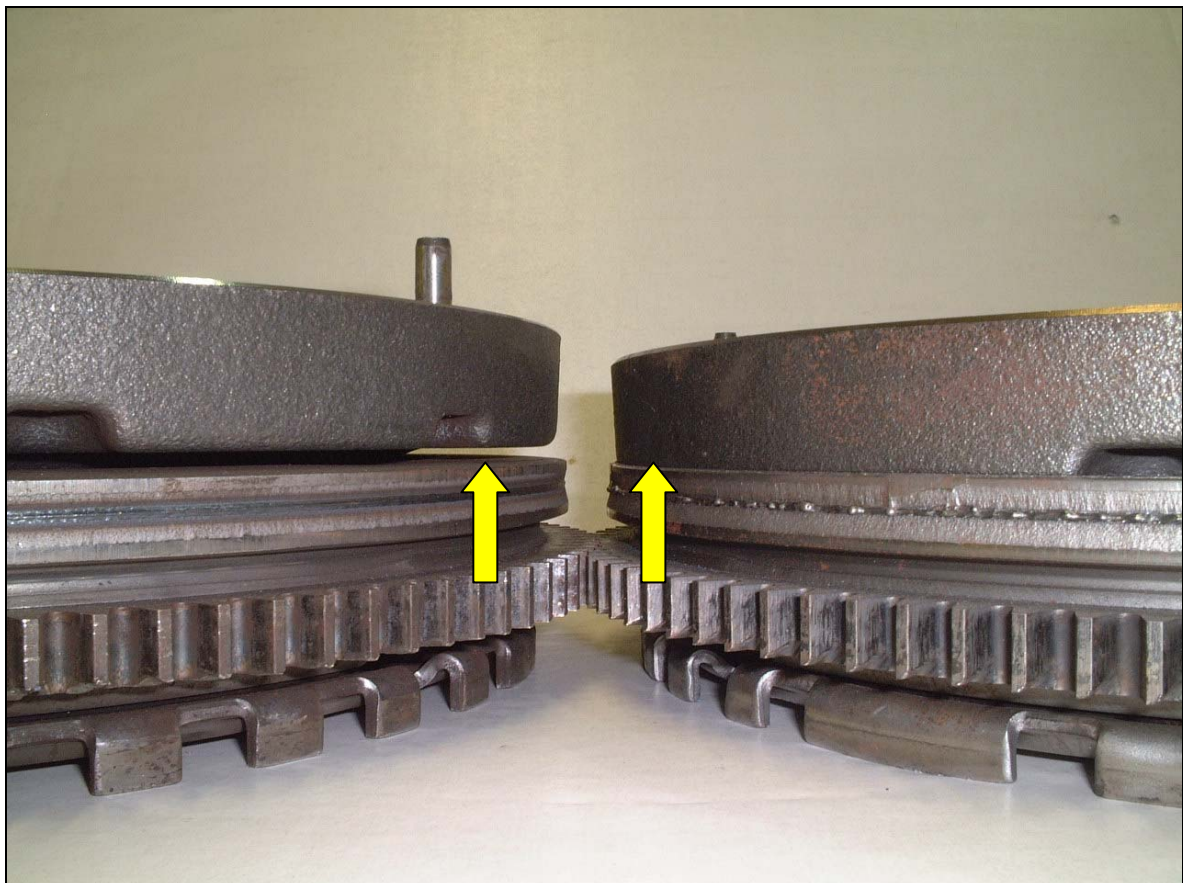
This application has a Dual Mass Flywheel (DMF) fitted as Original Equipment. When replacing the clutch on this application it is recommended to check the DMF and replace if necessary. During a clutch replacement it is advisable to thoroughly clean the bellhousing and any clutch dust or swarf be removed. If the DMF wears to excess the two masses can begin to make contact as shown on the right hand side of the picture below. This can cause a build up of swarf in the bell housing. Due to the design and mounting of the starter motor it can become contaminated if this residue is not removed. The swarf from the worn flywheel will cause premature wear to the starter gear and be drawn through into the magnets damaging the armature itself.

If the starter motor is being replaced and excessive wear can be seen on the gear and shaft it is recommended that the DMF be checked at the same time.
