Objective:

To help you to identify old core that is in such a condition that is acceptable for return back to Remy for our re-manufacturing process and identify units that should be rejected back to the customer.

CALIPERS

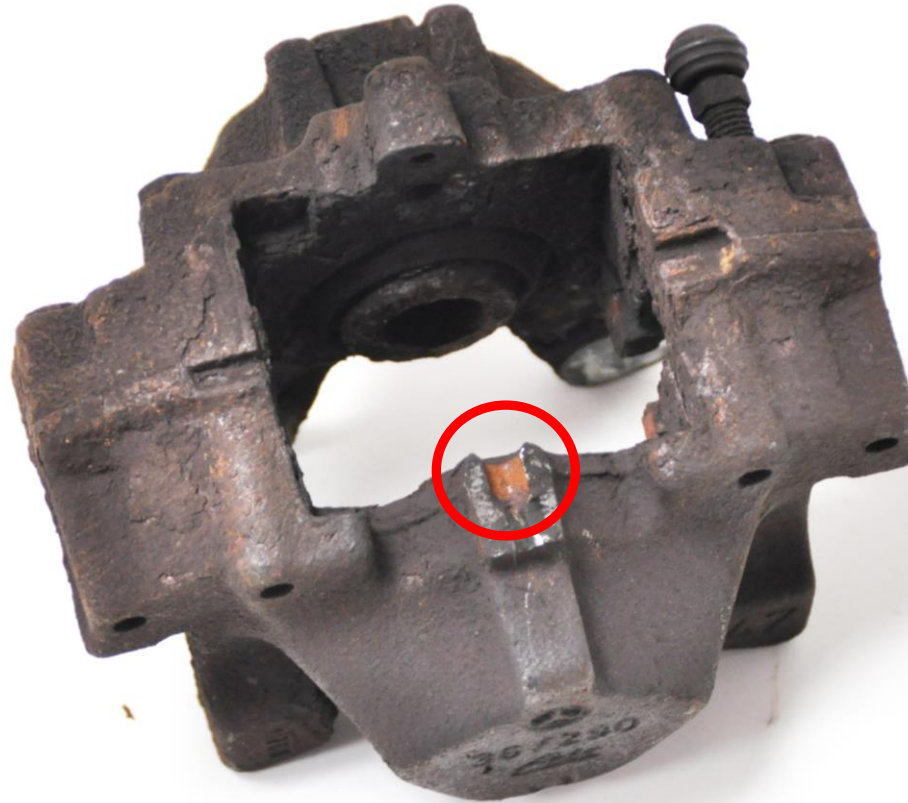
BROKEN CASTING

You will notice in the picture that the casting is broken where the pad retaining pin locates.

Due to a brake caliper being a safety critical product, Remy would not accept a core back for remanufacturing in this condition.

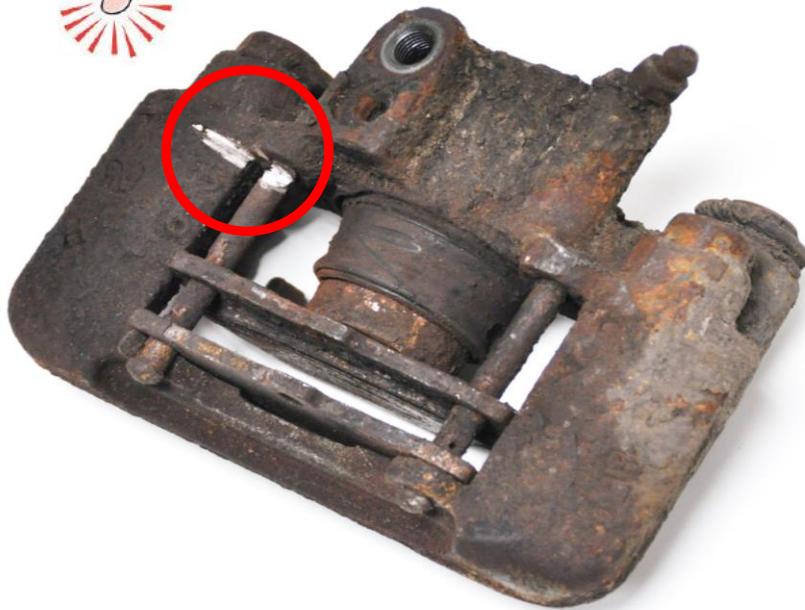
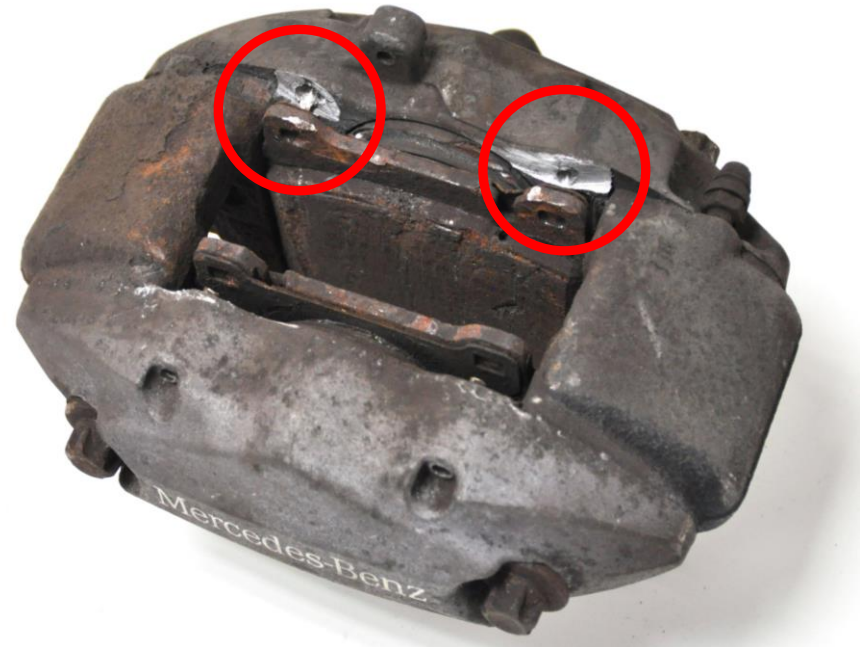
DAMAGED CASTING

You will notice from the picture that the castings show evidence of grinding marks.

This is likely to have been caused during attempted removal of the pad retaining pin. Due to a brake caliper being a safety critical product, Remy would not accept a core back for remanufacturing in this condition.

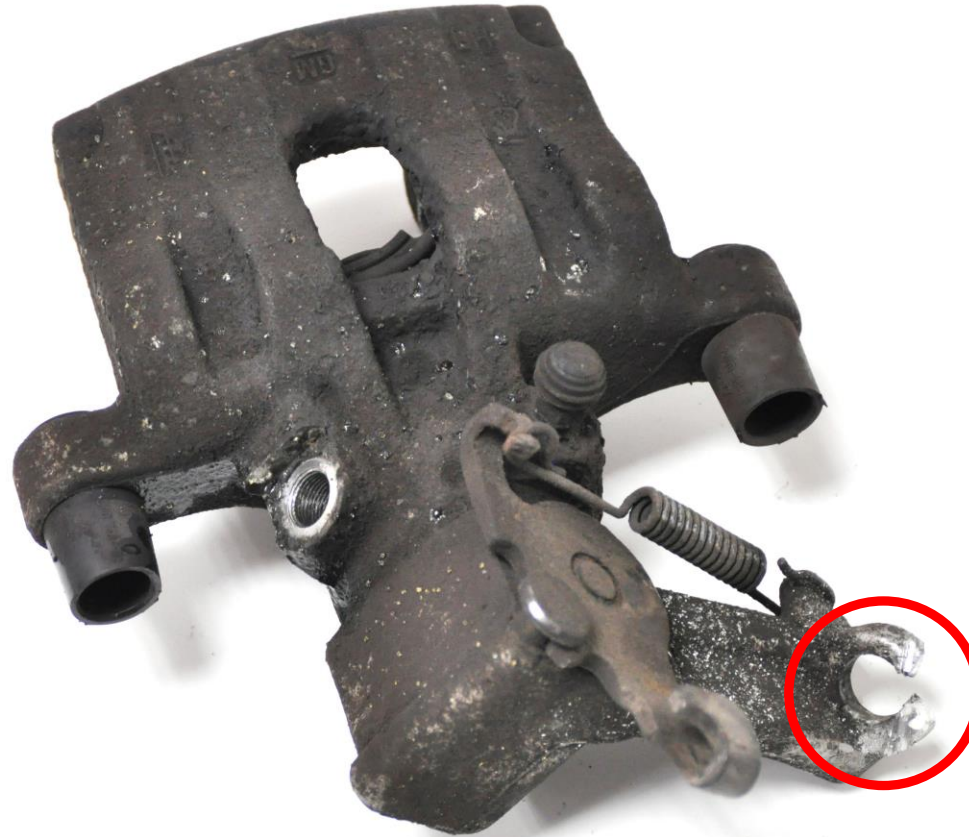
DAMAGED CASTING

You will notice in the picture that the casting has been cut

This is likely to have been deliberately cut to remove the handbrake cable. Due to a brake caliper being a safety critical product, Remy would not accept a core back for remanufacturing in this condition.

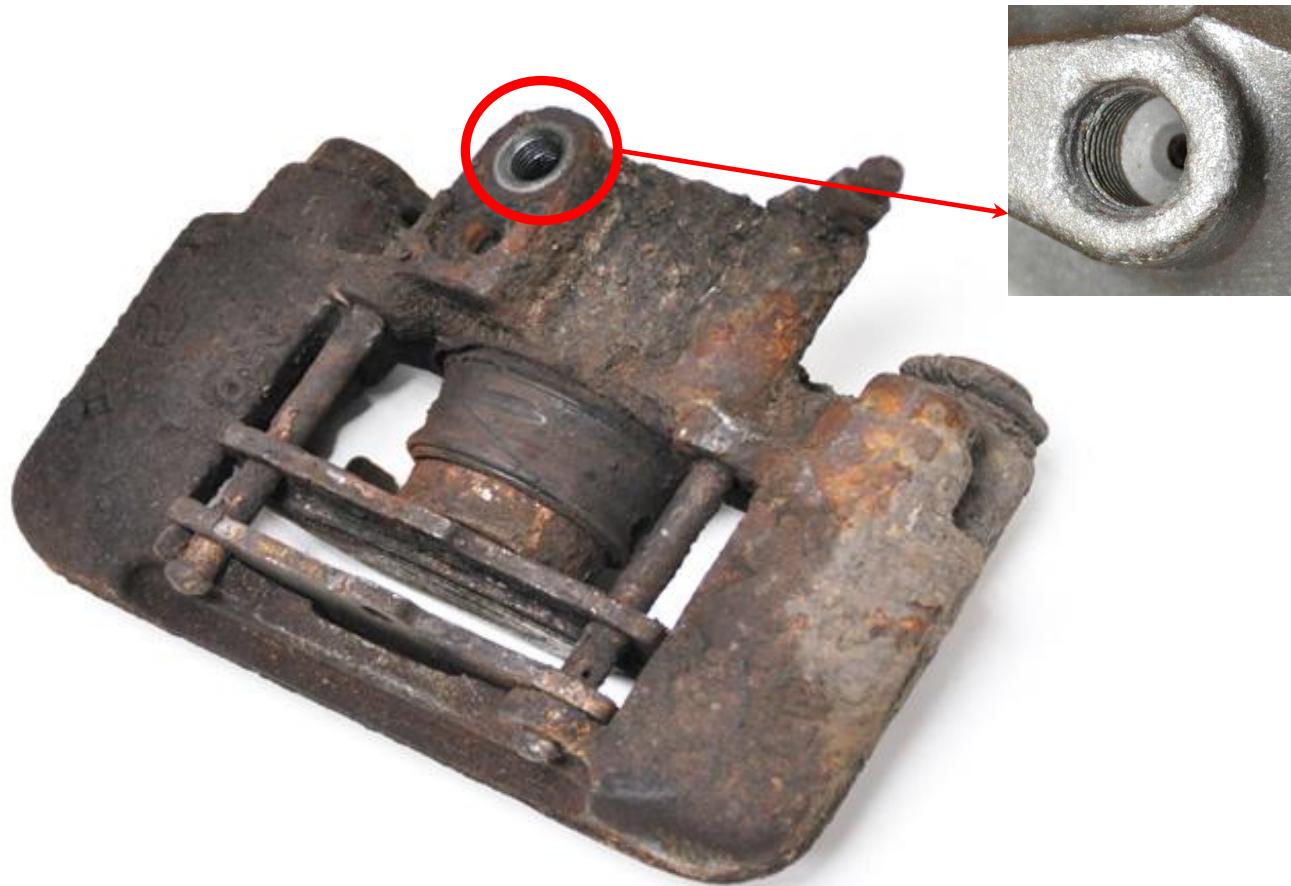
STRIPPED THREAD

You will notice in the picture that the inlet port thread is stripped/damaged.

Any stripped/ damaged threads will result in a rejected core.

Due to a brake caliper being a safety critical product, Remy would not accept a core back for remanufacturing in this condition.

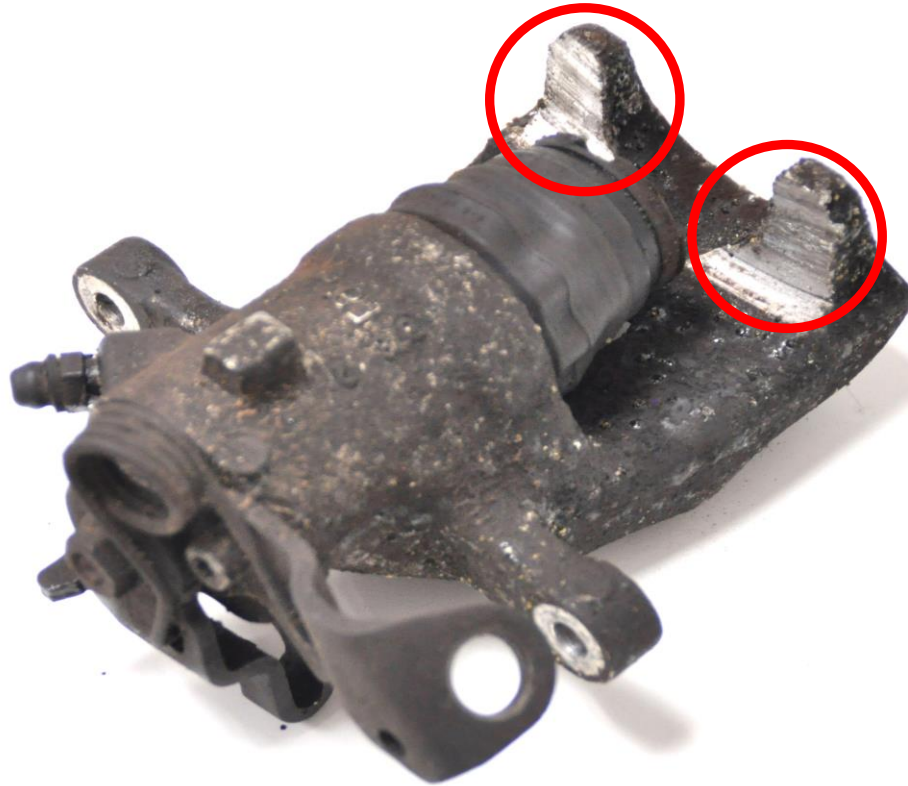
EXCESSIVE WEAR

You will notice from the picture that this caliper core has been damaged by the brake disc cutting into the casting.

This is likely to have been caused by the brake pad being worn to excess. Due to a brake caliper being a safety critical product, Remy would not accept a core back for remanufacturing in this condition.

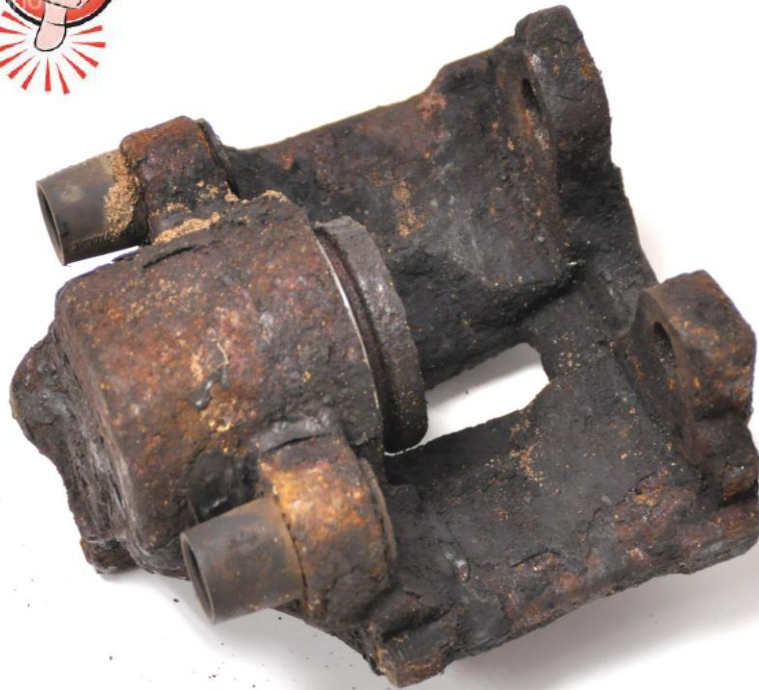
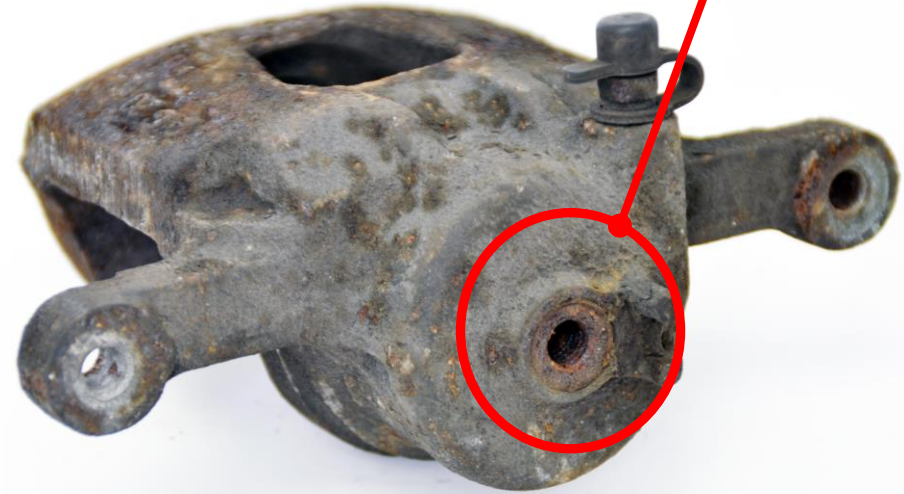
SEVERE CORROSION

You will notice that caliper core pictured shows severe corrosion.

The inlet port face should be clean and free of corrosion. If there is evidence of corrosion on the port face then it is likely that the caliper has not recently been removed from the vehicle and should be rejected back to the customer.

Remy would not accept a core in this condition for remanufacture as a brake caliper is a safety critical product.

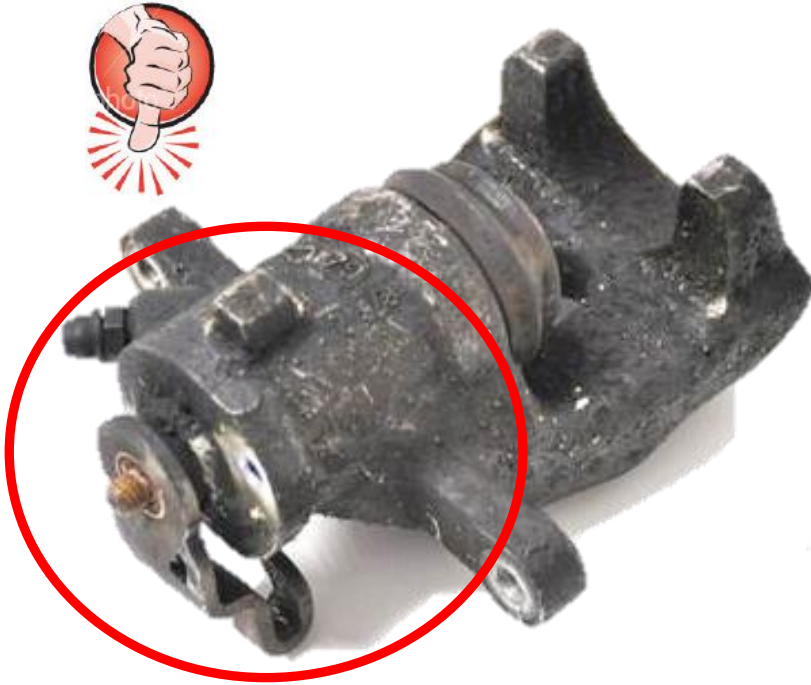
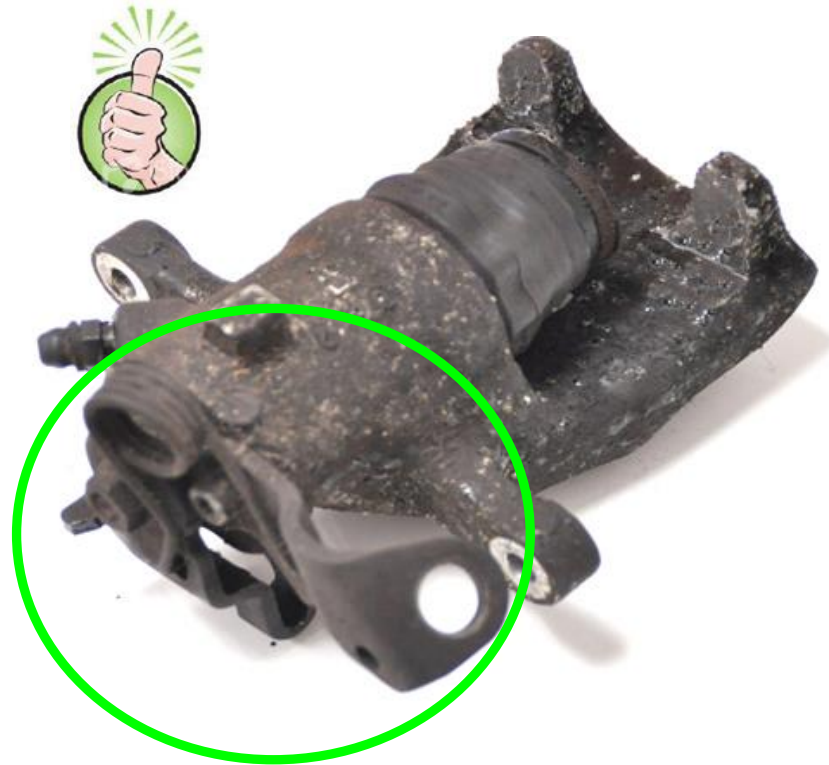
MISSING PARTS

You will notice in the picture on the left that part of the handbrake mechanism is missing.

The core must be returned to Remy as a complete assembly.

Due to a brake caliper being a safety critical product, Remy would not accept a core back for remanufacturing in this condition.

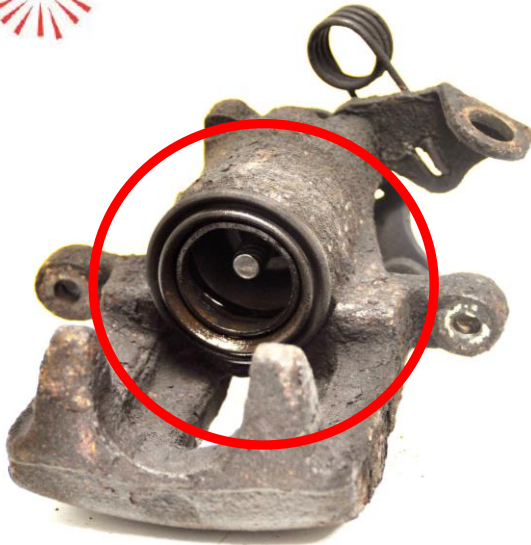
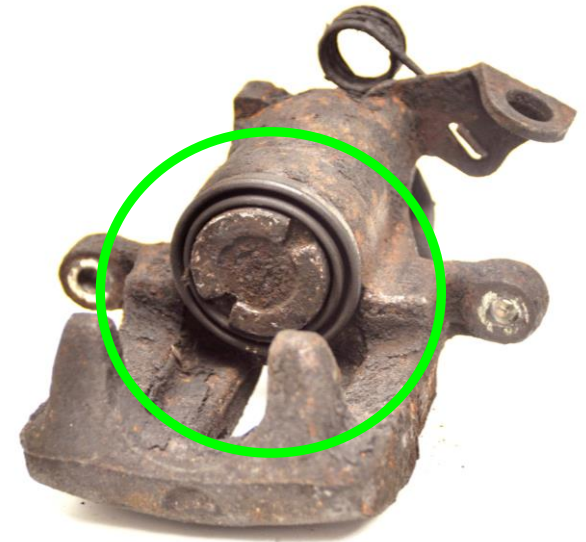
MISSING PARTS

You will notice in the picture on the left that the piston is missing.

Due to a brake caliper being a safety critical product, Remy would not accept a core back for remanufacturing in this condition.

However if the piston has fallen out but is returned in the box with the caliper it is acceptable

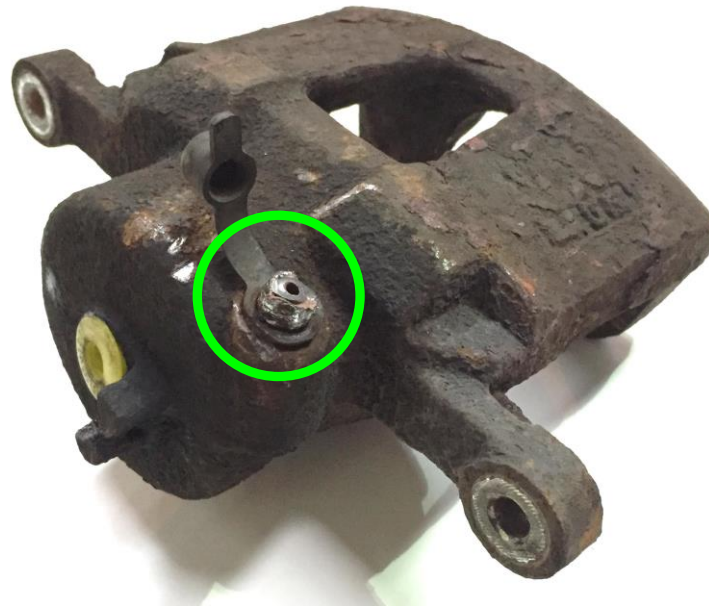
ACCEPTABLE DAMAGE

You will notice in the picture that the bleed screw has been snapped off.

Remy **will** accept core back for remanufacturing in this condition UNLESS there has been an attempt to drill the snapped screw out of the casting and the drill has broken off inside.
