Welcome to our Remy UK core criteria document

Objective:

To help you to identify old core that is in such a condition that is acceptable for return back to Remy UK for our re-manufacturing process and identify units that should be rejected back to the customer.

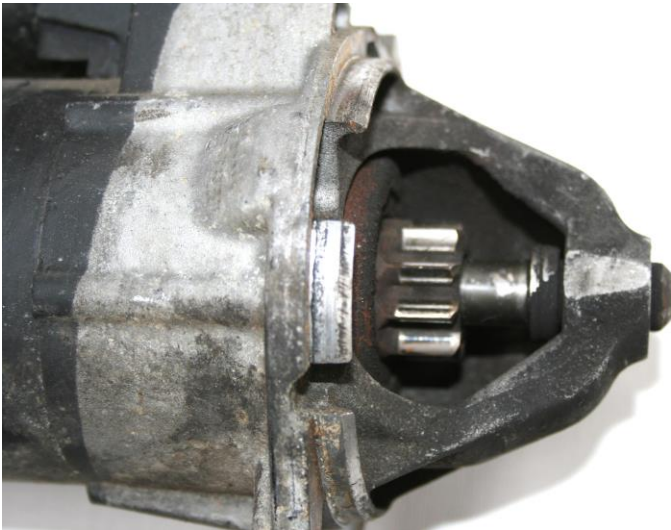
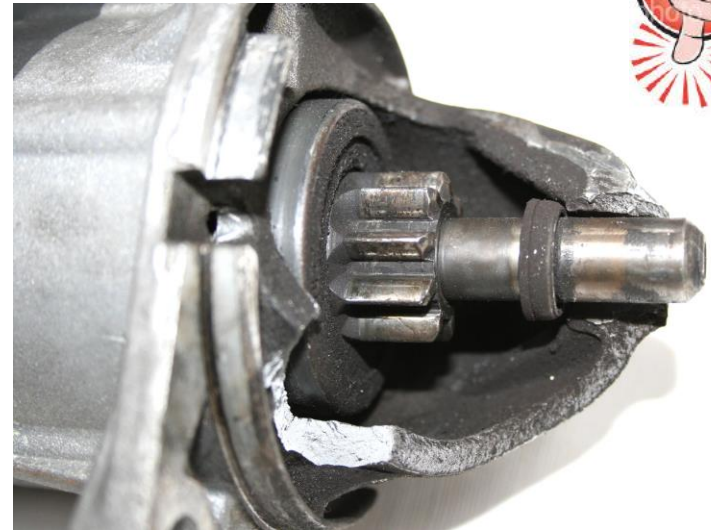
BROKEN / DAMAGED: Brackets

You will notice from the picture that the NOSE HOUSING is broken. This has been caused by an external force and not a fault of the starter motor.

In the event you need to reject the core back to the customer, you can inform them that the likely cause of the damage is due to a vehicle problem or mishandling and is not a fault of the Starter Motor and that the core will not be accepted back for remanufacturing.

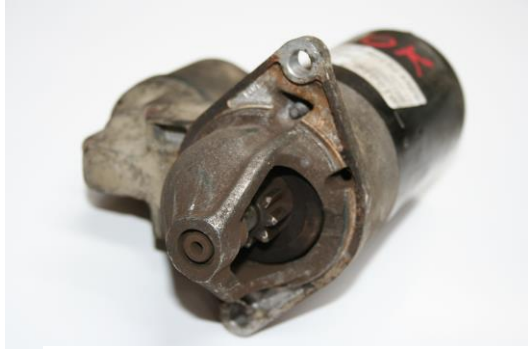
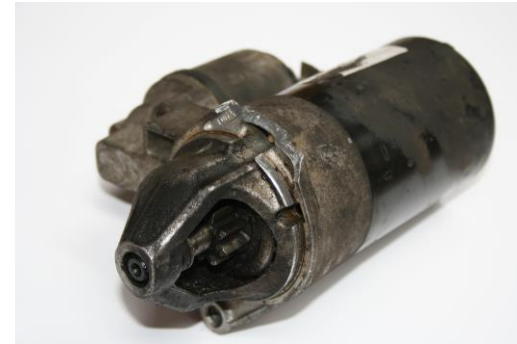
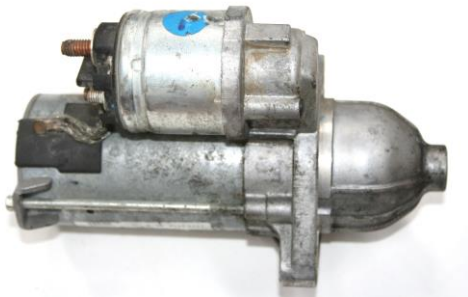
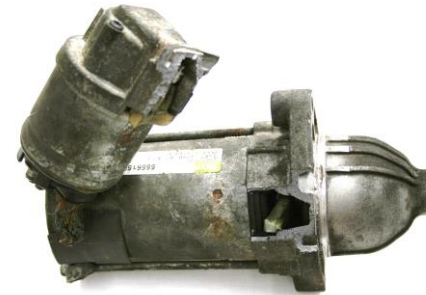
BROKEN / DAMAGED: Brackets

You will notice from the pictures that the BRACKET is broken. On inspection of a unit, if any of the brackets show evidence of a break, then it is likely that the bracket has been broken during the removal of the unit, been dropped or even involved in a vehicle impact.

In the event you need to reject the core back to the customer, you can inform them that it is likely that the bracket has been broken during the removal of the unit, been dropped or even involved in a vehicle impact and in such a condition is unfit for remanufacture.

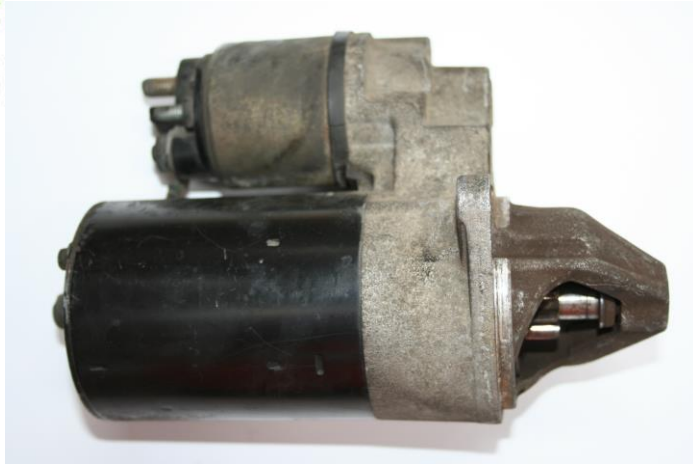
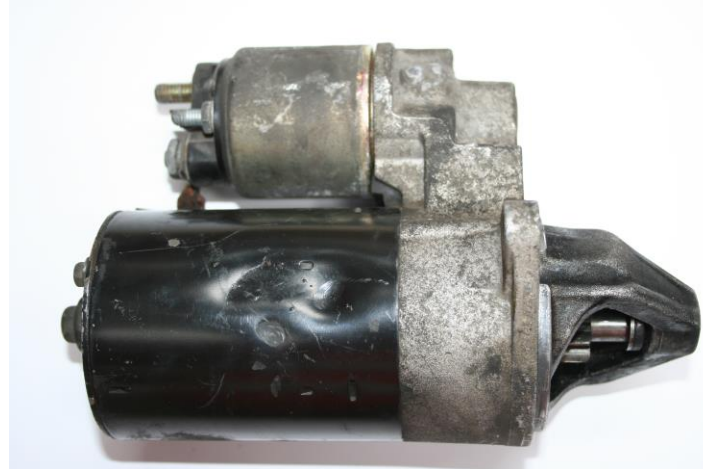
BROKEN / DAMAGED: Frame/Body/Yoke

You will notice from the picture that the Frame/Body/Yoke is damaged. On inspection of a unit, if the Frame/Body/Yoke shows any evidence of damage, then the core should be rejected.

In the event you need to reject the core back to the customer, you can inform them that if the starter motor body is damaged it is likely that it has been deliberately impacted in an attempt to re-start the vehicle. This causes damage to the starter motor's internal components meaning that the unit is unfit for remanufacturing.

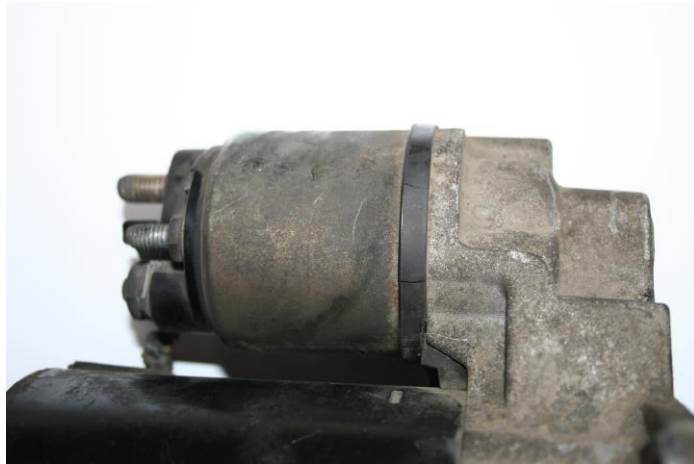
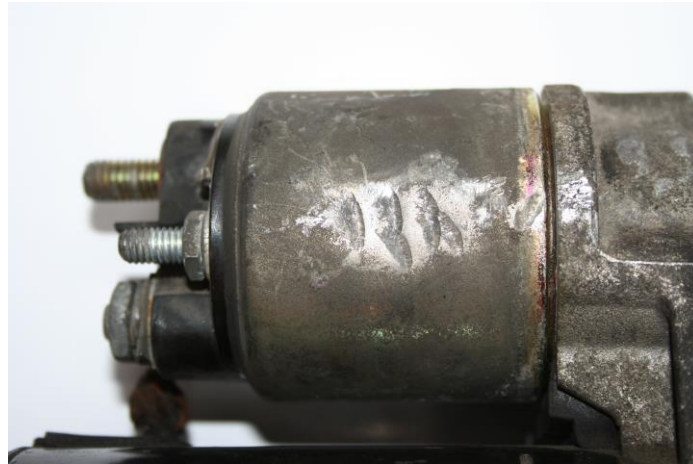
BROKEN / DAMAGED: Solenoid Body:

You will notice from the picture that the Solenoid Body is damaged. On inspection of a unit, if the solenoid body shows any evidence of damage, then the core should be rejected.

In the event you need to reject the core back to the customer, you can inform them that if the solenoid body is damaged it is likely that it has been deliberately impacted in an attempt to re-start the vehicle. This will cause damage to the solenoid's internal coil windings meaning that the unit is unfit for remanufacture.

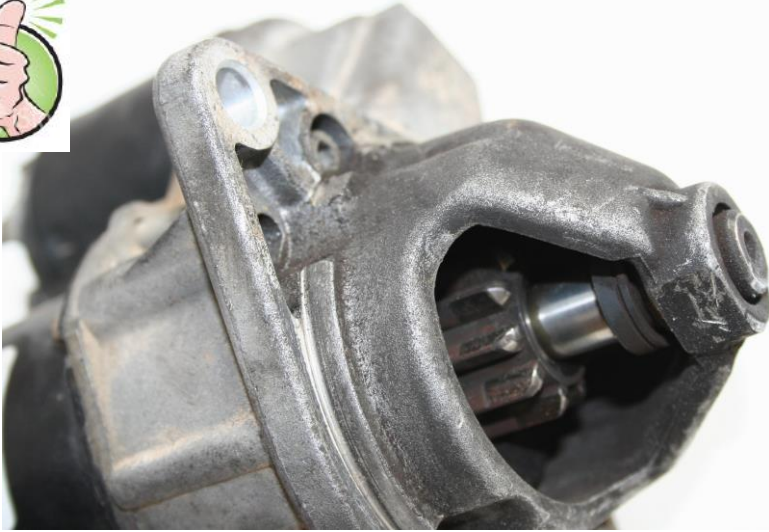
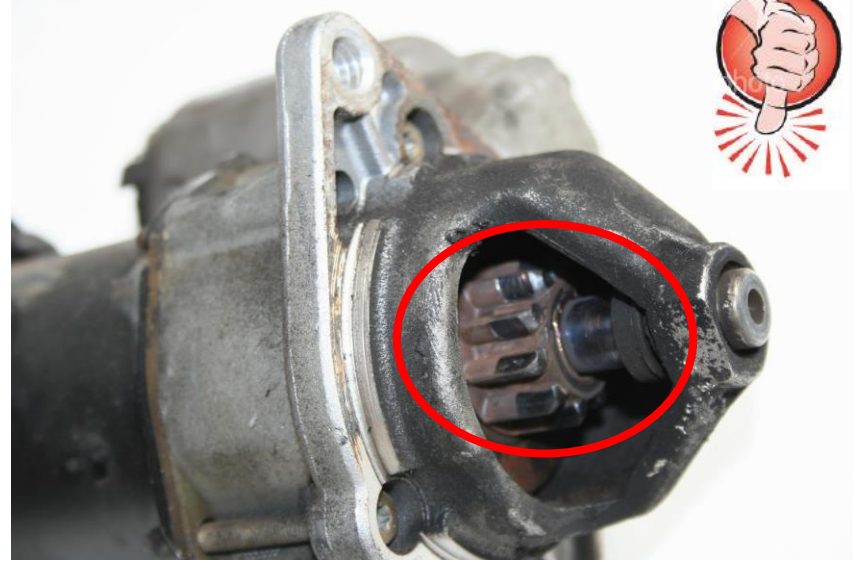
BURNT STARTER: Blue Drive and/ or shaft (over run)

You will notice from the picture that the pinion and/or shaft is a blue colour. This has been caused due to a permanent electrical feed (external of the starter motor) to the starter motor's solenoid causing the pinion to stay engaged with the ring gear resulting in it running continually at high speed. This condition is called "Over run". In most cases you can smell the burnt insulation from the solenoid coils. Sometimes the smell is so strong that you can smell it on just opening up the box.

Likely root cause: sticking key switch or relay

In the event you need to reject the core back to the customer, you can inform them that the pinion being discoloured (blued) is the result and not the cause of failure (a starter motor cannot burn itself out as it does not generate its own power). The cause is due to a permanent electrical feed to the starter's solenoid. The starter has been in an "Over run" condition. The core will not be accepted back for remanufacturing as this type of failure is likely to have damaged the internal components.

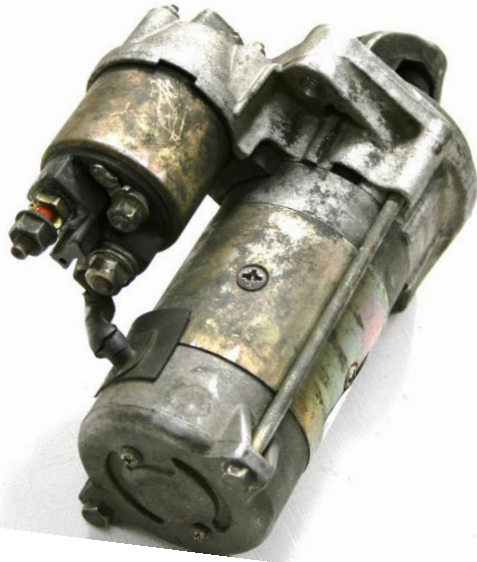
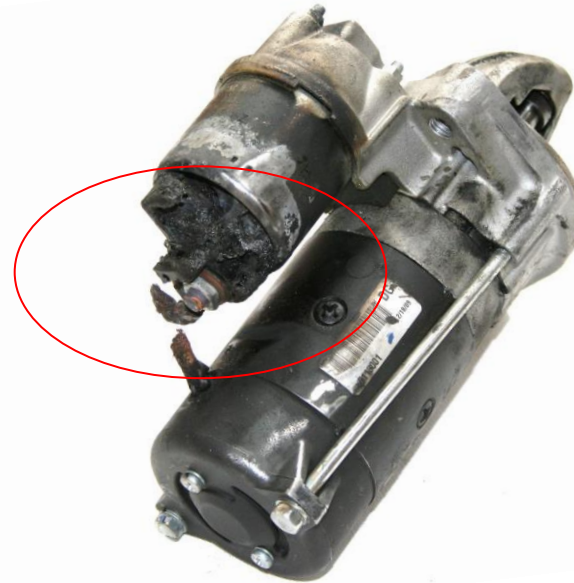
BURNT STARTER: Burnt motor (over cranked)

You will notice from the picture that the motor lead and cap is burnt. This is the result of over cranking or continual cranking where the key has been held on for a prolonged period. The heat generated due to over cranking or continual cranking will cause the starter motor to overheat. You can notice this by looking at the condition of the motor. In some cases the motor lead is so badly burnt that it has blown apart similar to a fuse.

Likely root cause: Low system voltage.

In the event you need to reject the core back to the customer, you can inform them that the motor lead being burnt/overheated is the result and not the cause of the failure (a starter motor cannot burn itself out as it does not generate its own power). You can inform the customer that the unit has been over-cranked or continually cranked over a prolonged period of time generating heat resulting in damage to the motor. Also, if the motor strap is burnt then it is likely that the internal motor is burnt out too. The core will not be accepted back for remanufacturing as this type of failure is likely to have damaged internal motor components.

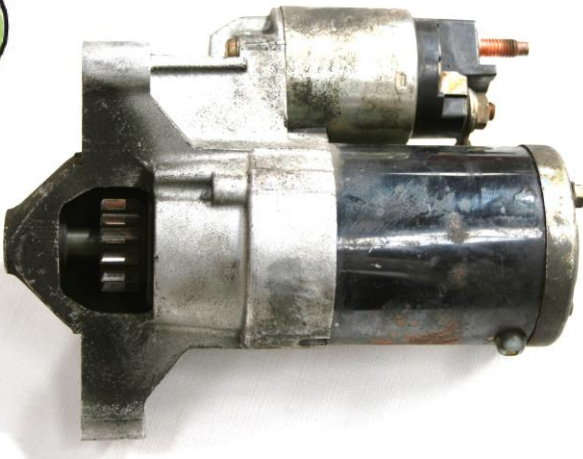
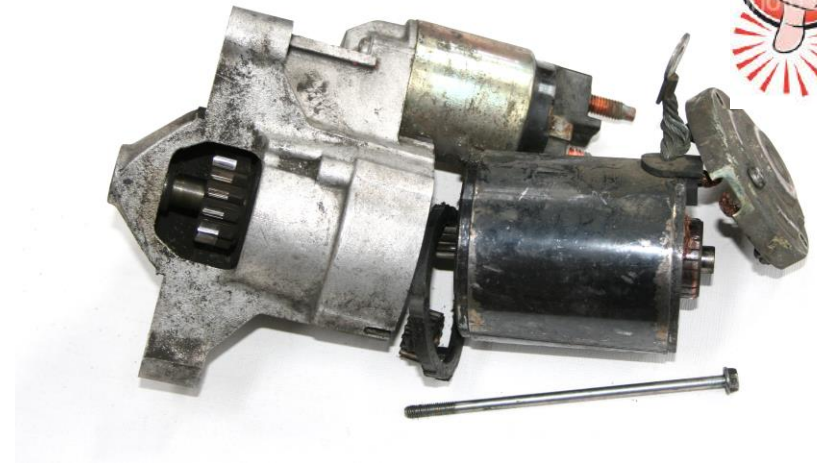
DISMANTLED UNIT: (An old core that has been taken apart)

A Starter Motor that has been removed from a vehicle should only be accepted if it is complete and has not been dismantled.

In the event you need to reject the core back to the customer, you can inform them that the core should be complete (as it would be on removal from the vehicle). There is no reason for it to be dismantled and you cannot be certain that all components are present.

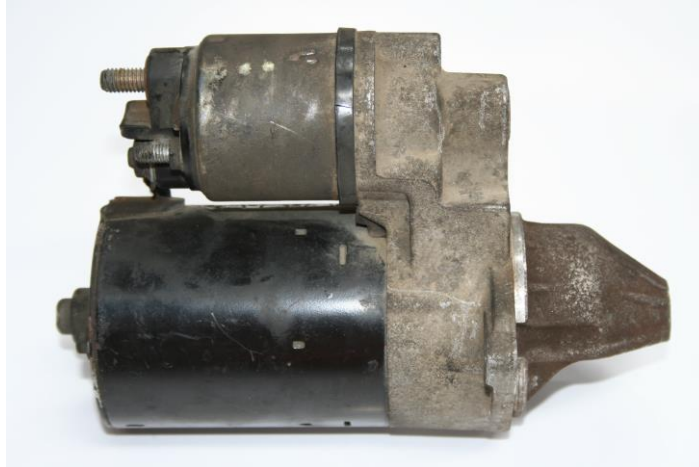
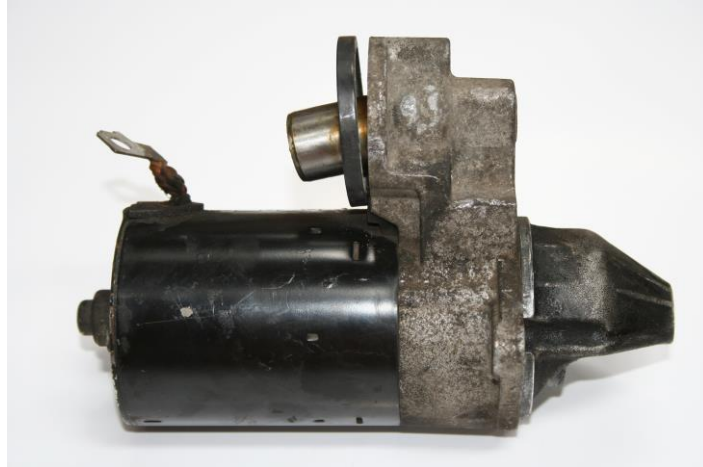
MAJOR COMPONENT MISSING: (Missing solenoid, nose housing, rear bracket, frame)

In the example pictured the SOLENOID is missing. Units that have any major parts missing should be rejected back to the customer.

In the event you need to reject the core back to the customer, you can inform them that the core would have been complete on removal from the vehicle and there is no reason for any parts to have been removed. All major components are required for Remy to be able to remanufacture the unit.

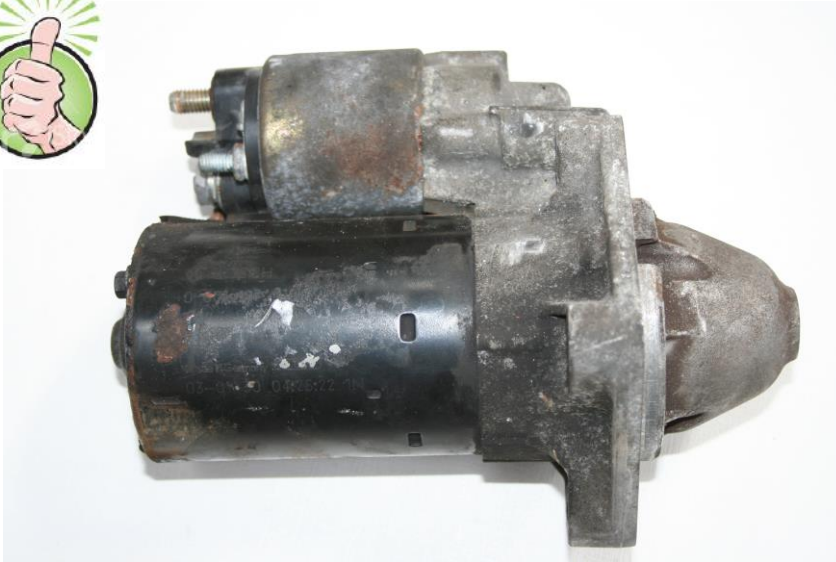
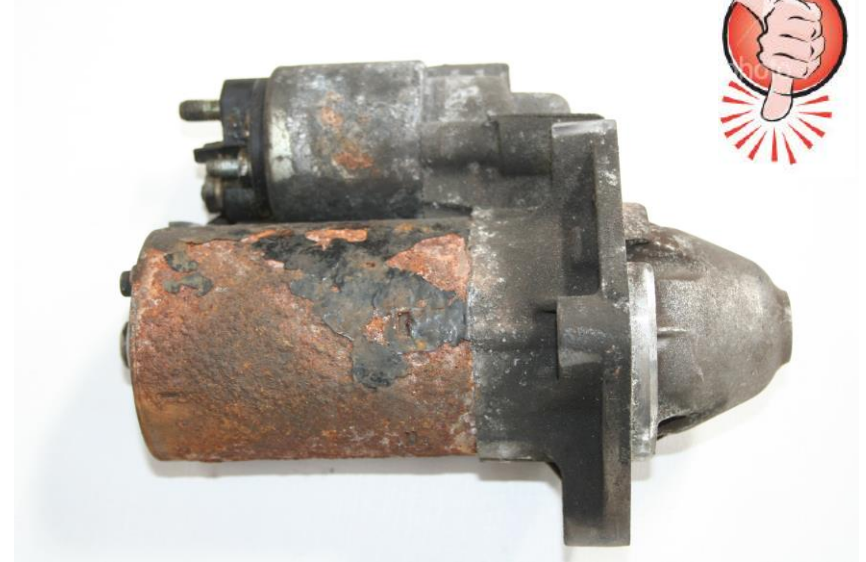
SEVERE CORROSION: (Where the corrosion on the frame/body is extreme)

Where the frame/body shows evidence of severe corrosion. You will notice that the picture on the right has a severely corroded outer frame.

In the event you need to reject the core back to the customer, you can inform them that it is likely that the starter motor has not recently been removed from a vehicle and due to the condition of the frame/ body, it is likely that the internal components are also corroded.

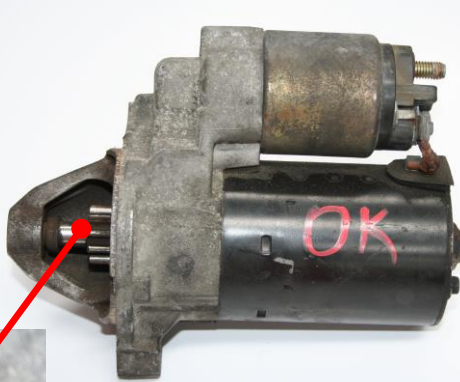
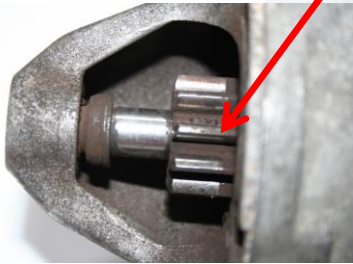
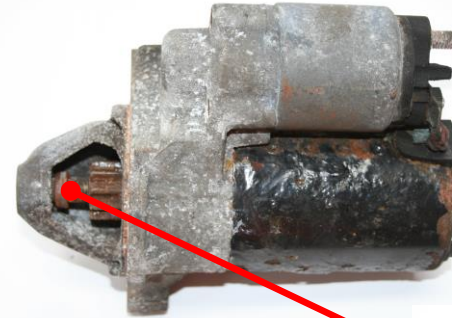
SEVERE CORROSION: (Where the corrosion on the shaft and pinion is extreme)

The pinion and shaft end of the starter motor would be expected to be in a reasonably clean condition with no signs of corrosion. You should be able to rotate the pinion by hand. If the starter is in such a condition that the pinion will not rotate and is severely corroded then it is likely that the unit has not recently been removed from the vehicle and should be rejected back to the customer.

In the event you need to reject the core back to the customer, you can inform them that it is likely that the starter motor has not recently been removed from a vehicle. This is due to the severely corroded frame/body/pinion or shaft. It is likely that other internal components are also corroded.

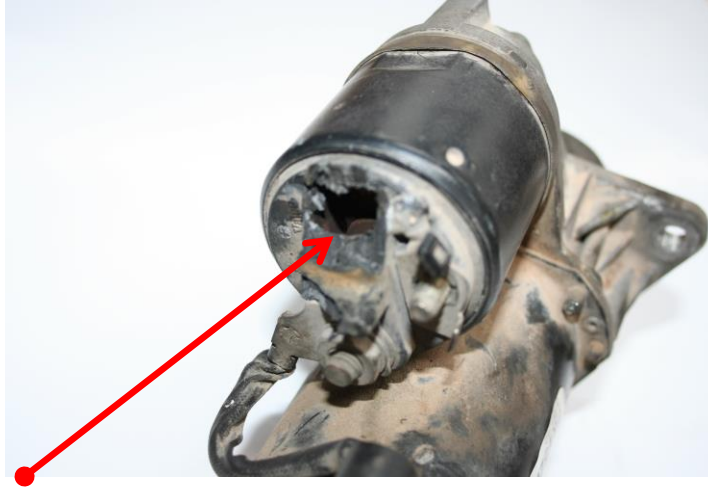
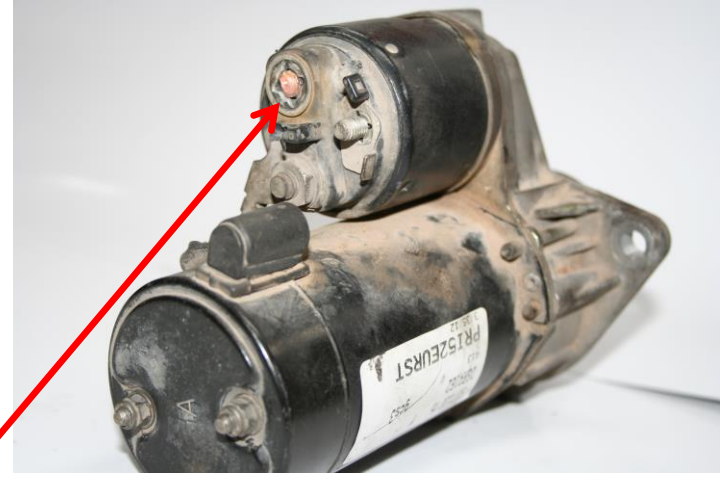
SOLENOID CAP and TERMINALS :

In the case where the Solenoid Cap (Plastic) and Terminals are:

- Broken (Damaged)
- Cracked
- Missing
- Terminals broken off
- Terminals missing
- Terminals cross threaded

Note: All of the above will be ACCEPTED

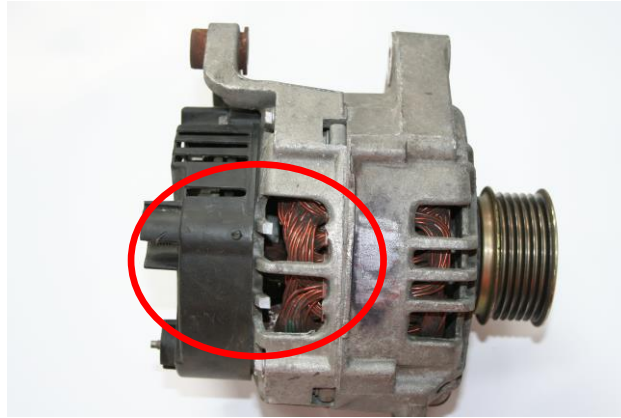
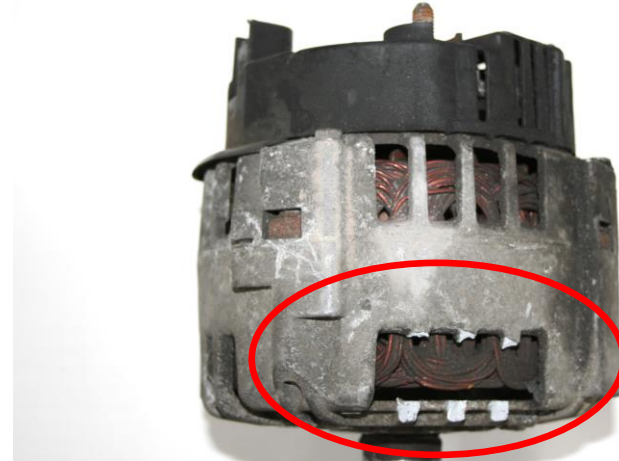
BROKEN / DAMAGED / CRACKED BRACKETS: (Broken Fins)

Alternators with 2 or more broken fins on the same side of the same bracket- NOT ACCEPTABLE

You will notice from the picture that the BRACKET is broken/damaged. Units that have broken brackets should be rejected back to the customer. In some cases the bracket will show evidence of a clean break and it is likely that the bracket has been broken/damaged during the removal of the unit, dropped or even a vehicle impact.

In the event you need to reject the core back to the customer, you can inform them that this type of damage has been caused by mishandling. The fins are required to protect the internal components in a remanufactured unit, and multiple breaks can compromise the strength of the bracket. Therefore a core which has this type of damage cannot be accepted for remanufacture.

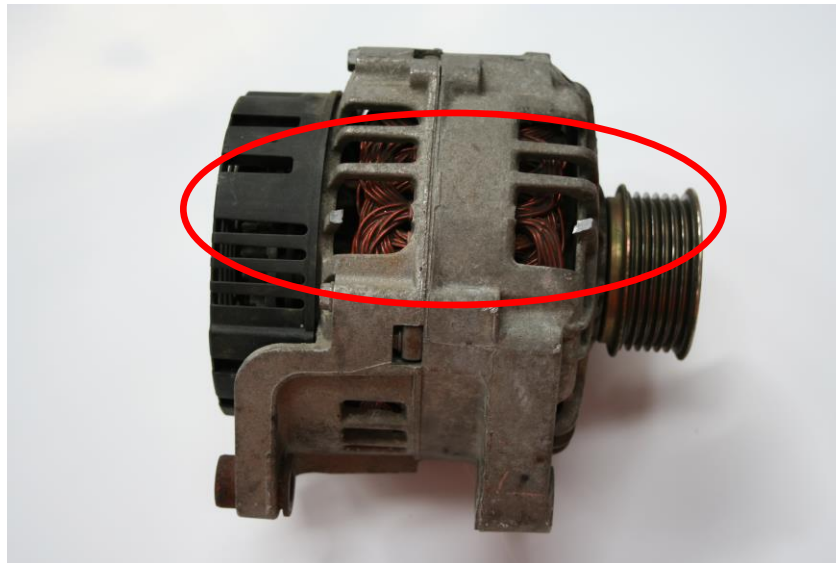
ACCEPTABLE

Alternator casings consist of 2 brackets which are bolted together.

It is acceptable for a maximum of 2 fins to be broken on each bracket (4 in total per core)
BUT if there are 2 broken fins on one bracket, they must be on different sides.

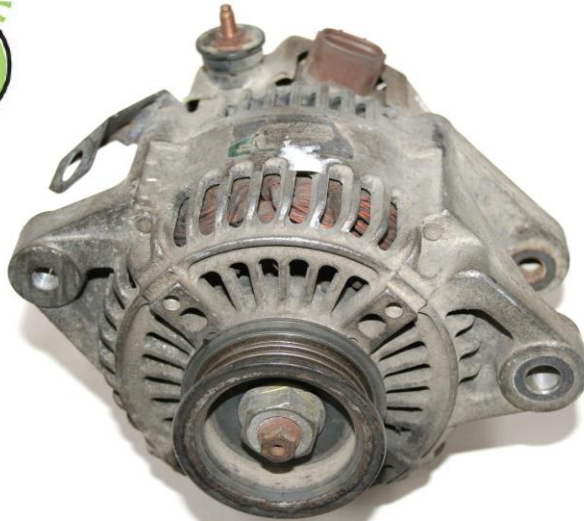
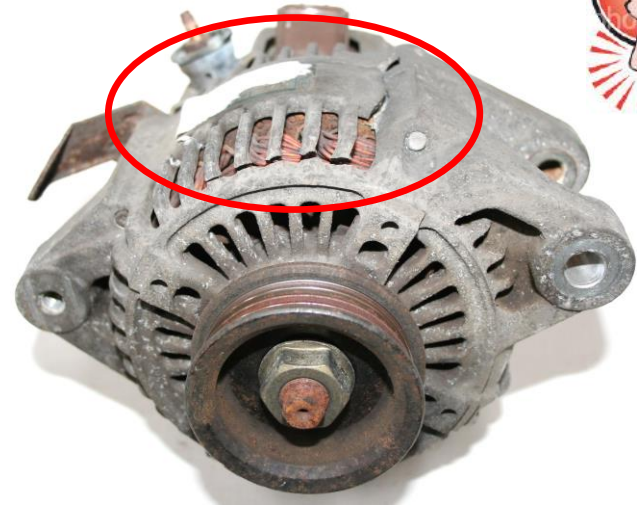
BROKEN / DAMAGED / CRACKED BRACKETS : (Cracked Brackets)

You will notice from the picture that the BRACKET is damaged. Units with this type of damage should be rejected back to the customer. On inspection of a unit, if any of the brackets show evidence of a break, then it is likely that the bracket may have been broken during the removal of the unit, been dropped or even involved in a vehicle impact.

In the event you need to reject the core back to the customer, you can inform them that this type of damage has resulted in the unit being unfit for remanufacture as the damage cannot be repaired.

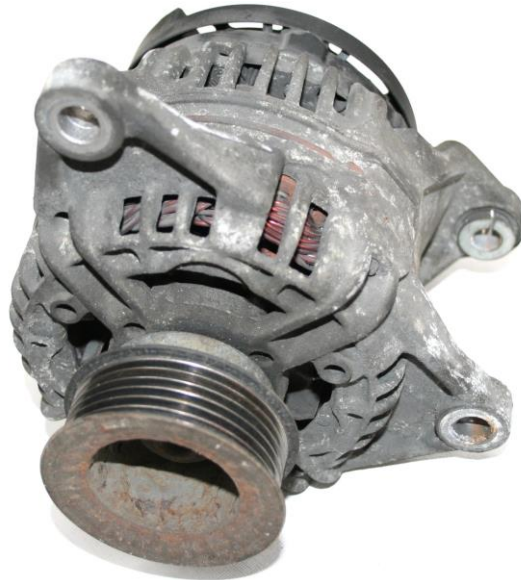
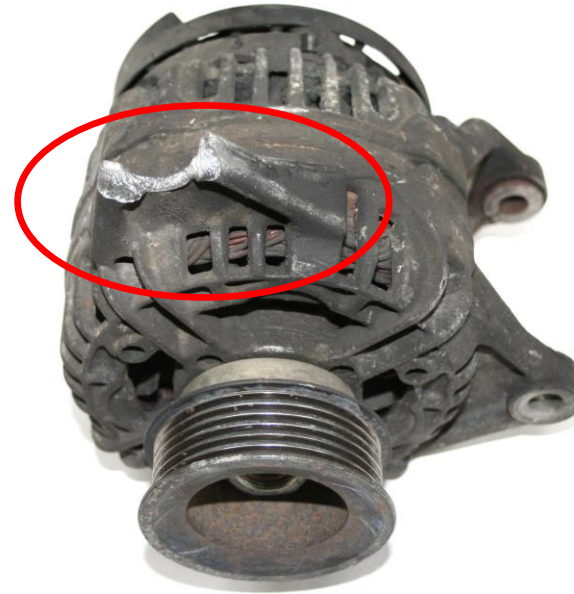
BROKEN / DAMAGED / CRACKED BRACKETS : (Broken Mounting Bracket)

You will notice from the picture that the MOUNTING BRACKET is broken/damaged. Units that have broken brackets should be rejected back to the customer. On inspection of a unit, if any of the brackets show evidence of a break, then it is likely that the bracket may have been broken during the removal of the unit, been dropped or even involved in a vehicle impact.

In the event you need to reject the core back to the customer, you can inform them that this type of damage has resulted in the unit being unfit for remanufacture as the damage cannot be repaired.

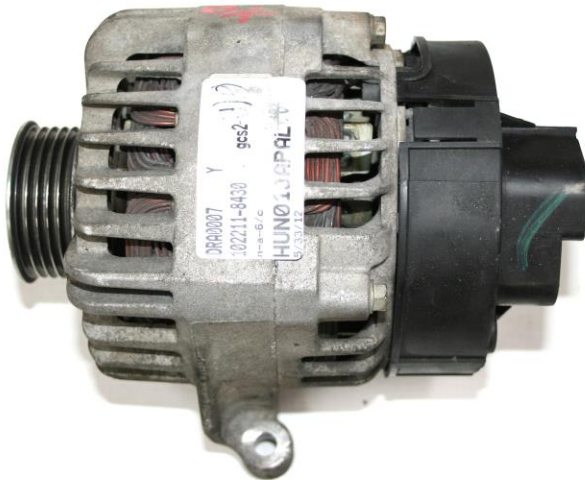
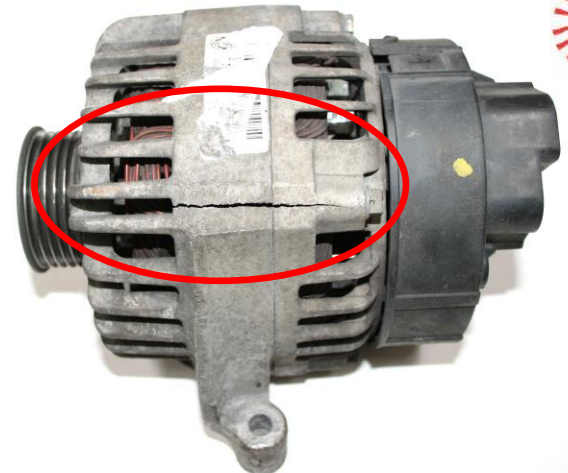
BROKEN / DAMAGED / CRACKED BRACKETS: (Hairline Cracks)

You will notice from the picture that the BRACKET is cracked. Units that have hairline cracks in the bracket should be rejected back to the customer.

In the event you need to reject the core back to the customer, you can inform them that this type of damage makes the core unsuitable for remanufacture as the damage cannot be repaired.

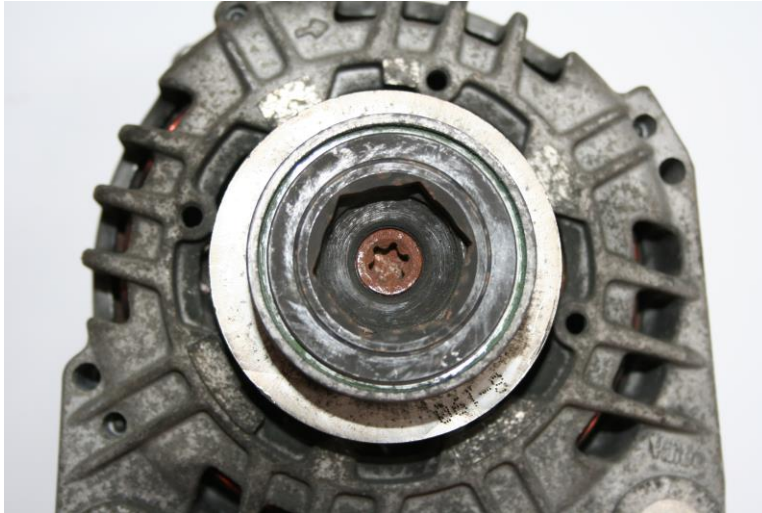
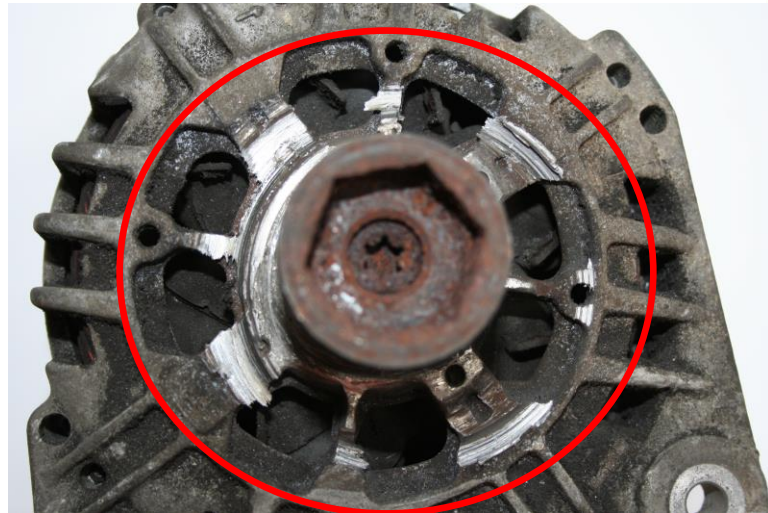
DAMAGED BRACKET: DRIVE END (D/E) BRACKET

You will notice from the picture that the DRIVE END BRACKET (D/E Bracket) is damaged. If the clutch pulley is missing the unit will be accepted as old core under the condition that the drive end bracket is in good condition with no signs of damage.

Regardless of whether the pulley is on the unit or not, if on visual inspection you can see that the D/E bracket is damaged then the core is rejected.

In the event you need to reject the core back to the customer, you can inform them that this type of bracket damage makes the core unsuitable for remanufacture as the damage cannot be repaired.

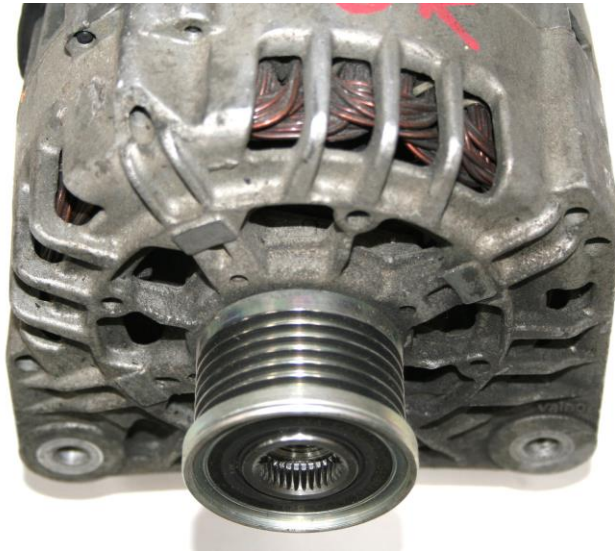
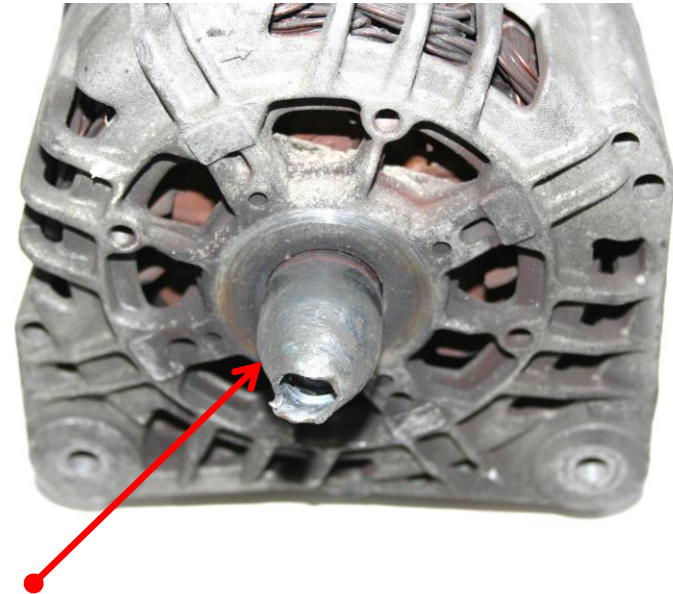
DAMAGED ROTOR SHAFT:

You will notice from the picture that the ROTOR SHAFT is damaged. If the clutch pulley is missing the unit will be accepted as old core providing the rotor shaft is in good condition, with no signs of thread, heat and/or mechanical damage.

In the event you need to reject the core back to the customer, you can inform them that this type of bracket damage makes the core unsuitable for remanufacture as the damage cannot be repaired.

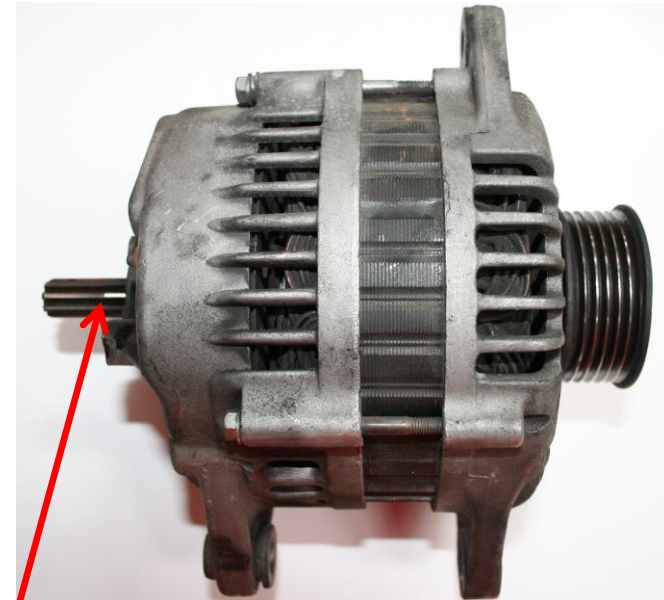
Missing Vacuum Pump

You will notice from the picture that the VACUUM PUMP is missing. Units that have any major parts missing should be rejected back to the customer.

In the event you need to reject the core back to the customer, you can inform them that the core should be complete (as it would be on removal from the vehicle). There is no reason for it to be dismantled and you cannot be certain that all components are present.

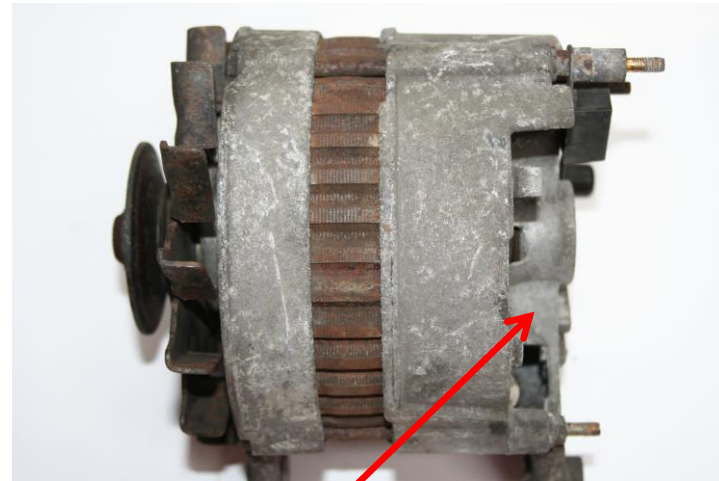
Missing Regulator

You will notice from the picture that the REGULATOR is missing. Units that have any major parts missing should be rejected back to the customer.

In the event you need to reject the core back to the customer, you can inform them that the core should be complete (as it would be on removal from the vehicle). There is no reason for it to be dismantled and you cannot be certain that all components are present.

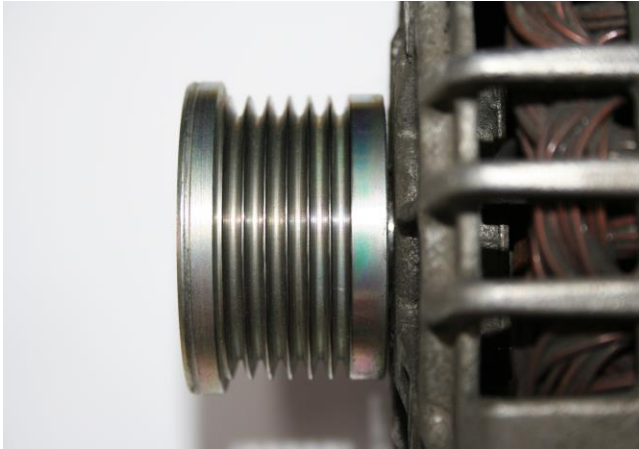
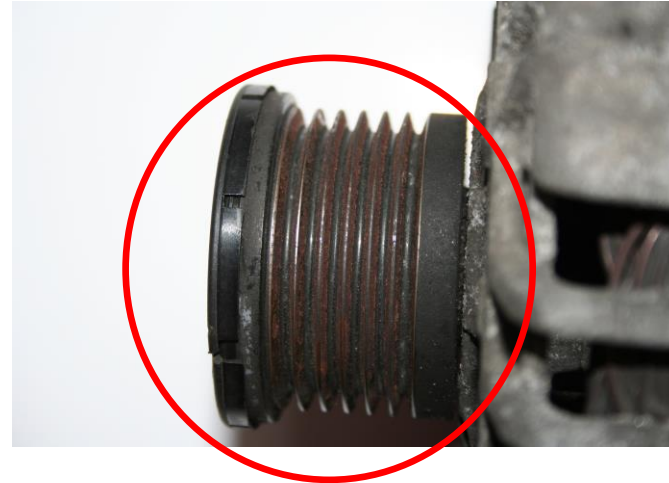
SEVERE CORROSION AND PULLEY SEIZED: (Where severe corrosion has resulted in a seized pulley)

The alternator's pulley should be in reasonably clean condition as it is covered by the drive belt and is continually rotating while the vehicle's engine is running.

If the pulley and unit show evidence of severe corrosion and the pulley will not rotate, then the unit should be rejected back to the customer as it is likely that this unit has not recently been removed from a vehicle. (If the pulley is seized/locked up with no signs of corrosion/damage then the core will be accepted).

In the event you need to reject the core back to the customer, you can inform them that it is likely that the alternator has not recently been removed from as the pulley would be protected by the belt on the vehicle. The condition of the pulley tells us it is likely that the internal components are also corroded and the unit is unsuitable for remanufacture.

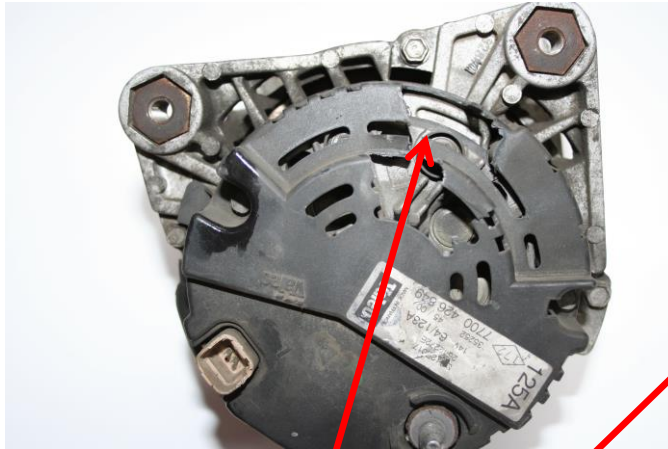
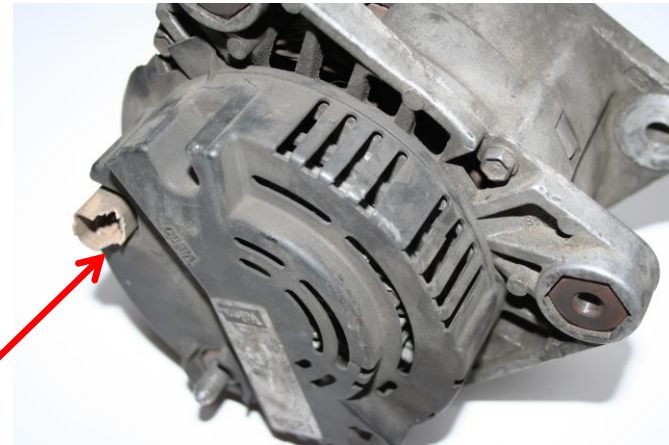
REAR COVERS AND TERMINALS :

Acceptable Damage

In the case where the Cover and Terminals are:

- Broken (Damaged)
- Cracked
- Missing
- Terminals broken off
- Terminals missing
- Terminals cross threaded

Note: All of the above will be ACCEPTED
