Technical Bulletin

Disc run-out

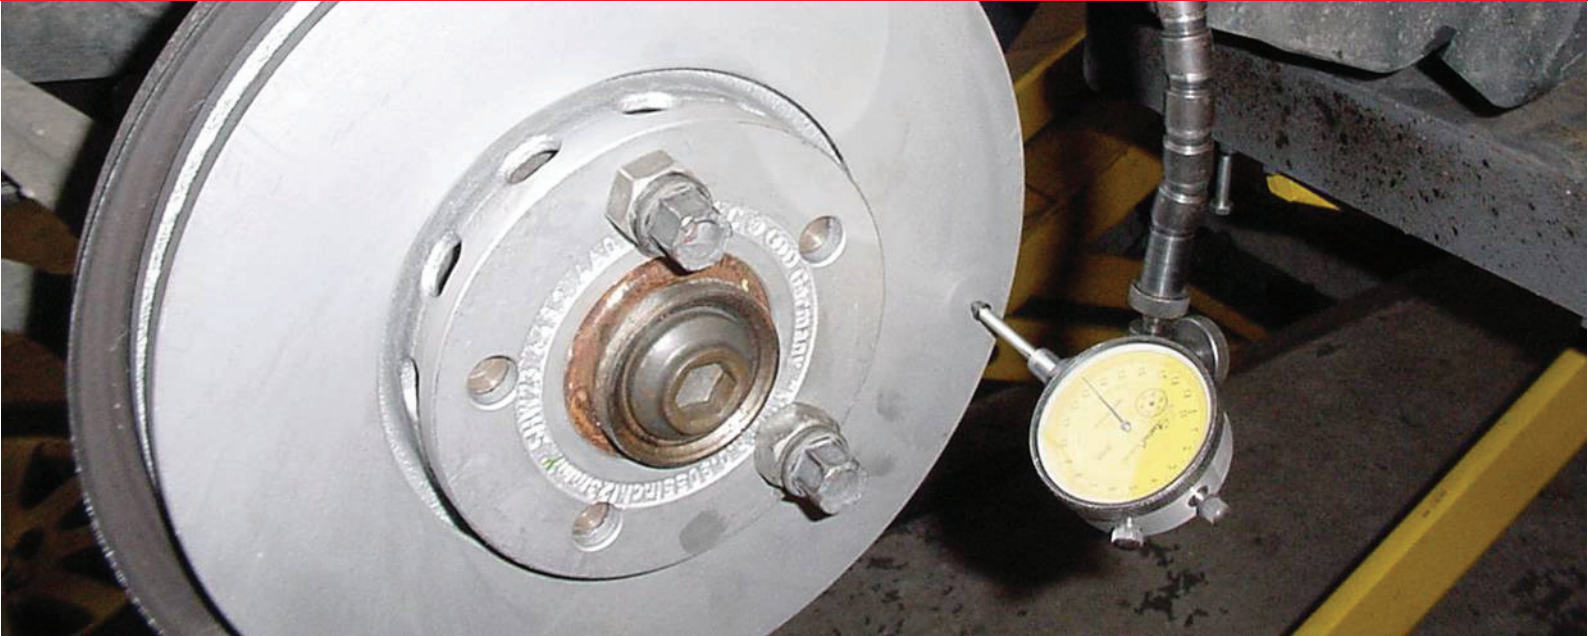
When installing the new brake disc ensure that the surface of the hub is clean and free from damage. All too often disc run-out is caused by imperfections on the hub surface, resulting in the disc not fitting true on the hub.

If possible measure the run-out using a dial gauge. It should be no more than 0.1mm. The run-out on the hub itself should not exceed 0.002mm.
