## 515074 - Heater Resistor For: VAG Range

Please be aware if failure of the heater resistor occurs, the replacement of the resistor may not solve the problem. Please check the following:

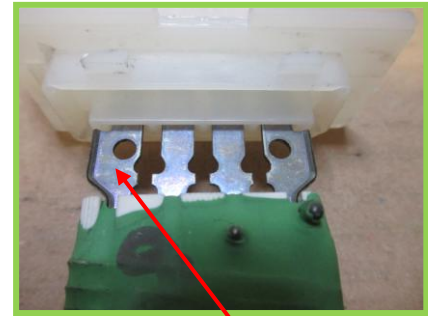
Heater controls for VAG vehicles are only working on the highest setting.

Thermal damage on the pins of the electrical connector due to an overload.

*Blueing on the resistors pins*

**When water leaks onto the blower motor it may generate high current and overload the heater resistor, causing thermal damage.**

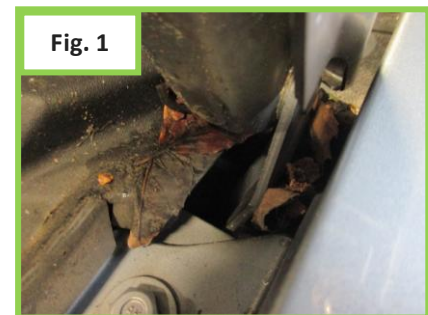
Fig. 1

1. Ensure that the windscreen drains are clear of debris (Fig. 1).
2. Ensure that the plastics are covered, correctly fitted and the rubber weather seal is fitted correctly.
3. Ensure no water is leaking on the blower motor.
4. Check that the scuttle panel, specifically the drains around the cabin air filter are not clogged (Fig. 2).

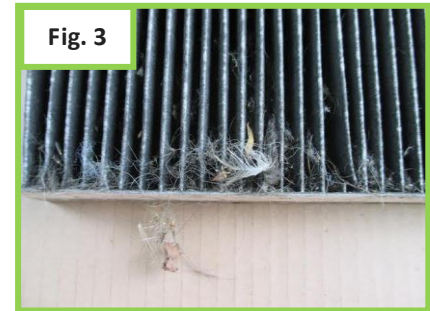
1. Switch off the engine and all electrics.
2. Rotate the blower motor fan to check for free movement. If there is resistance then the bearing could be rusted internally. This can cause the blower motor to overload .
3. Ensure that the pollen filter is not clogged (Fig. 3). This can cause the blower motor to overload.
4. Ensure the blower motor has no visible rust (Fig. 4).

If any of the above has occurred, it is advised to replace both blower motor and pollen filter. If a new heater resistor is fitted to a vehicle displaying the above symptoms then it will be very likely that the thermal fuse on the resistor will blow due to the additional strain.
