509536 failure due to a faulty wiring loom

Part Number: 509536

For vehicle: Renault Megane MK 2 2002 - 2008

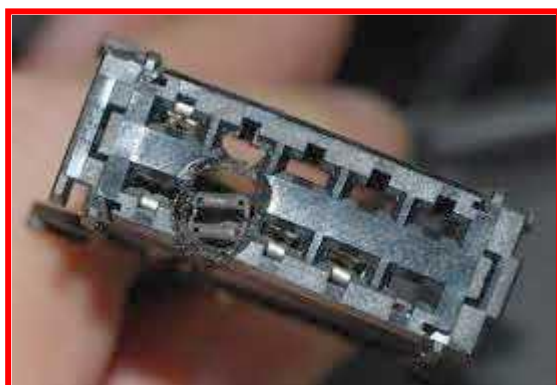
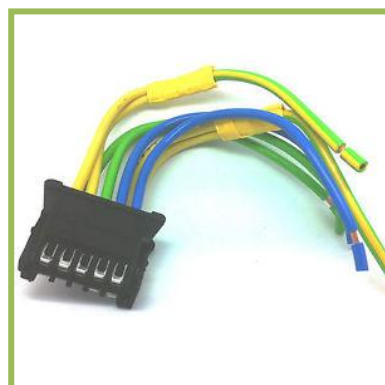
The Valeo Service Technical department have had several claims stating that heater resistor 509536 fails immediately or after several days of being fitted to the HVAC system. After investigating the issue Valeo technicians have identified that the heater resistor itself is not at fault and the defect is with the wiring loom.

Valeo Service is also aware of an aftermarket wiring loom upgrade/repair kit that has extra cables (as seen above). This isn't a mistake; these extra cables share the current between adjacent terminals, to assist with the overheating issue in the original.

If this occurs the heater resistor or blower motor will not need replacing, only the wiring loom itself.

Please note: to eliminate the possibility of making a wiring mistake Valeo Service recommend cutting and crimping only one cable at a time. The loom comes ready-terminated with crimp connectors, so only one lot of crimping and stripping is required.
