Clutch fork fracture checks before fitment of 826583, 826499 and 826234

Part Number: 826583, 826234, 826499

For Vehicle: BMW Mini

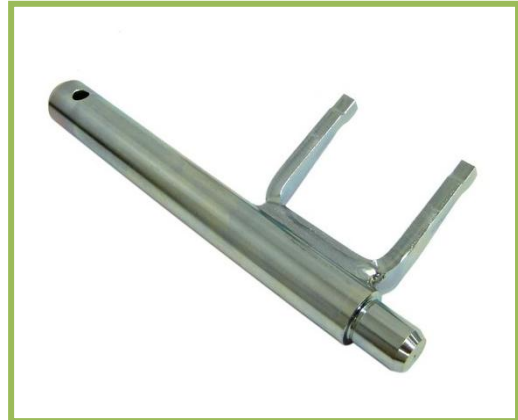
The causes of the problem can lie with fractures occurring in the weld of the clutch fork which in turn stops the clutch from fully engaging. This can result in the driver experiencing symptoms of difficult gear selection (especially reverse), judder and sometimes a dragging clutch.

It is very important that the clutch fork on these vehicles is inspected and checked for any damage during a clutch fitting. Due to the lengthy time necessary to replace a clutch it is best practice to replace this component during every clutch change.

Replace the clutch fork on every clutch change
