Water ingress into the wiring connectors

Part Number: 579756, 574281

For Vehicle: Renault Scenic Models

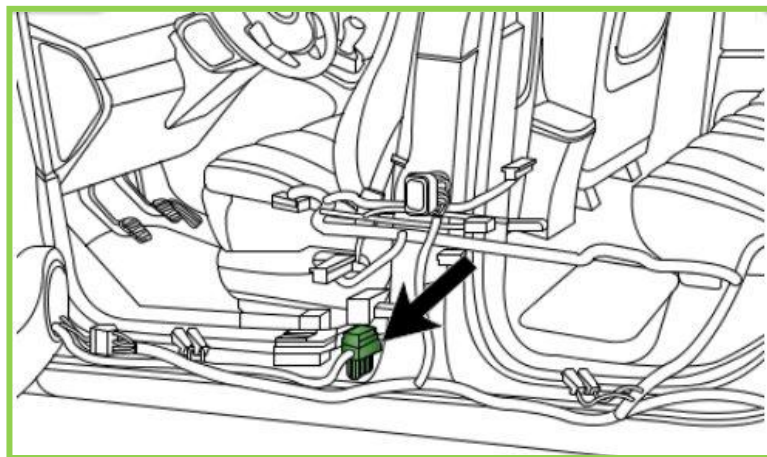
After investigating the issues with local garages Valeo technicians have identified that the rear wiper system is not at fault and the issue is caused by water ingress into the wiring connectors under the sill along the driver's seat.

This water ingress is a result of the wiper compartment water drain becoming clogged.

As a result of the water ingress it is best practice to check connectors for corrosion and amend or renew the connector. Once performed the voltage to the window motor, wiper motor and central locking should be checked for correct operation.
