T.S.B. No.:
EC003 / 08

PRODUCT:
Heaters

SUBJECT:
Premature leakage

Technical Services **Bulletin**

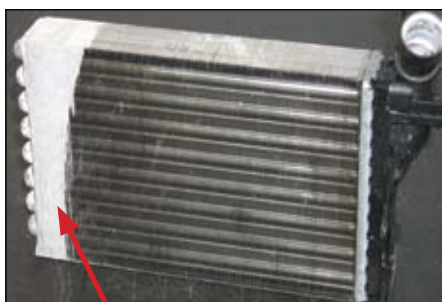
*Image 1
Image shows complete heater radiator leaking after nine months of being fitted to the vehicle.*

Valeo Technical Services have been receiving calls from some garages regarding heaters leaking prematurely, usually around the bottom U-bends of the pipes on the heater core. (see image 1.) The pipes include turbulators which are designed to create the coolant swirl in the tubes, these WILL collect foreign matter if the system is not flushed out correctly and cause premature failure of the heater. (see image 2.) If foreign matter collects on the turbulator there is a short period of time during which the corrosion process takes hold. Valeo Technical Services have also found that this blockage creates a build up of pressure in front of the foreign matter, causing a very fine high pressure spray jet of coolant which can blow holes in the U-bends. (see image 3.)

Valeo Technical Services strongly advise that the cooling system is flushed through thoroughly, using a cooling system flush and an additive cooling system conditioner with the replacement coolant.

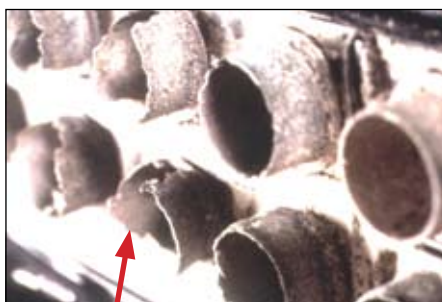
*Image 2
Image reveals how corrosion typically attacks the aluminium tubes inside the heater core. When cooling systems are not flushed through thoroughly, or when incorrect / insufficient quantities of antifreeze are used.*

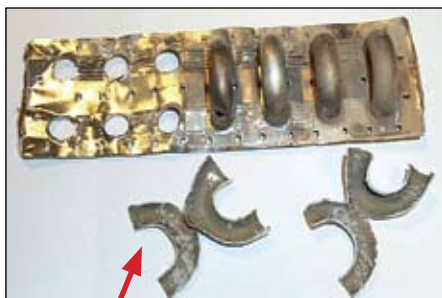
*Image 3
Image reveals a cutaway section of the U-bends. There are visible signs of foreign matter collected on the inner walls of the U-bends.*

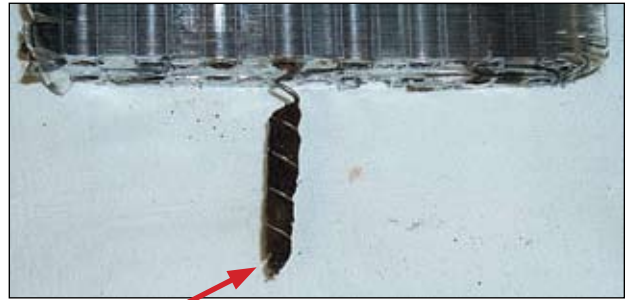
Image 4
The image reveals how foreign matter collects on the turbulators, which accelerates the corrosion process of the U-bends.

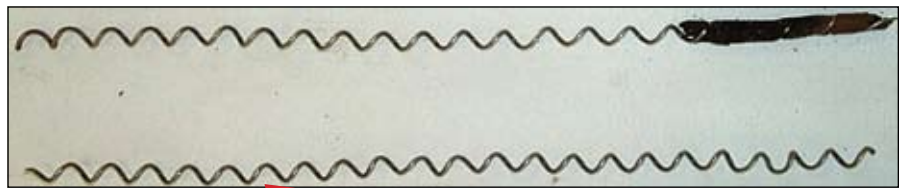
Image 5
The image shows the turbulator spiral formation which creates coolant swirl as it travels through the tubes and maintains maximum heat exchange.

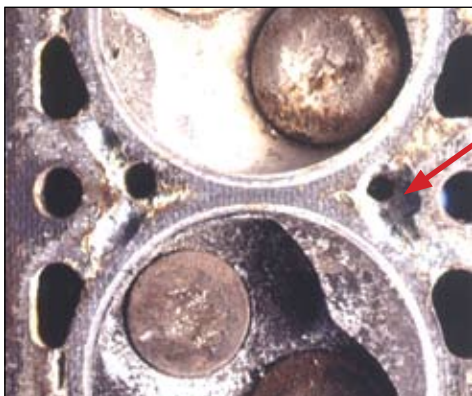
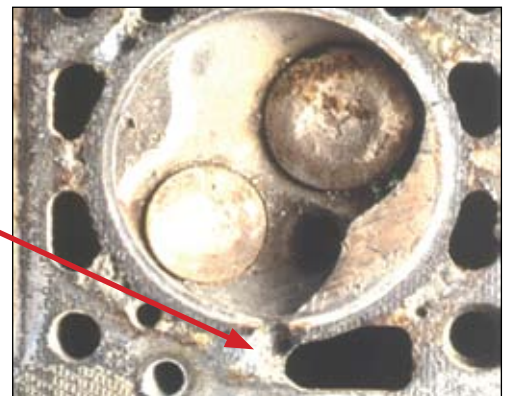
Images 6 and 7
Image reveals how corrosion attacks cylinder head faces when poor or insufficient anti-freeze used. This metallic foreign matter circulates around the cooling system in the coolant, blocking the smaller orifices in its path. (i.e Heater U-Bends.)

12. When this process is completed screw the drain plug back into engine block, and refill with 50% antifreeze - Monoethylene Glycol (MEG).
13. Add a cooling system conditioner, (Valeo Technical used proprietary brand cooling system conditioner) this product should contain inhibitors protecting the aluminium surfaces against acidic corrosion, electrolytic corrosion, and cavitation erosion, all of which accelerate the corrosion process.
