| Post Equipment | Beep and Park | Control Unit | All Makes

Beep and Park interference

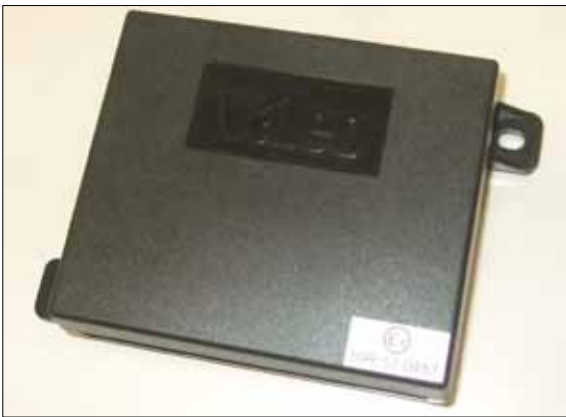
After investigation and testing on a vehicle with this particular issue, it has been found the Beep and Park control unit was experiencing some interference from another system fitted in the vehicle and the unit will need to be relocated or a shield fitted if relocation is difficult.

Valeo beep and park control unit

To test if a unit is experiencing interference, move the unit to another, temporary location away from any electrical units and check if the system is working correctly. This is to clarify there is not a fault with the beep and park kit.

If the unit is working correctly and does not experience the same faults, the unit will need to be relocated.

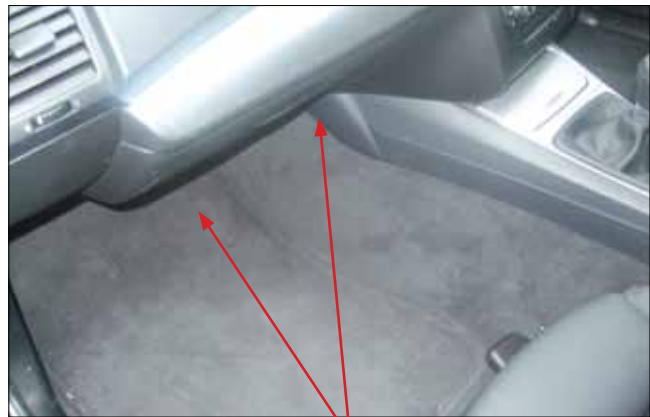
Units fitted in this area may be affected by interference

This issue is more likely to occur in newer vehicles when a control unit is fitted near a number of standard fit control units, in the vehicles front centre console for example.
