Top 3 installation errors to avoid on kits 835035 and 828002

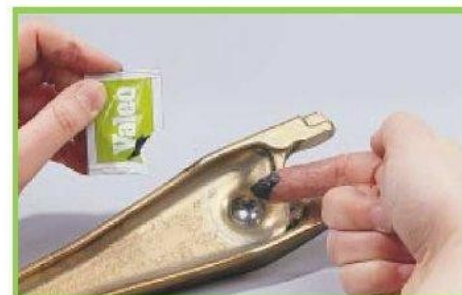
The Valeo Service warranty department receive a number of returned clutches with issues of juddering or slipping of the clutch. After inspecting the returned parts, there is clear evidence of incorrect, too much or incorrectly applied grease which has radiated from the drive plate hub from centrifugal force and coated the friction surface. Once the grease has come into contact with the friction surface, the coefficient of friction of the drive plate is reduced so it can no longer transmit all of the engine torque resulting in the effect of juddering or slipping. Always check the condition of the gearbox and the engine to prevent oil and other contaminants leaking into the gearbox.

Use the grease applied in the kit sparingly

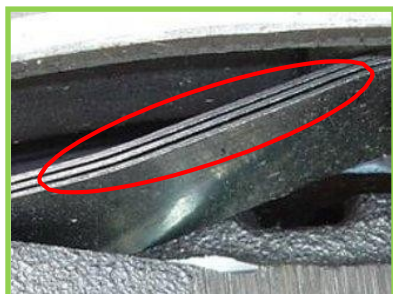
**Figure 1, separated drive strap*

The clutch cover in 828002 and 835035 can only be mounted correctly one way on to the flywheel dowels. It is important to identify that the timing mark on the flywheel does not need to be situated between the two prongs on the clutch cover (see figure 1). Failure to do mount the cover in the correct position and to the correct torque (check fitting instruction) can result in separated drive straps. A separation on the drive strap (see figure 2) will result in reduced pressure plate lift in this area of the cover, which may result in gear selection difficulties.

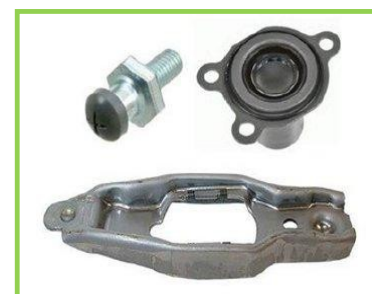
**Figure 3, clutch ball pin, guide tube and release arm*

The Valeo Service warranty department receive a number of returned clutches with issues of juddering or slipping of the clutch. After inspecting the returned parts, there is clear evidence of premature wear to the diaphragm fingers. This is a result of incorrect preload (the release mechanism being incorrectly set) to the release mechanism of the vehicle. This can be attributed to a number of commonly worn parts fitted to the vehicle including the clutch ball pin and clutch release lever (figure 3), the gear synchro hubs (in particular the third and fourth) and both gear wheels.

**Failure to check and replace where necessary will result in difficult gear change or vehicle judder and/or vibration.*
