Top 3 installation errors to avoid on kits 826729 and 826712

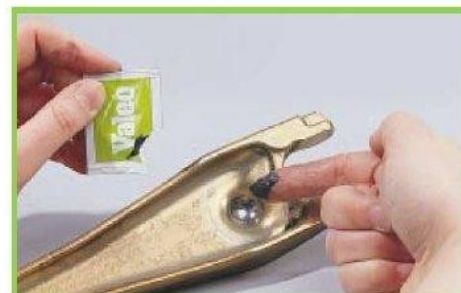
Grease contamination

The Valeo Service warranty department receive a number of returned clutches with issues of juddering or slipping of the clutch. After inspecting the returned parts, there is clear evidence of incorrect, too much or incorrectly applied grease which has radiated from the drive plate hub from centrifugal force and coated the friction surface. Once the grease has come into contact with the friction surface, the coefficient of friction of the drive plate is reduced so it can no longer transmit all of the engine torque resulting in the effect of juddering or slipping. Always check the condition of the gearbox and the engine to prevent oil and other contaminants leaking into the gearbox.

Use the grease applied in the kit sparingly

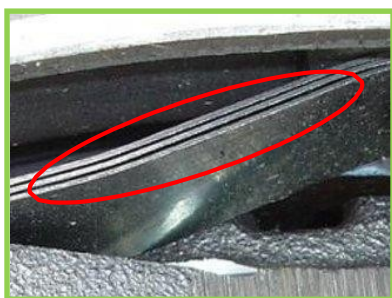
**Figure 1, separated drive strap*

The clutches 826729 and 826712 fit to the same vehicle but the choice is dependent on the flywheel technology. 826729 is only suitable for the LUK design flywheel. 826712 is only suitable for the Sachs design flywheel. Ensure the clutch is fitted to the correct flywheel and to the correct torque (check vehicle manufacturer guideline). Over torque can result in separated drive straps. A separation on the drive strap (see figure 1) will result in reduced pressure plate lift in this area of the cover, which may result in gear selection difficulties.

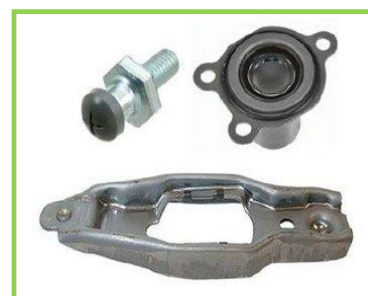
**Figure 2, clutch ball pin, guide tube and release arm*

The Valeo Service warranty department receive a number of returned clutches with issues of juddering or slipping of the clutch. After inspecting the returned parts, there is clear evidence of premature wear to the diaphragm fingers. This is a result of incorrect preload (the release mechanism being incorrectly set) to the release mechanism of the vehicle. This can be attributed to a number of commonly worn parts fitted to the vehicle including the clutch ball pin and clutch release lever (figure 3), the gear synchro hubs (in particular the third and fourth) and both gear wheels.

**Failure to check and replace where necessary will result in difficult gear change or vehicle judder and/or vibration.*
