Blue Print Bulletin

Toyota Celica 2.0 GT Injection (ST182/3S-GE) CV Joints

Date Issued: 01/07/02

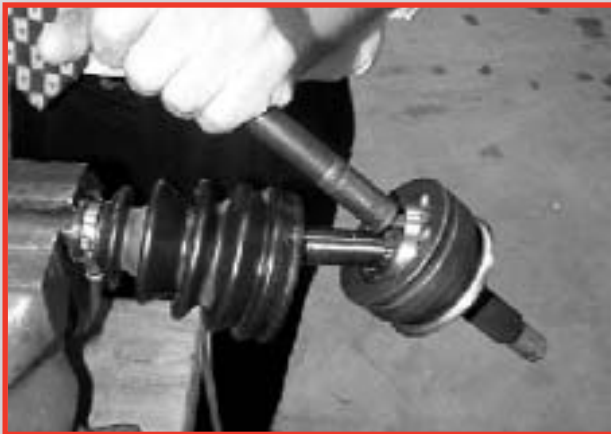
Removal of the original joint

Difficulty is often encountered removing the original CV joint from the driveshaft on the above application. This is because the manufacturer uses a 'heavy duty' type **internal** circlip to retain the joint. It is sometimes necessary to cut or grind the original joint from the shaft, taking great care not to damage the shaft splines. If a disc grinder is used, the grease must be cleaned out to prevent the likelihood of fire.

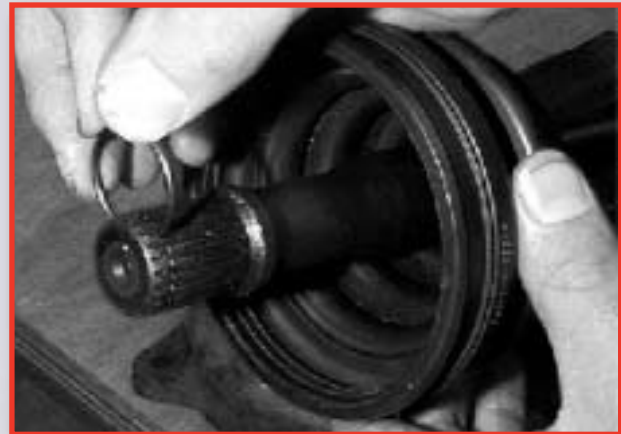
Fitment of new Blue Print CV Joint (using new internal clip supplied)

To assist you with the replacement, Blue Print CV Joints are supplied with the internal clip, high specification boot, two steel boot clips, retaining nut and locking pin plus 100gm of the correct specification grease.

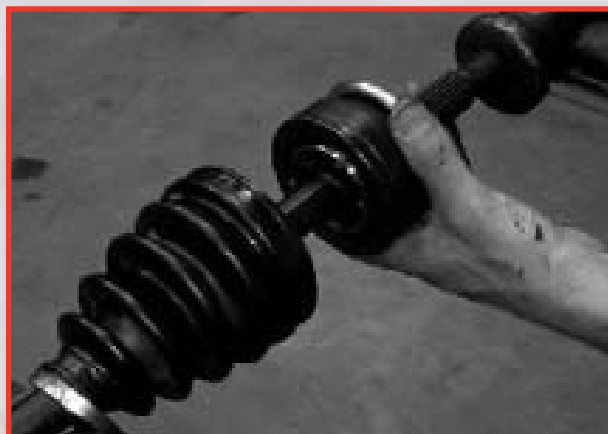
Installation of new joint
