# Correct installation of type 2.1 Bearings

FBK809, FBK994, FBK1063, FBK1092, FBK1097, FBK1101, FBK1113, FBK1171, FBK1173, FBK1198, FBK1199, FBK1216

WBTB 0001

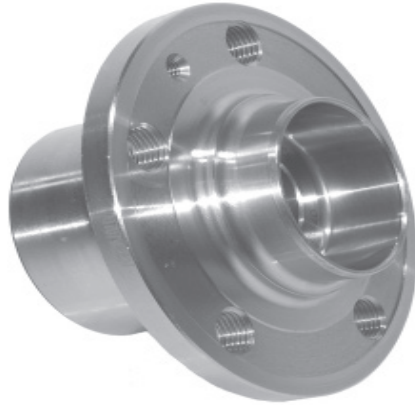
Fig 1

Whilst the Type 2 bearing (single flange hub fig 1) has been in use for some time now, a newer version has become increasingly common in the market place.

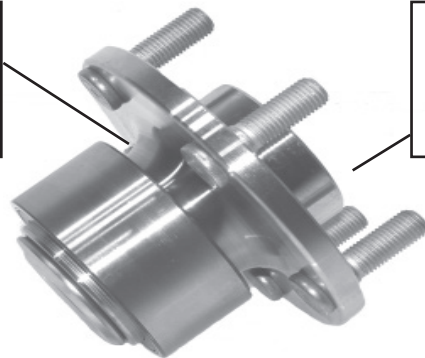
Fig 2

This is the Type 2.1 bearing (as shown in fig 2). Where this type of bearing differs is that the wheel flange is integral with the inner races of the bearing.

Press in bearing using outer race

DO NOT APPLY LOAD TO WHEEL FLANGE!

Any load placed on the flange is transferred directly to the inner races of the bearing which can lead to spalling or separation of the races.

1.) Firstly, the wheel flange **CANNOT** be used to press the bearing into the vehicle knuckle.

A special tool is required for the fitment of this bearing, which applies the load to the outer race, ensuring the bearing is fitted correctly and without damage.

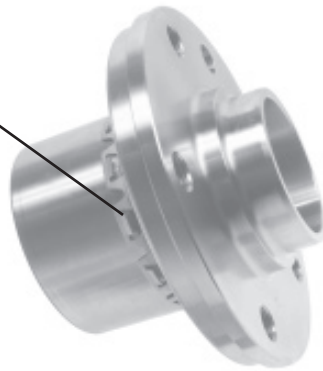
Fig 3

2.) Some versions of this bearing are fitted with a locking ring around the outer race of the bearing. (fig 3)

This ring is designed to locate the bearing correctly and will clip into a groove once the bearing is pressed fully into the knuckle.

Failure to locate the bearing correctly can lead to premature failure and on ASB variants of the bearing, result in an intermittent or total loss of wheel speed signal.

This would result in the anti-lock braking, traction control or similar systems not functioning correctly.

Ensure locking ring is fully located into knuckle.
