Difficult gear change and judder/vibration

Part Number: 835035, 826712, 826729

For Vehicle: *Audi, Seat, Skoda, VW, 1.9 TDI with a BKC, BLS or BXE engine*

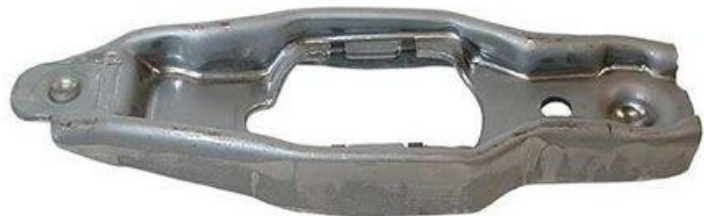
Figure 2. Guide tube

- Are the gear synchro hubs worn, damaged or faulty?
- Is the clutch ball pin worn, broken or faulty? (figure 1)
- Check the clutch release arm for wear, cracks and correct actuation. (figure 3)
- Check the guide tube for wear and cracks. (figure 2)
- Are the gearwheels in good condition with no wear?
- Check correct gear oil is being used.

Check and renew all of the above parts if necessary. All of the above are available through the vehicle manufacturer.
