OAP7144

Opel & Vauxhall 1.4 Petrol

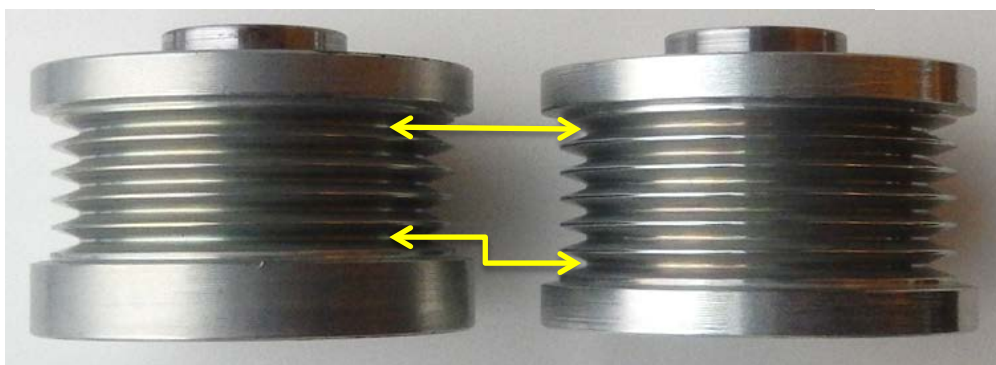
Fig. 1

On certain Opel/Vauxhall engines (codes: A14NEL, A14NET, A14XEL, A14XER) the belts may have 5 or 6 ribs while the pulleys may have 5 or 6 grooves. It depends on the manufacturing date of the car. Gates recommends replacement of a 5 groove OAP (Fig.1 left side) with the 6-grooved OAP7144 (Fig. 1 right side).

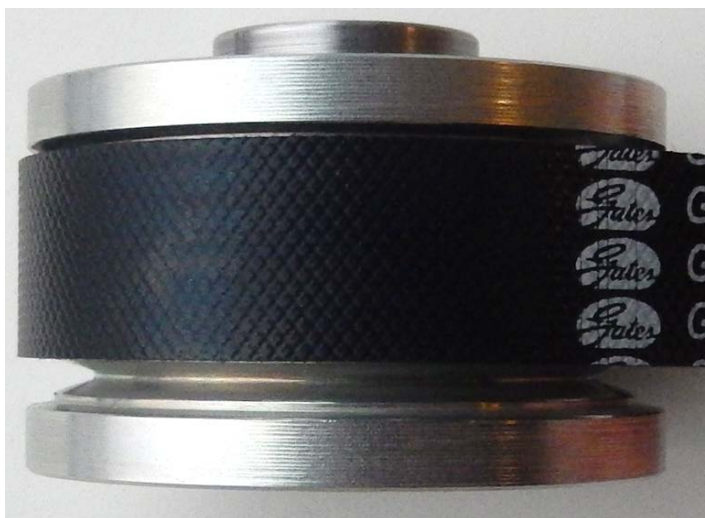
Fig. 2

If a belt with 5 ribs must be installed on to OAP7144 (Fig. 2), the outer groove (away from the engine) must be left open. If the belt is not placed correctly on the OAP like this, severe misalignment occurs, which may cause premature failure.
