## OAP7144

### Opel & Vauxhall 1.4 Petrol

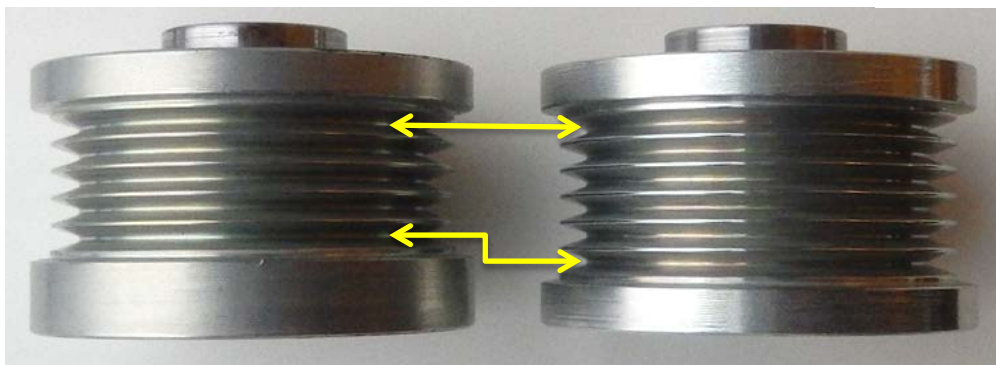
Fig. 1

On certain Opel/Vauxhall engines (codes: A14NEL, A14NET, A14XEL, A14XER) the belts may have 5 or 6 ribs while the pulleys may have 5 or 6 grooves. It depends on the manufacturing date of the car. Gates recommends replacement of a 5 groove OAP (Fig.1 left side) with the 6-grooved OAP7144 (Fig. 1 right side).

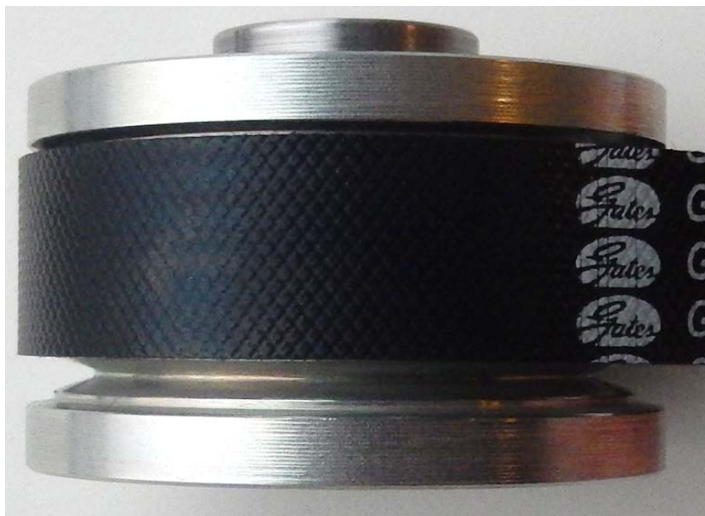
Fig. 2

If a belt with 5 ribs must be installed on to OAP7144 (Fig. 2), the outer groove (away from the engine) must be left open. If the belt is not placed correctly on the OAP like this, severe misalignment occurs, which may cause premature failure.

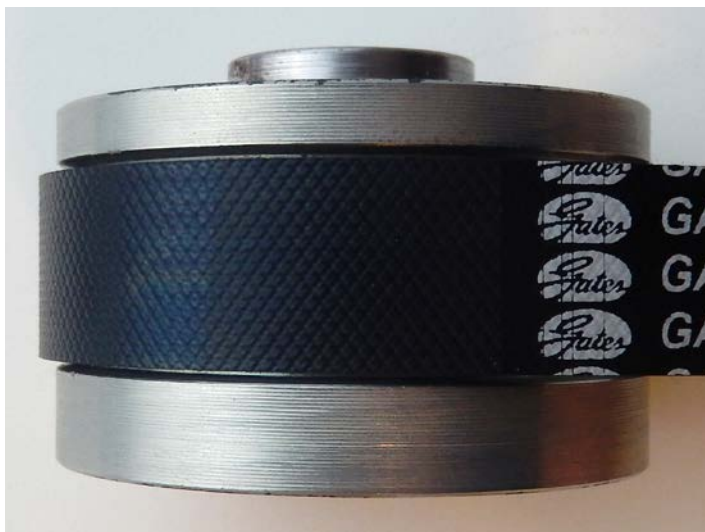
Fig. 3

Fig.3 shows an OAP with 5 grooves that must be replaced by the 6-grooved OAP7144.
