febiEXAKT

Chain tensioner

febi No. 33044

Vauxhall 2.0l turbo and 2.2l petrol engines

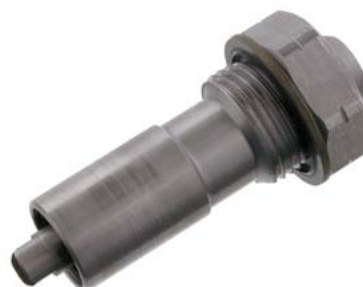
Although all the components have been correctly fitted, rattling noises are often present (caused by the elongation of the timing chain). If the timing chain slips as a result, then the engine can run erratically and misfire and in the worst case cause extensive engine damage. This affects Z22YH and Z22SE engines.

A blocked timing chain tensioner. The original version (repl. no. 0636 549) of the chain tensioner had a green O-ring and a rubber-lined washer (see Fig. 1). The vehicle manufacturer fitted this version in the engines mentioned above. A modified chain tensioner has been used in production since model year 2009.

febi bilstein recommends using only the new chain tensioner febi 33044 (repl. no. 4807 839). This is provided with a rubber-lined metal washer under the head (see Fig. 2). This ensures perfect guidance of the timing chain.

We always recommend that a new timing chain (febi 33043 repl. no is 5636 396) is fitted when replacing the chain tensioner. Both components are included in the chain kits febi 33042 (fits Z22YH) and febi 33045 (fits Z22SE)!

To prevent the timing chain from skipping when the engine is running, the chain tensioner should not be brought into the working position until the chain has been fitted. Please refer to the attached febiinfo for details.
