febiEXAKT

Belt tensioner

febi no. 26775

ref. no. 611 200 04 70

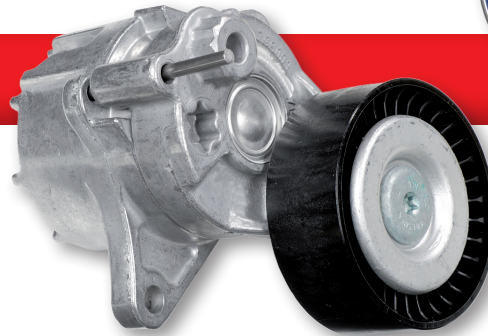
For design reasons, when the vehicle is driven with the original version of the belt tensioner installed (ref. no. 611 200 04 70), noise may occur. (The manufacturer has now replaced this version.)

The noise is generated because the spring is too long and makes direct contact with the base of the housing (1). Only the spring's torsional characteristics are important for this application (2), (6).

The noise is caused when the spring touches the cast-in hollow pin (3) and the base of the housing (4).

febi supplies the belt tensioner febi no. 26775 (ref. no. 646 200 02 70) for the free aftermarket. A highly wear-resistant plastic bushing (5) distance the spring from the base of the housing and prevents metal-to-metal contact where the spring is located. Since only the springs's torsional characteristics are important the height has been reduced (6). The spring makes contact with the plastic bushing (7) and is therefore prevented from touching the base of the housing. No noise can therefore occur. In the new version (8), a steel pin has been cast in the base of the housing in order to center the spring.
