VAG 1.4 & 1.6 16V / Synchronous Drive / Installation Info.

GATES REFERENCE:	5565XS & related kits.	
MAKE:	AUDI, SEAT, SKODA, VOLKSWAGEN.	
MODEL:	Various.	
MOTOR CODE:	1.4 16V, 1.6 16V.

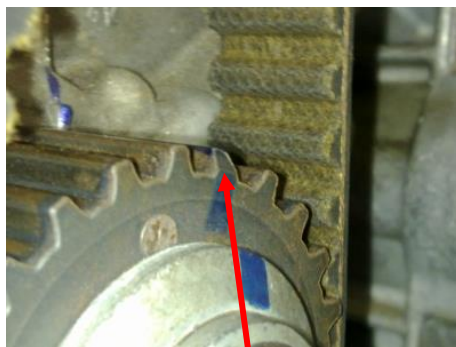
Fig. 12

Put the engine at its Top Dead Centre (TDC).
Slanted tooth of the crankshaft pulley (Fig. 12) has to be in line with right hand positioning rib (Fig. 13).

Slanted tooth

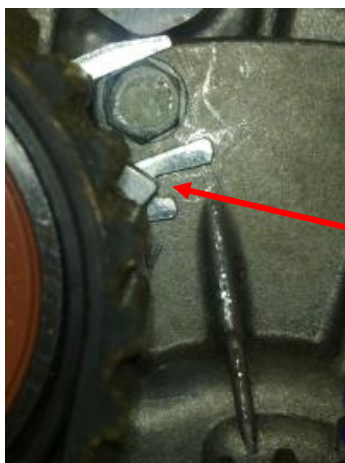
Fig. 15

Pointer in centre of the notch

Make sure the thread in the engine block is undamaged and clean.
 Install the new tensioner.
 Tighten the tensioner bolt finger tight assuring it's correctly placed (Fig. 10).
 Install a new PowerGrip® belt.
 Turn the tensioner pulley clockwise till the pointer and base plate notch are well in line (Fig. 15).

Torque tensioner bolt (20 Nm)
 Turn engine 2 revolutions to TDC and verify pointer position (adapt if needed).

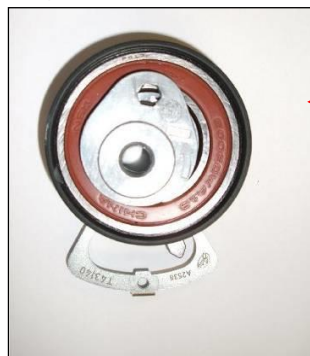
Fig. 16 shows the automatic tensioner for the cam-cam drive.

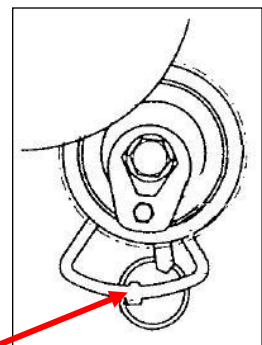
Fig. 17

Locating lug

It is clear an incorrect position of the locating lug will lead to problems like tensioner misalignment with drive failure as a result.

- When installing this tensioner, make sure:
- the locating lug is placed in the hole in the cylinder head at 6 o'clock (Fig. 17).
 - the tensioner is turned anti-clockwise until the pointer is in line with the positioning lug
 - the tensioner bolt is torqued to 20 Nm
 - the engine is turned 2 revolutions to TDC and pointer position verified (adapt if needed).
