Condensation in light units

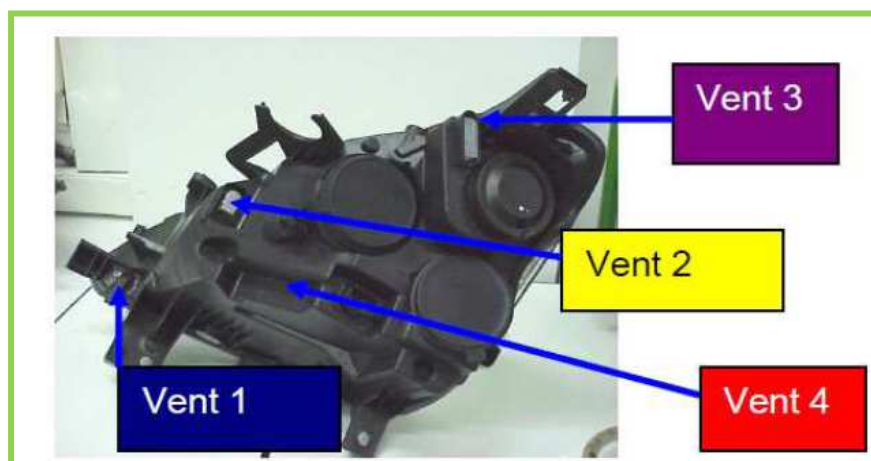
Example of a headlamp with moisture on the lens

This is an accepted occurrence in light units and does not affect the performance or life span on the lens. A light unit is designed with ventilation ports to allow air to escape freely when there are differences in air pressure.

If the condensation is not evaporated away from the lighting surface or droplets of moisture are inside the lamp, excess moisture will need to be dried away and the lamp conditions closely monitored. If this reoccurs, the light unit could be damaged, allowing too much moisture to enter and should be replaced.
