# Blue Print Info

# **Clutch Release Bearing** Application references: ADN13309, ADN130141, ADN130253 Applications: Nissan Navara D22, NP300, D22S

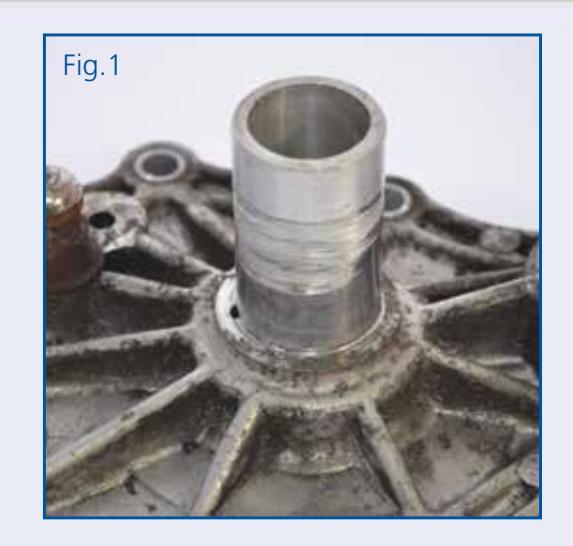
This guide tube from a Nissan D22 (Fig.1) shows scoring and damage caused by an incorrectly installed clutch release bearing.

Before fitting any new clutch components, inspect the clutch fork for corrosion, wear or damage and inspect the guide tube for pitting, scoring, wear and for any remains of the old bearing, replacing any non-serviceable parts as necessary. Check that the new bearing moves freely on the guide tube.

When replacing the clutch release bearing, care must be taken to ensure that it's fitted correctly. It is possible to inadvertently fit the bearing 180 degrees out and in doing so severely restrict the pivoting action of the bearing on the clutch fork. If fitted incorrectly, bearing failure is inevitable and damage will occur to the guide tube, which is part of the gearbox front cover.

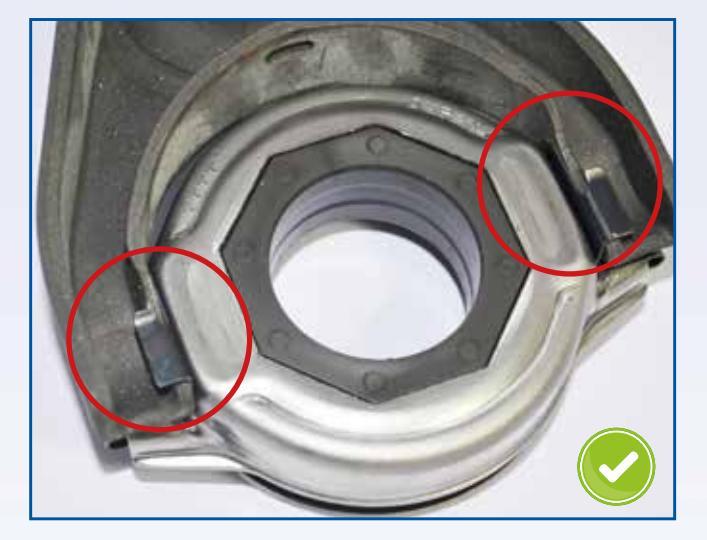
#### **Correct installation:**

It's important to note the position of the release bearing retainers on the clutch fork. In the correct position like this, the bearing can pivot on the fork as it travels along the guide tube.

Application of a lithium-based grease to the guide tube, clutch fork pivot point and release bearing retainers is important for its long term operation, but over lubrication must be avoided to prevent contamination of the friction surfaces.

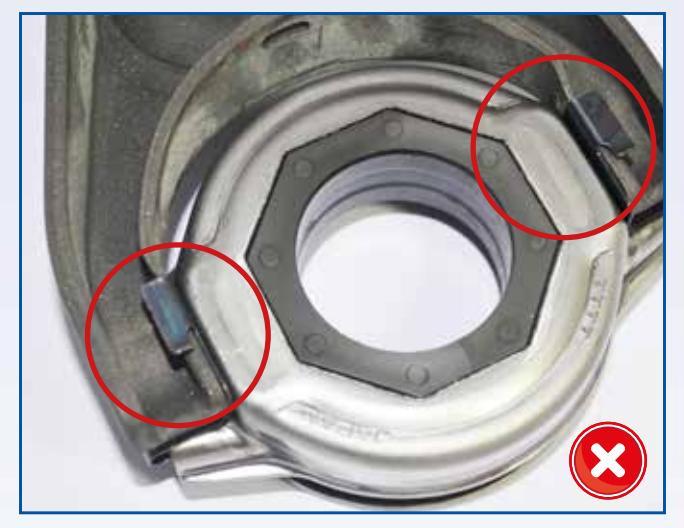
### **Incorrect installation:**

In this position the bearing cannot pivot on the fork and as a result the release bearing will drag against the guide tube causing premature wear, damage to the guide tube and will eventually lead to clutch failure.
