# Not fast & making them furious!

Written by Charles Figgins - Blue Print Technical Consultant

The car in question is a 350Z which is a high performance 3.5 V6 Nissan – the owner kept experiencing the MIL (Malfunction Indicator Lamp) coming on, followed by the car going into 'limp home mode', which resulted in it having all the driveability of an old 1.0 Micra – it wasn't much fun to drive!

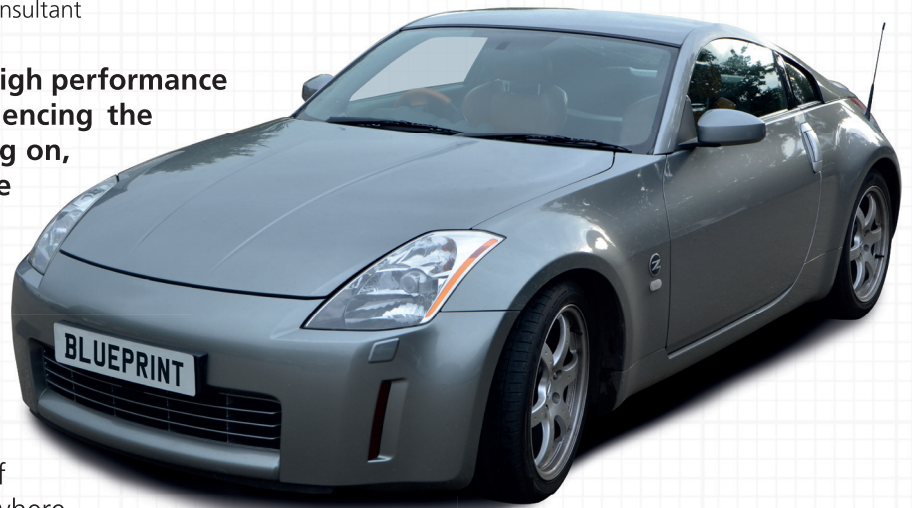
As the car was driving well most of the time and going by the only clues we had, I started with a code read of the whole car. It returned a P2135 Throttle Position Sensor code in the engine management, ABS, and immobiliser systems – on the 350Z the immobiliser is built in to the engine ECU and it's fitted with traction control. Before starting any testing I needed to consider what systems I was going to test and what information I had on this vehicle.

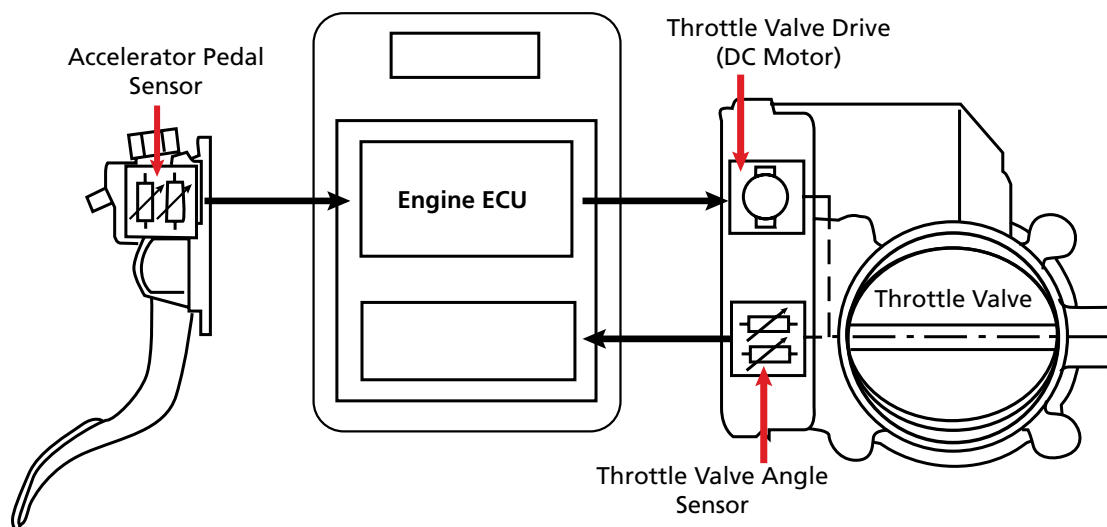
Figure 1

Gone are the days when there was a simple cable running from the accelerator pedal to the throttle butterfly – vehicles have all gone fly by wire in one way or another. Now you have an ECU that's responsible for controlling the throttle valve with a motor to control the throttle valve angle; feedback is then given to the ECU by a throttle position sensor – these components together make up the Electronic Throttle Control **Figure 1**.

To trigger this device there is an accelerator pedal position sensor, so when the driver puts their foot down the input is registered by two potentiometers. The engine ECU

takes this into account, along with engine speed and temperature, plus other information from the ABS ECU. This includes feedback such as wheel spin, which causes the traction control to back the throttle off, even if the accelerator pedal is flat to the floor.

The ECU then calculates the throttle valve opening which corresponds to the driver input and converts it into a signal for the throttle control motor. With this set up it becomes possible to precisely adjust the throttle valve to the required setting.

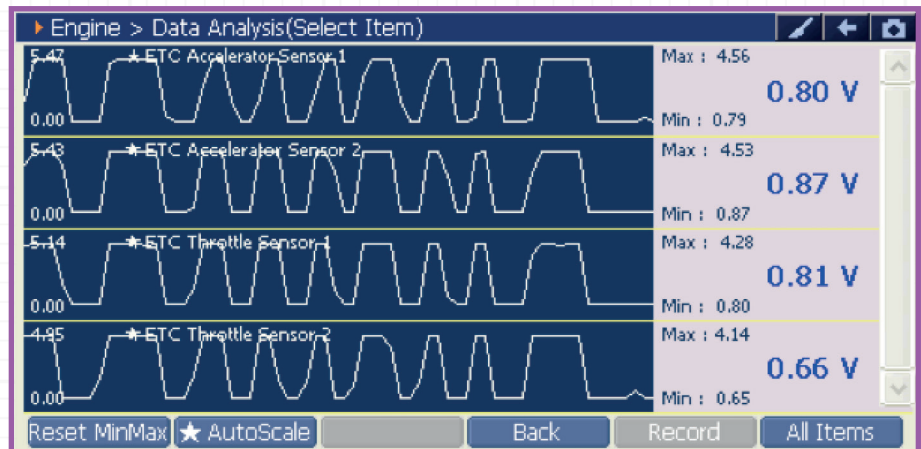
Knowing how the system worked, I graphed the data coming from the engine ECU for the throttle position sensor and the accelerator. In order to do this the ignition needs to be on, but the engine shouldn't be running; also the vehicle has a gear neutral switch, so you must select first gear otherwise you will not get data back from the throttle position sensor. This seems to be the case with all the other Nissan vehicles that I have tested.

On operating the accelerator pedal several times, I checked for any voltage drop outs or differences in demand between the accelerator and feedback throttle position sensors – I was looking for the sensors to be operating within a range of between 0.36 volts and 4.75volts.

If we had an incorrect voltage reading this could be the possible result of an open or short circuit, but at this stage everything looked fine.

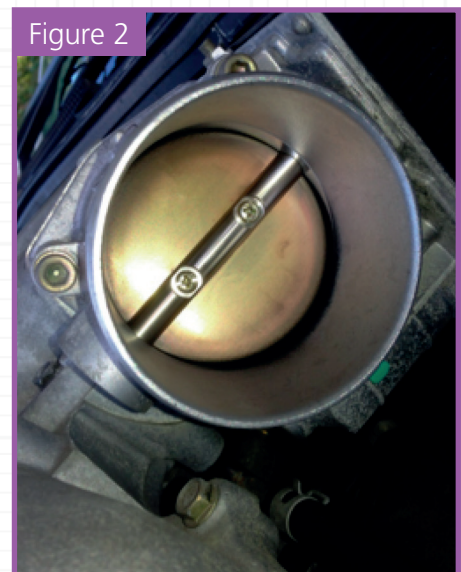
The next thing to check was the operation of the throttle valve and again, this seemed to be OK – there was no sticking or jerky operation **Figure 2**. Following on from this, I looked to see if there could be a wiring or connector fault; or was the ECU not giving me enough information?

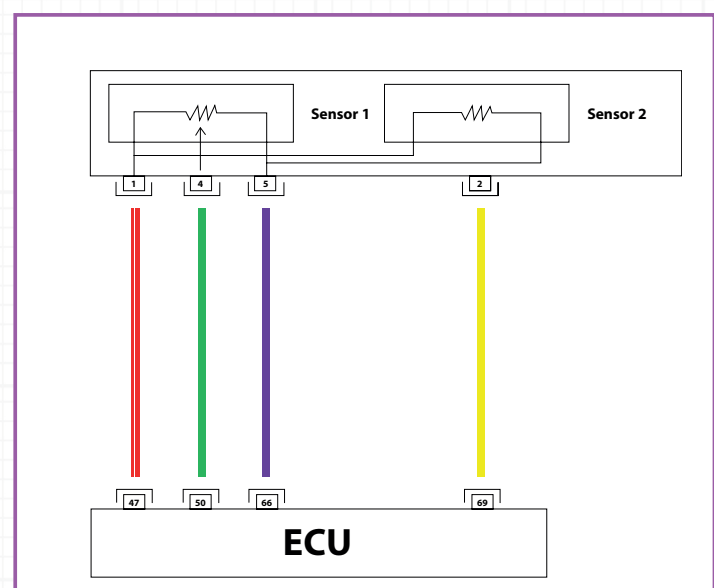
ECU Terminal No.	Item	Condition	Data
47	TPS Power Supply	Ign.Switch on	Approx. 5v
50	TPS 1	Acc.fully released	More than 0.36v
50	TPS1	Acc.fully depressed	Less than 4.75v
66	TPS Ground	Engine running	Approx.0v
69	TPS2	Acc.fully released	Less than 4.75v
69	TPS2	Acc.fully depressed	More than 0.36v

**Note:** All measurements were made reference to the vehicles ground and should not be made reference to any of the ECU's grounds. All voltage readings given from Sensor 2 are inverted – compared with the data given earlier, the ECU changes them from a low to high voltage as displayed on the G-Scan.

All measurements checked out correctly so the next step was to carry out a resistance check on each wire between the TPS and the ECU using volt drop testing. This was so I could test the wiring under load and again everything was fine.

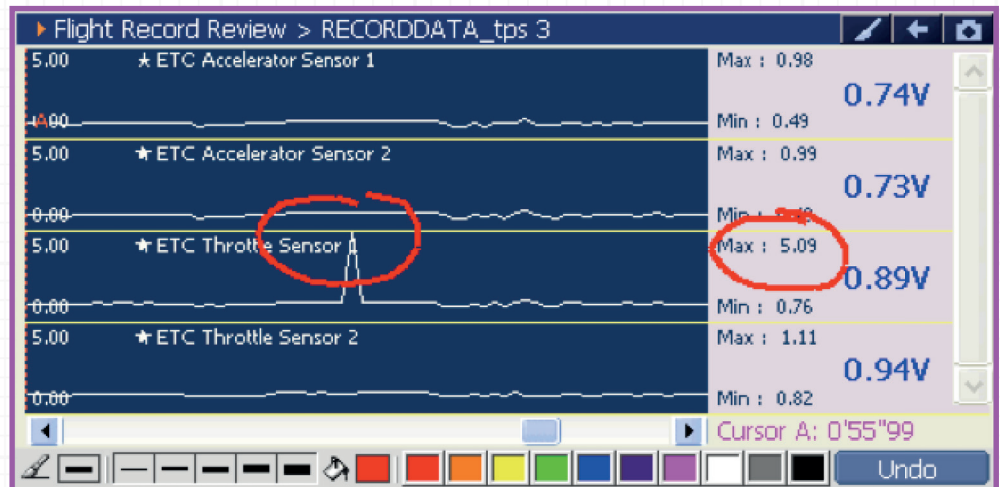
As everything was checking out under workshop conditions it was time for a road test, so I plugged the G-Scan back in and set it to 'flight record mode' to monitor the accelerator pedal and the throttle position sensors for a good five miles. Again the results showed nothing - this was getting very frustrating! A few miles later, as I was accelerating out of a junction and changing up from first to second, the MIL lamp came on and we went into limp home mode, just as the owner had described.

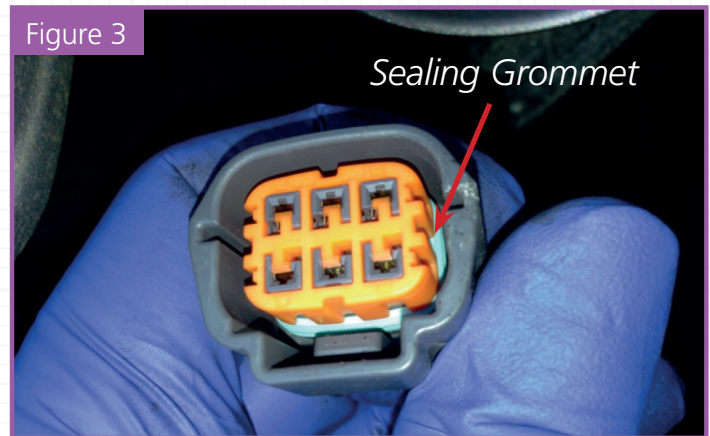
Figure 3

The G-Scan had recorded an open circuit on TPS Sensor 1, so we had found the reason for the MIL lamp coming on; now all we had to do was find the cause. On inspecting the connectors at the ECU and at the sensor, I found the sealing grommet missing at the sensor end see **Figure 3**. After finding a suitable replacement, checking all connections and giving them a quick clean with contact cleaner, there was a better connection. But had this fixed the problem?

Before carrying out another road test, now everything was back together, I went through all the basic settings and learning procedures.

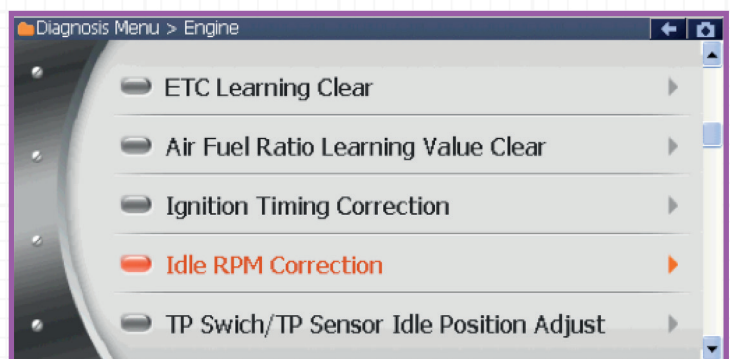
**Note:** Make sure you carry out the above before carrying out any of the learning procedures that requires a diagnostic tool.

I road tested the vehicle once more, and it was back to its high performance best; it's amazing how such a small problem can cause so much poor drivability!
