# JURATEK®

## Universal Brake Pads

## Fault Diagnosis

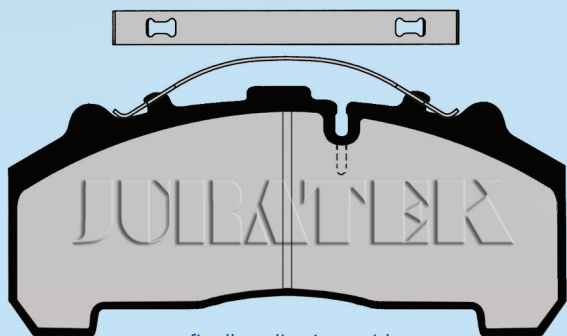
JCP1000

to fit all applications with:  
 Knorr Bremse SB7000 & SN7000 calipers  
 WVA: 29042, 29059, 29061, 29087, 29105, 29106, 29108,  
 29109, 29163, 29167, 29179, 29201, 29202

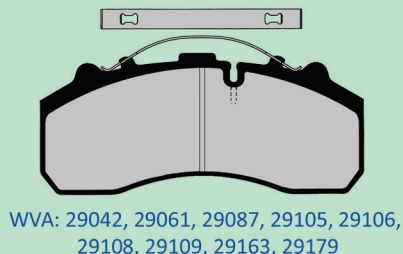
WVA: 29042, 29061, 29087, 29105, 29106,  
 29108, 29109, 29163, 29179

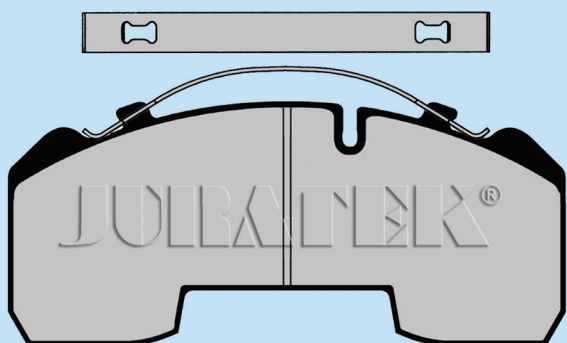
JCP1001

to fit all applications with:  
 Knorr Bremse SB6000 & SN6000 calipers  
 WVA: 29093, 29094, 29095, 29096, 29145,  
 29165, 29166, 29184, 29197

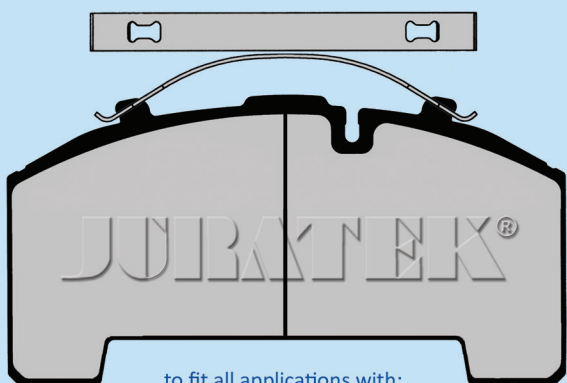
JCP1002

to fit all applications with:  
 Knorr Bremse SK7000 calipers  
 WVA: 29158, 29171, 29271
