Cooling

FWP 1574

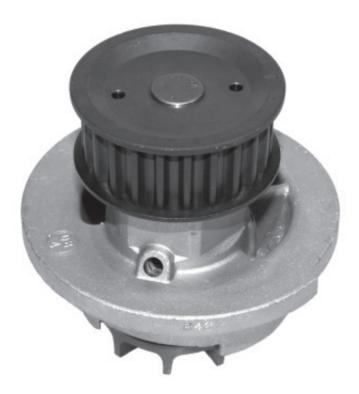
FWP 1574 fits vehicles with a 23 tooth pulley.

It is important to check this is the correct part before fitting to the vehicle.

If the incorrect pump is fitted then timing belt failure will occur soon after installation resulting in damage to the cylinder head and valve gear.
