Noise Occurrence on GDB1363 and GDB1431

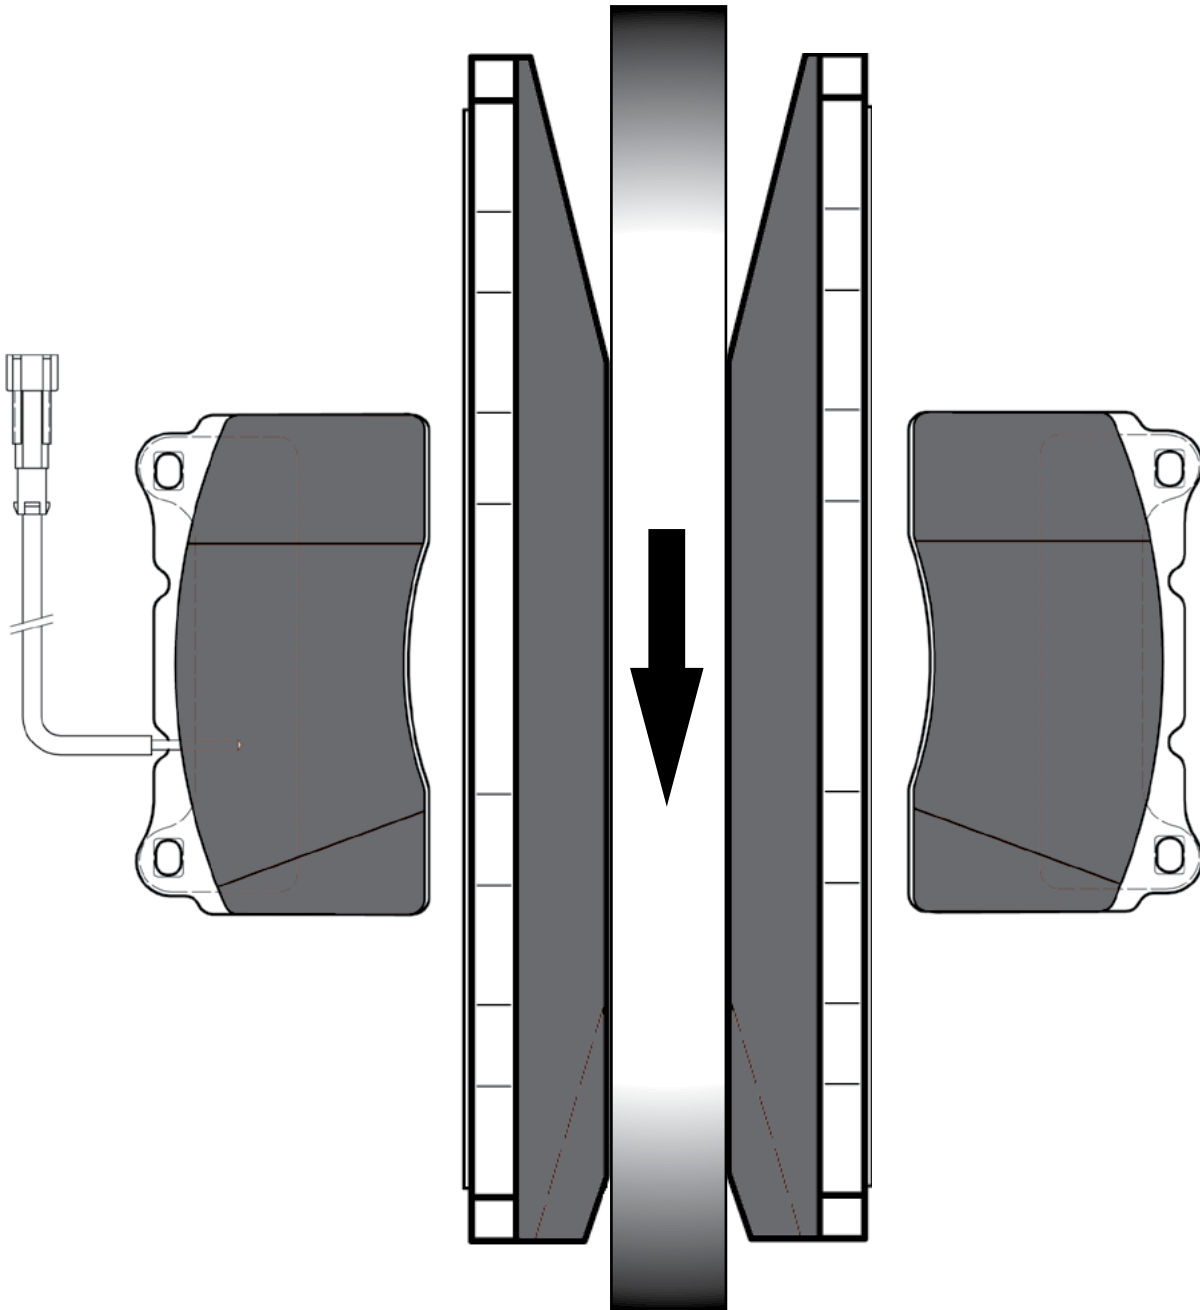
noise. The arrow indicates the disk forward rotation. If the Brake Pads are not fitted as shown above, noise will occur. To ensure the correct fitment in future TRW will print indicator arrows on the back plate.
