Fiat 1.6 petrol engines / Synchronous Drive / Tensioner Info.

GATES REFERENCE:	5432XS and related kits.	
MAKE:	FIAT / LANCIA.	
MODEL:	Albea, Brava, Bravo, Dedra, Delta, Doblò, Lybra, Marea, Multipla, Palio, Siena, Stilo, Strada.	
MOTOR: MOTOR CODE:	1.6 petrol. 178B3000, 178C7098, 178D2011, 182A4000, 182A6000, 182B5098, 182B6000, 182B6000CNG, 182B6024, 185A3000, 186A3000CNG, 186A4000.

Technical Bulletin

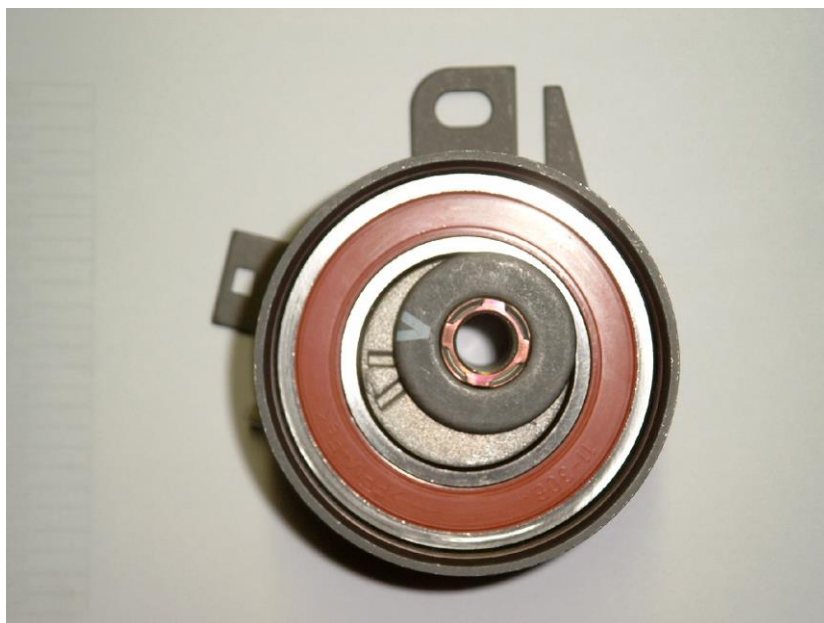
| Fig. 1 tensioner in kit until 08/2004 | OE ref. 46792898 |

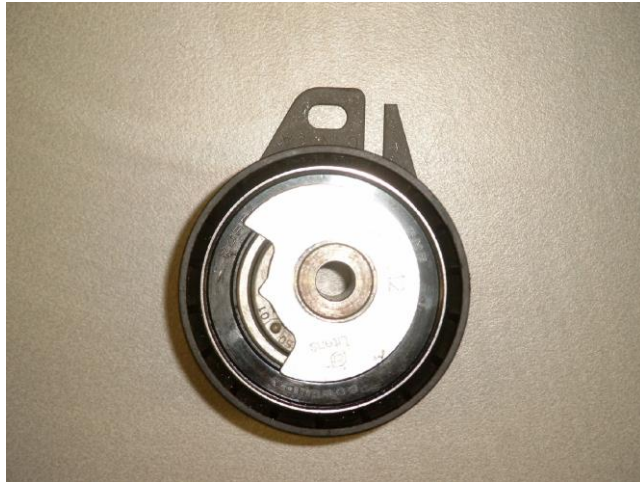
| Fig. 2 tensioner in kit from 09/2004 until 11/2005 | OE ref. 46416489 |

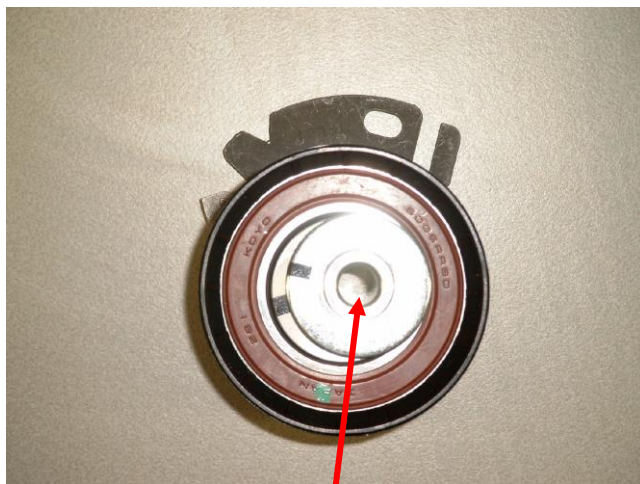
| Fig. 3 tensioner in kit as of 12/2005 | OE ref. 71734799 |

A

The latest version that is now used on OE(S) level replaces the two previous parts.

It may be possible that the tensioner on the car is still an older model. There is no problem to install the latest version tensioner with the old stud and nut. Although the depth of the fixing hole (A) of the tensioner is deeper and the stud stays the same, there is still enough room on the stud to fix the nut properly, see Fig. 5 (B).

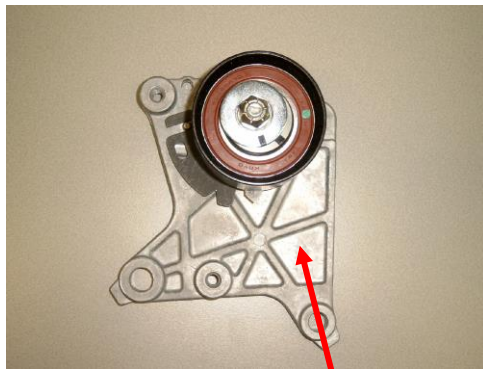
C

Fig. 4 and Fig. 5 show the latest version of the tensioner fixed on the bracket.

Normally this bracket (C) is mounted on the engine block and does not have to be removed.

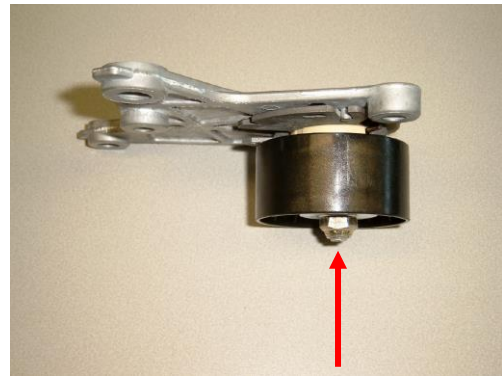
Fig. 5

B

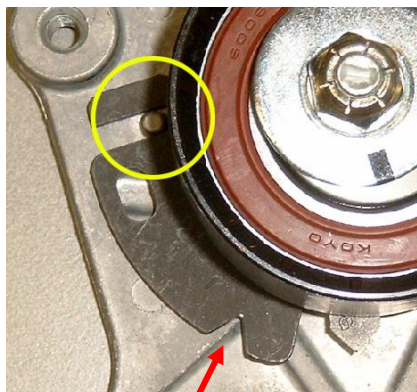
Fig. 6

E

To lock the tensioner, position the open oblong hole in the base plate of the tensioner on the pin on the bracket (Fig. 6).

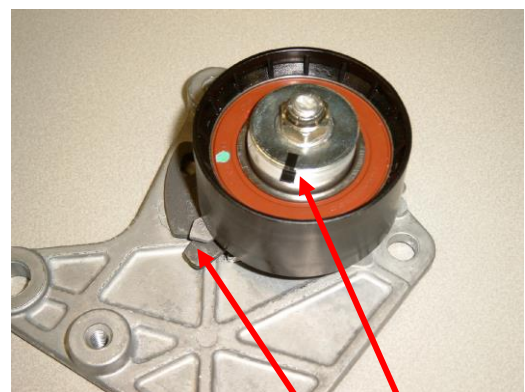
Fig. 7

D

F

When the belt and the tensioner are replaced, following the installation instructions inserted in the kit, and after two engine revolutions, the pointer (D) has to be in the middle of the "V" in the base plate of the tensioner (E). At that moment the two black marks (F) will also be aligned. Only then the tensioner is correctly installed.

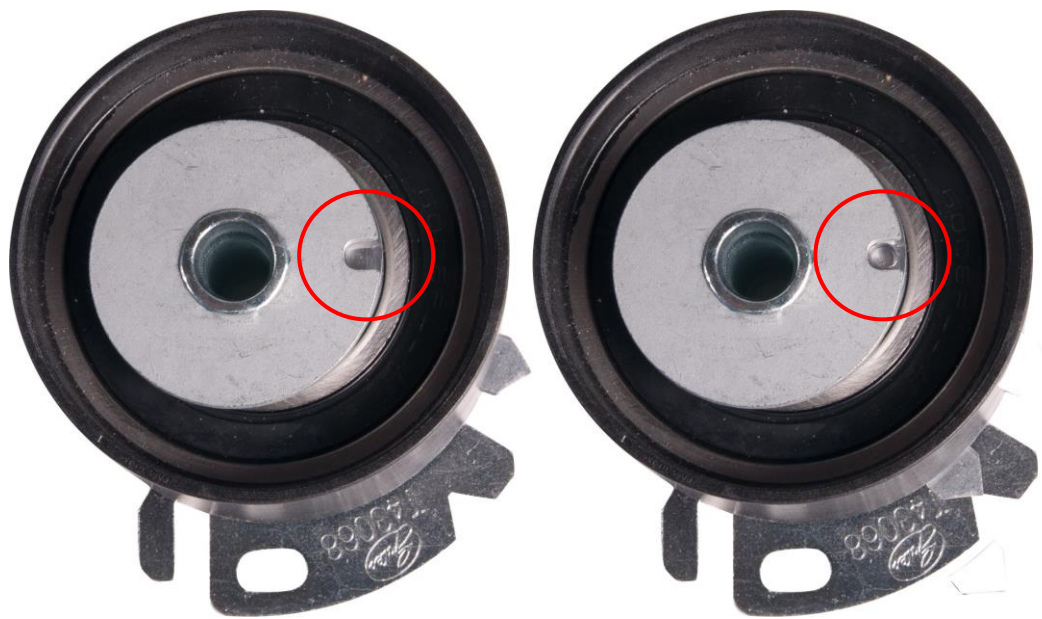
Fig. 8

In the actual kits you find the tensioner (Fig. 8) on which we have changed the black marks into a new positioning system. The indicator of the correct position is a point in relief.

Not in the correct position:

In the correct position:
