## Blue Print Top Tip

Mitsubishi Airtrek, Carisma, Colt, FTO, Galant, Shogun, Space Runner, Space Star, Space Wagon – Ignition Coil Failure Applicable References: ADC41473

## Date Issued: 06/2005

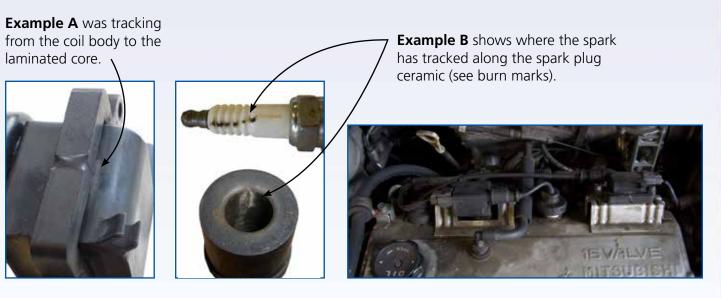
Progressive insulation failure of the coil or spark plug tube is most often experienced where a misfire is detected during cold/

damp conditions (e.g. from cold starts) or during high engine loads. This can be exacerbated by dirt contamination or high resistances in the spark plug or HT leads. Tracking can sometimes be visible or audible during operation, and may leave carbon traces where regular tracking to earth is occurring.

## Typical examples below are from the two original coil failures.

Blue Print strongly recommend that the spark plugs and HT leads are replaced in addition to the coil assembly, or that they are carefully checked. We also recommend that a logical diagnosis procedure is followed (prior to replacing the ignition coil) to prevent it being replaced unnecessarily.
