## Removing air from the hydraulic system

Part Number: 804529, 810123

For Vehicle: Audi, Ford, Seat, Skoda, VW

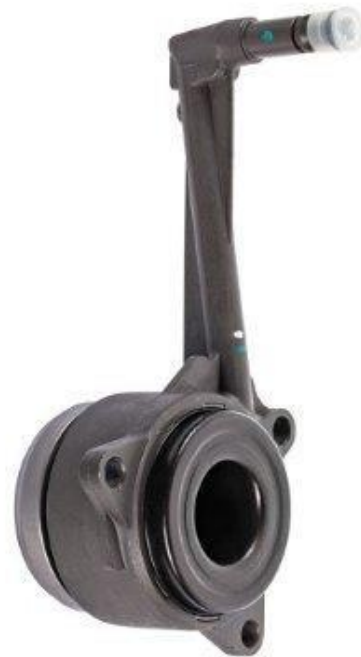
4. Remove the protective cover from the bleed screw at the connection of the central release mechanism and insert the tubing from the air removal bottle onto the bleed screw.

5. Switch on the air removal device and set it to a working pressure of 2.0 bars.
6. Loosen the bleed screw by a quarter turn and allow 100 cm<sup>3</sup> of brake fluid to flow out.

7. With the bleed screw open actuate the clutch 15-18 times by hand performing 2 actuations per second. When doing this it is important for the clutch pedal to reach the lower and upper stops. If this is not performed appropriately the CSC can burst and become damaged.
