Heater resistor failure due to a damaged blower motor

The Valeo Service warranty department receive a high number of heater resistors being returned for the Opel/ Vauxhall Corsa with customers stating that the heater controls will only work on setting four.

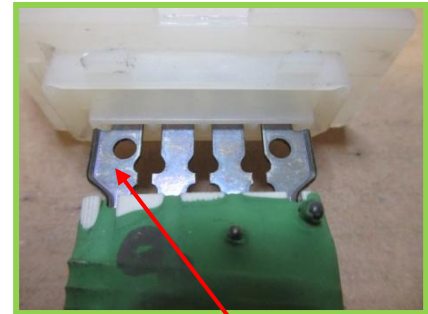
When the part has been visually inspected there is evidence of blueing (thermal damage) on the pins of the electrical connector. This indicates that the resistor has been subjected to over current.

Blueing on the resistors pins

If the heater does not work or only works on the highest setting it is important to ensure no water is leaking onto the blower motor and causing it to fail **before** attempting to fit another heater resistor. This is the most common cause of failure associated with this heater resistor.

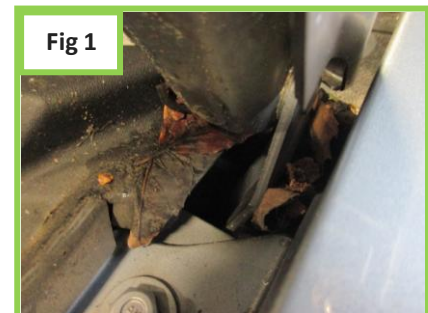
Fig 1

Firstly, check that the wind screen drains are clear of debris (leaves) and ensure the plastics are correctly fitted and the rubbers make a good seal (Fig 1).

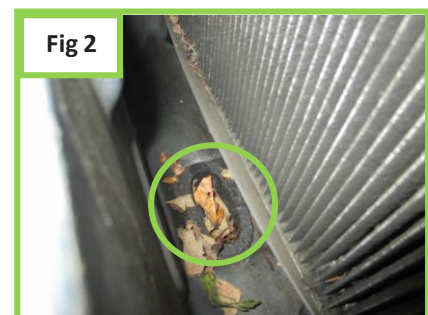
Fig 2

Next check the scuttle panel paying specific attention to the drains around the pollen filter. If filled with debris it can become blocked causing water to enter the pollen filter, rise up and spill over into the blower motor (Fig 2).

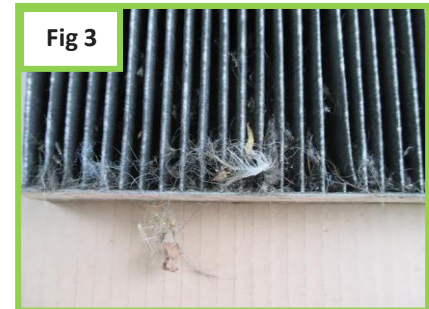
- Ensure the pollen filter isn't blocked (Fig 3) as this will cause the blower motor to overload causing excess current.
- Ensure the blower motor has no rust on it (Fig 4). This means the blower motor has been subjected to water contamination.
- Switch off the engine and all electrics and then by hand rotate the fan to check for free movement, any resistance in the bearings is a good indication of internal rust damage and would most defiantly cause premature failure of the resistor.

If any of the above has occurred it is advised to replace both blower motor and pollen filter. If a new heater resistor is fitted to a vehicle displaying the above then it will be very likely the thermal fuse on the resistor will blow due to the additional strain put on the resistor by either the blower motor or pollen filter.
