## 087923 and 087924 headlights remaining on after engine shutdown

Vehicle - Citroen C5 2000 – 2004 (all models)

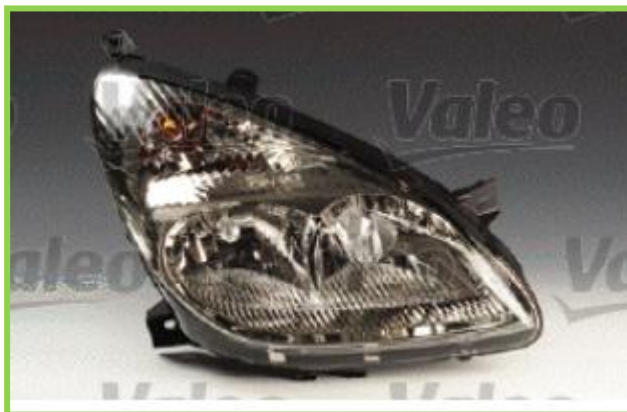
A common fault with the above vehicle has been found, where the headlights remain on after the engine is shutdown. The cause appears to be a faulty body control unit (built-in systems interface – BSI). Water penetration into the control unit causes a short circuit and leads to the fore mentioned fault. Please note there is no problem with the headlight and the only way to rectify this issue is by replacing the control unit. The unit is located on the driver side, below the 16-pole diagnostic plug. Please be aware that after installation the control unit must be re-coded.
