febiEXAKT

Rear axle bush for wheel bearing housing

febi no. 21174

**Mercedes-Benz C Class (202, 203 and 204),
E Class (207, 211 and 212), S Class (221) and other models**

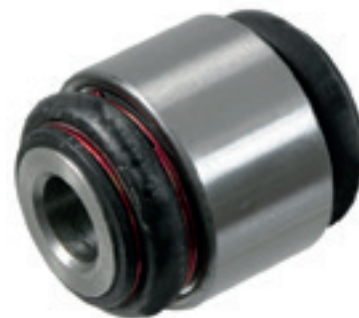
Knocking or creaking noises can occur in the region of the rear axle when driving.

febi bilstein recommends using the new version of the joint febi 21174 (Repl. no. 204 352 00 27). The modified joint has several channels instead of just one (see Fig. 2). This ensures a permanent supply of grease which lengthens the joint's lifetime.

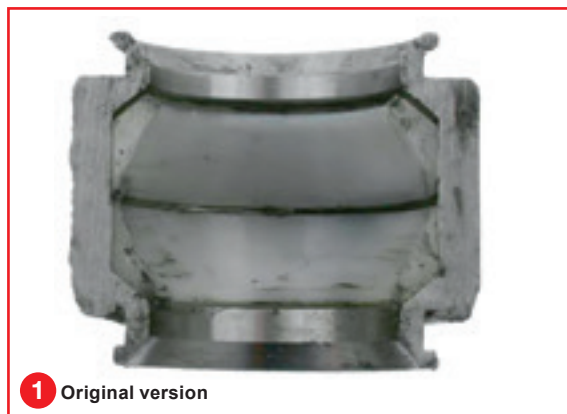
1 Original version

Due to its design, the life of the rear axle bush is shortened by poor road and weather conditions. The version originally fitted (Repl. no. 201 352 00 27) has a lubrication channel in the inner plastic tray (see Fig. 1). However, this is not always sufficient to lubricate the joint evenly. The drying out that is sometimes associated with this makes the joint susceptible to wear. Mercedes-Benz has withdrawn this version from service and replaced it.
