**SCANIA**

# Scania Retarder

## Troubleshooting

### Mechanical system and hydraulic system

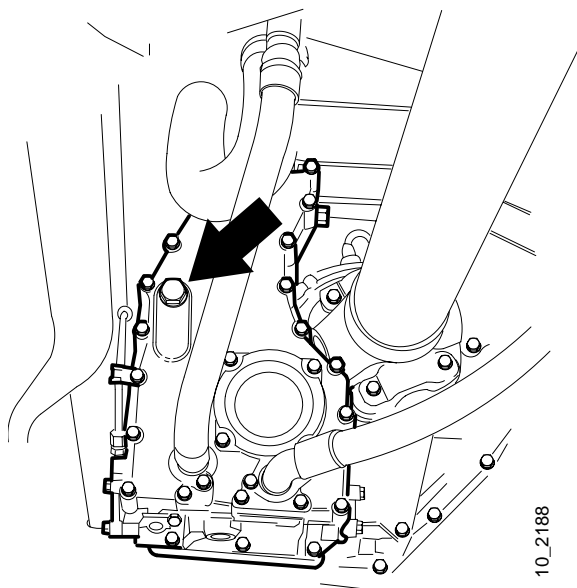
10\_2188

Check and adjust the oil level in the retarder. Press the diagnostic switch to empty the oil accumulator. Top up if necessary.

Do not remove the level plug only. The oil accumulator may contain oil and the level check will be unreliable or directly misleading.

**IMPORTANT!** Empty the oil accumulator with the diagnostic switch before checking the oil level. Otherwise, the oil level will be too high, resulting in foaming and leakage.

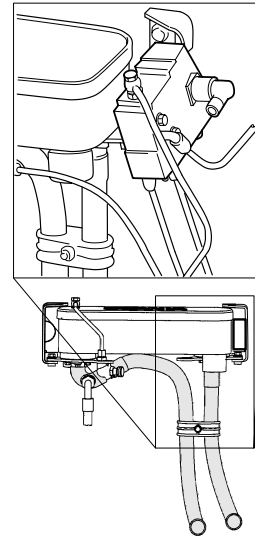
*Location of new proportional valve in trucks, introduced from 9908 on trucks and 9910 on buses.*

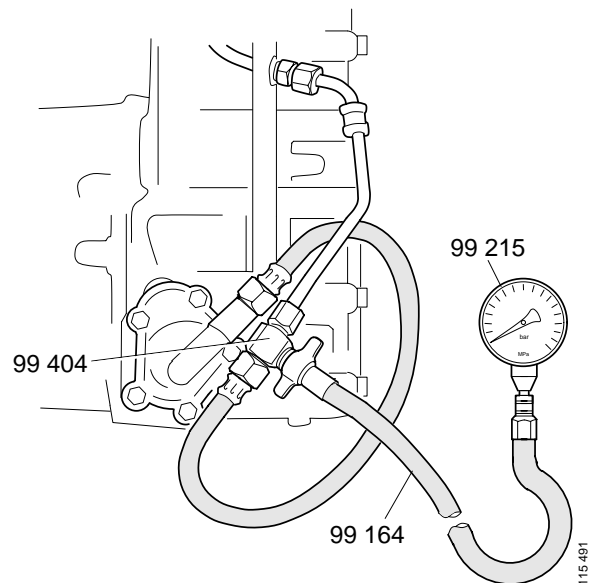
- Fit T adapter 99 404 to the compressed air line between the valve block V97 or the proportional valve V76, and the retarder control piston.
- Connect the hose 99 164 and pressure gauge 99 215.

**Note:** Make sure the pressure gauge has been calibrated. Refer to Main Group 10 Brake system testing for calibrating.

**Note:** In order to include the hysteresis of the proportional valve, test readings must be taken both when the pressure is rising and when it is falling.

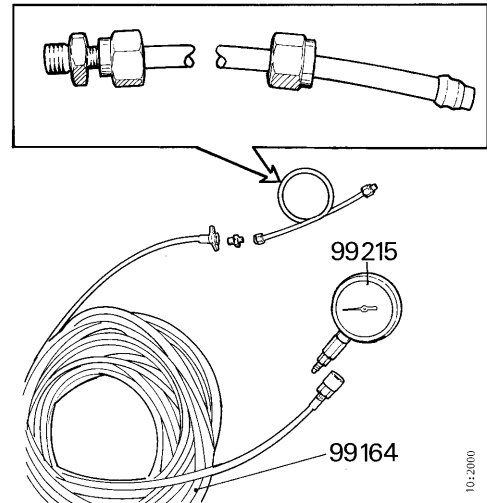
10-2000

- Make sure that at least 6 bar is reaching the proportional valve. Use pressure gauge 99 215, hose 99 164, union 1 319 272 and an 8 mm adapter hose.
- Make the adapter from a 0.5 metre long piece of 8 mm hose. The adapter hose is to be fitted with sleeve 814 809, ferrule 813 221 and nut 812 888 on both ends.
- Fit the adapter to hose 99 164 and connect pressure gauge 99 215. Take a reading at the distributor piece that supplies the proportional valve with compressed air.
- If there is no pressure, the fault may be in the solenoid valve for the compressed air supply.

**Note:** A minor and controlled air leakage from the proportional valve vent is normal. A hissing noise, therefore, does not indicate a fault.

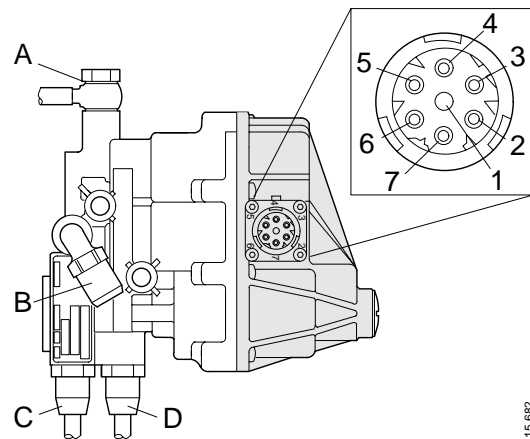
115 682

Valve block V97 with integrated proportional valve. The new valve block requires a higher pilot frequency, 360 Hz, which is obtained from control units manufactured from 9902.

- 1 Pin for proportional valve (+)
- 2 Pin for proportional valve (-)
- 3 Pin for solenoid valve for compressed air supply
- 4 Pin for earth
- 5 Pin for solenoid valve for oil accumulator
- 6 Pin for earth

- A Air connection to oil accumulator
- B Air supply
- C Air connection to retarder
- D Venting

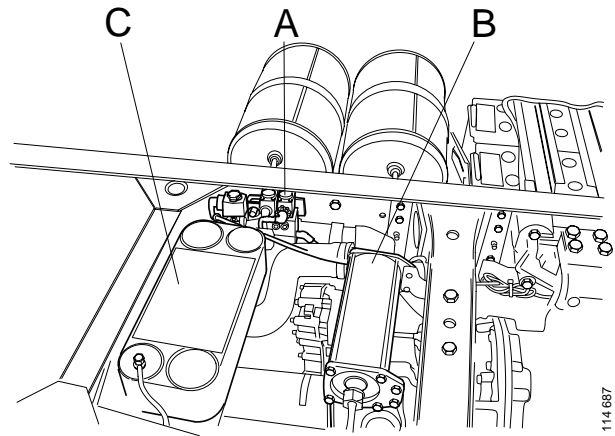
114 687

The proportional valve on trucks has occasionally broken due to impurities entering. A new exchangeable valve with integrated air filter has been introduced in production from chassis number SS1238870, SN4391326, SA9031574 and SLA3503385.

*A. Location of proportional valve*

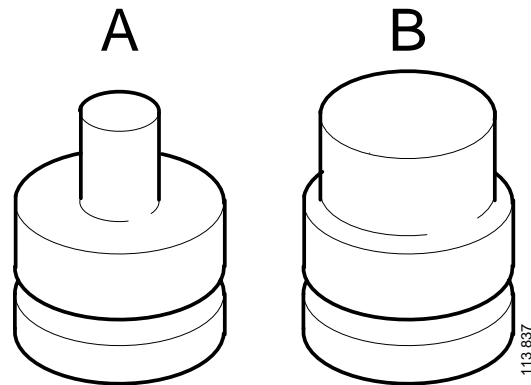
113 837

The proportional valve support sleeve has been modified and was introduced in production from chassis number SS1246832, SN4405293 and SA9038846.

*A. Old version of support sleeve.  
B. New version of support sleeve.*

The check valve and support sleeve can be renewed to rectify a possible air leak.

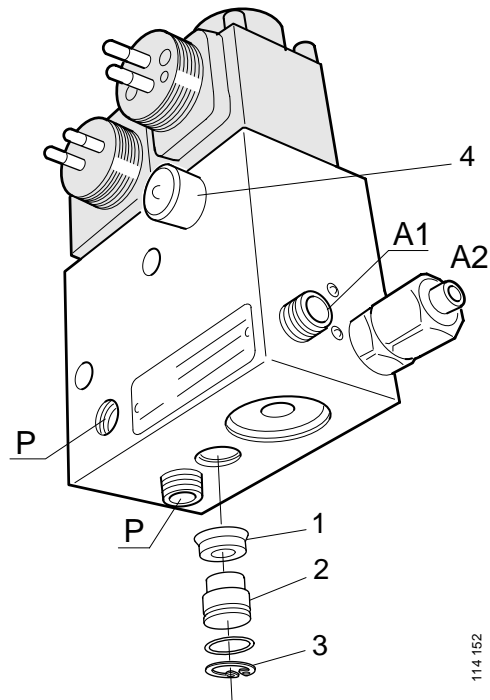
114 152

- 1 Remove the proportional valve.
- 2 Plug outlet A1/A2.
- 3 Clean the opening around the support sleeve 2.
- 4 Detach the retaining ring 3.
- 5 Connect the ON/OFF valve to 24 V.
- 6 Push out the support sleeve 2 and the check valve 1 by carefully adding compressed air to the supply P.

**Note:** Hold the check valve as illustrated and lubricate it with the grease included with the repair kit.

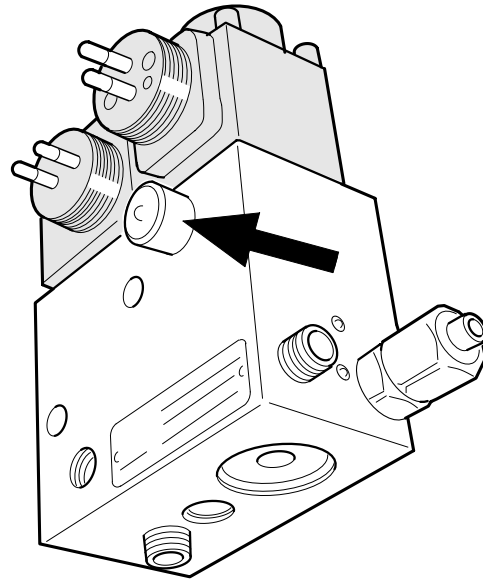
115 191

There have been occurrences of oil leakage from the proportional valve vent on trucks and buses. The oil comes primarily from the safety valve in which there is a leaking sealing ring. Leakage via the sealing ring on the control piston has also occurred. This leakage has occurred especially when parking in low outdoor temperatures.

A new safety valve with double sealing rings has been introduced in production from chassis number SS1251239, SN4414949, SA9043610 and SBK 1835768.

- 1 Old safety valve
- 2 New safety valve

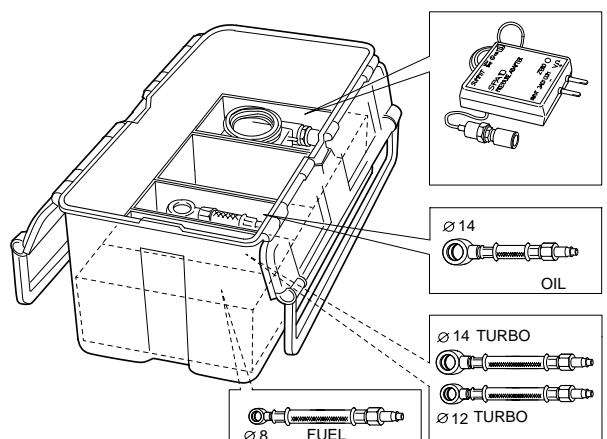
*Measuring set 99 362*

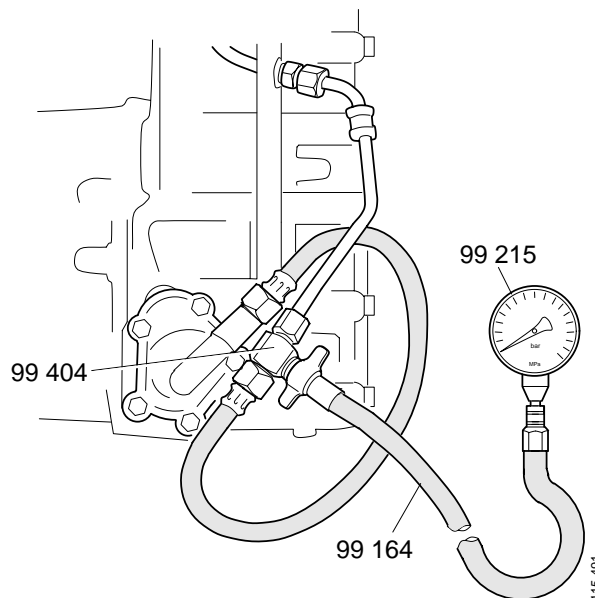
- 2 Replace the cover on the oil side of the control valve with a cover with test outlet, 99 378. Carefully pass the control piston spring over the nipple inside the cover. Leave the shims inside the spring.
- 3 Connect a multimeter and adapter to the nipple on the cover. The adapter is included in measuring set 99 362. This is where to measure the oil pressure obtained when using the retarder lever for activation.

- 4 Fit T adapter 99 404 to the compressed air line between the valve block V97 or the proportional valve V76, and the retarder control piston.
- 5 Connect the hose 99 164 and pressure gauge 99 215. This is where to measure the air pressure obtained when using the retarder lever for activation.

**Note:** Make sure the pressure gauge has been calibrated. Refer to Main Group 10 Brake system testing for calibrating.

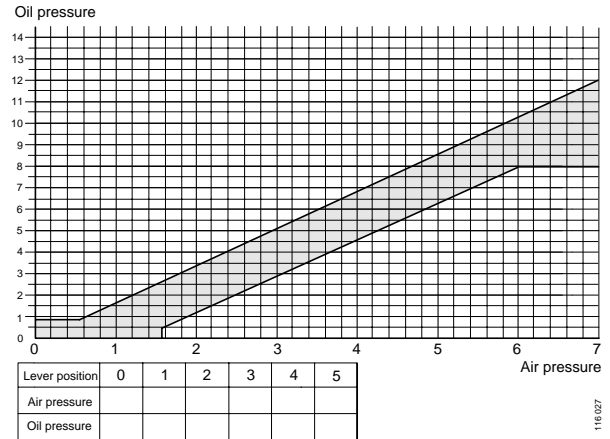
116 027

15 Evaluation: The test values should form a smooth line within the grey zone.

An uneven curve and erratic values will probably be caused by a sticking control valve. Change oil and renew filter. Clean the control piston and its barrel in the housing.

If several test values are below the grey zone, the number of shims under the control piston spring may be incorrect.

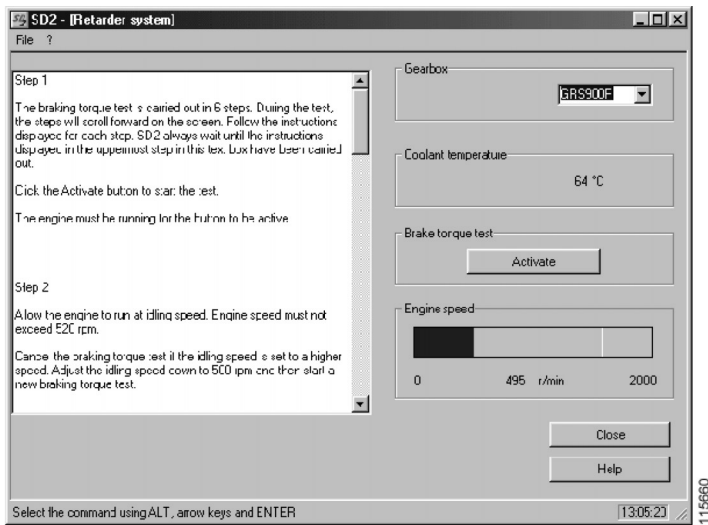
*Illustration from SD2 before starting the brake torque test.*

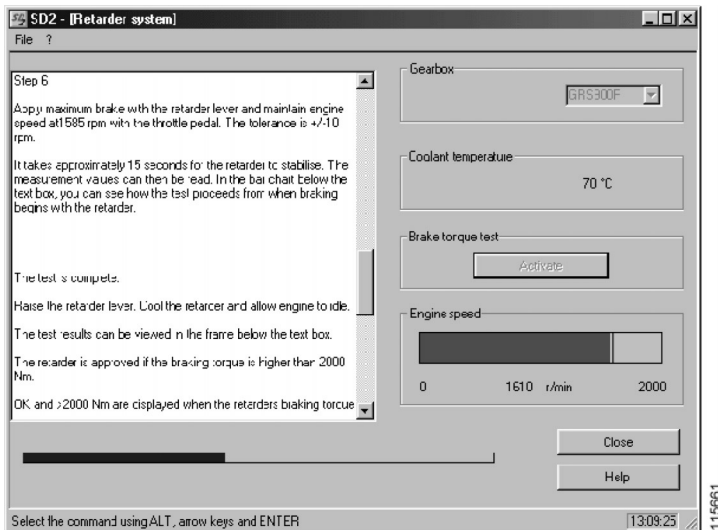
*Illustration from SD2 when the test is in progress, i.e. maximum braking with the retarder. The time bar under the text box is successively filled. The engine speed bar goes red when the "ideal point" has been exceeded. It is essential that the engine speed is kept within +/- 10 rpm.*

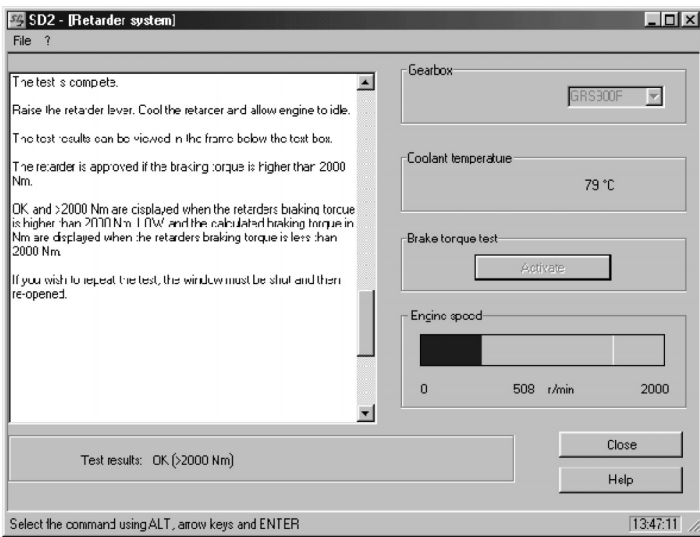
- 9 The test result shows "OK (>2000 Nm)" if it is approved. If the retarder torque is below 2000 Nm, "LOW" will be displayed together with the current brake torque.

*Illustration from SD2 after a test result has been approved.*

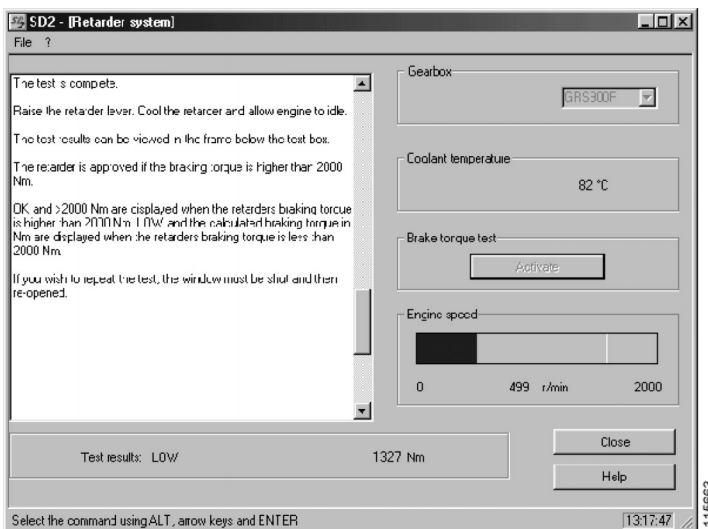
*Illustration from SD2 after a test result has failed.*

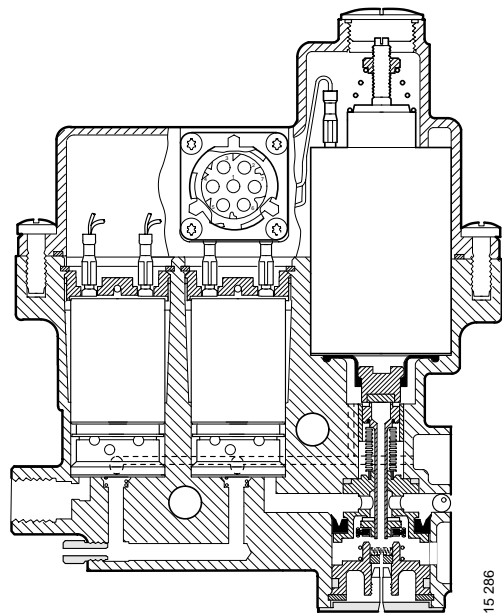
The checks described above for the proportional valve and accumulator are carried out on the valve block V97 in the same way as for the separate components. The difference being that if oil is leaking from the valve block vent, it is probably coming from the proportional valve or the accumulator solenoid valve.

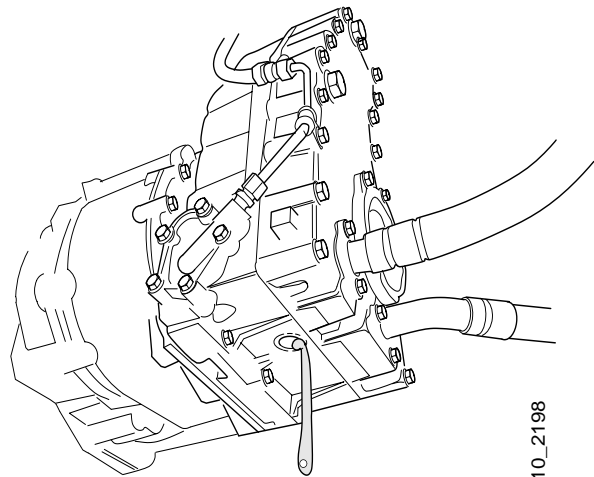
10\_2198

- 1 Remove the valve housing cover 16 where the compressed air enters the retarder.
- 2 Screw an M8 bolt into the valve plunger 10 and pull out the plunger.

**Note:** Do not press in the valve plunger. This will risk damaging the plunger ring 13 on sharp edges in the housing.

- 3 Remove the valve housing cover 18 on the other end.
- 4 Check that plungers 11 and 12 slide easily in their barrels, approx. 20 mm back and forth.
- 5 Check that the piston ring 13 is clean and in good condition.

**IMPORTANT!** It is important when refitting that plungers 11 and 12, and the valve housing cover 18 are fitted before the valve plunger 10. This will reduce the risk of damaging the ring 13 if the valve plunger 10 is pressed in too far.

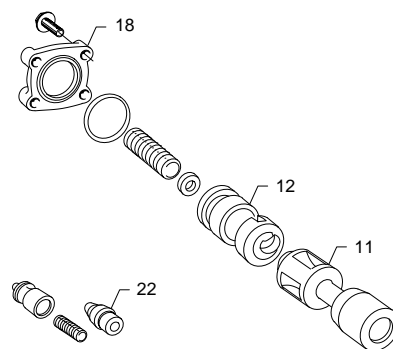
116 069

Check the safety valve 22. Pores must not be present in the O-ring groove. If the O-ring is damaged, it must be renewed.

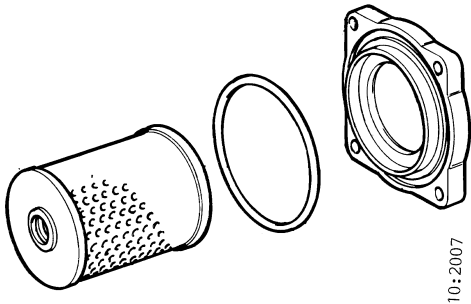
#### Components shown in Retarder housing

- Sealing rings 47
- O-ring 50
- Sealing ring of piston ring type 51
- O-rings 57

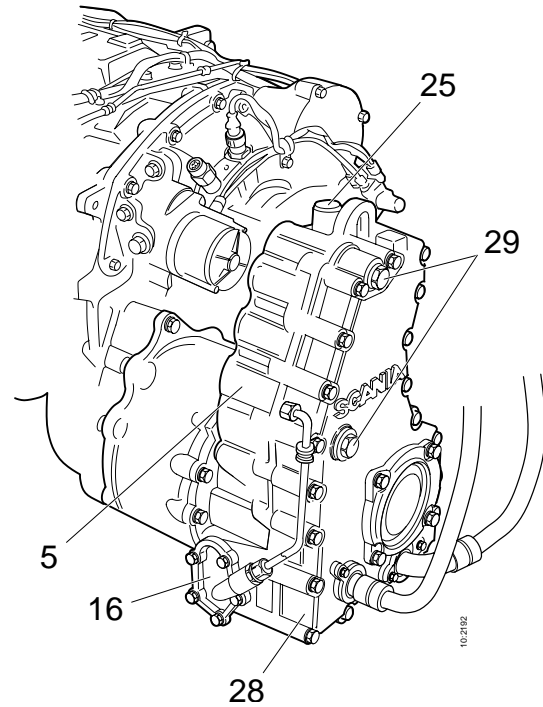
The numbers in the text refer to the illustrations under the headings Valve housing and Retarder housing.

- 5 Valve housing
- 16 Valve housing cover
- 25 Air filter
- 28 Oil sump cover
- 29 Plug

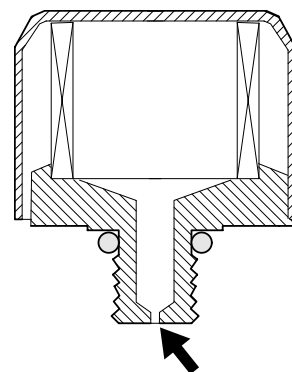
An improved air filter has been introduced to prevent oil leakage. The filter was introduced in production from chassis number SS1219748, SN4360756, SA9015143.

*New air filter with restriction.*

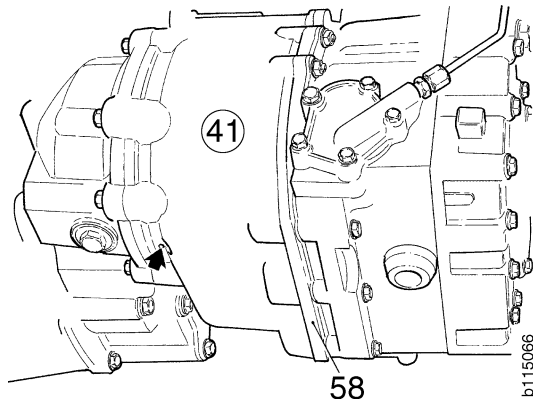
**Check for a leak between the end closure of the retarder 58 and the retarder housing 41**

Dismantle the retarder and renew O-ring 60.  
Check the two O-rings 49.

*41 Retarder housing*

*58 Retarder end closure*

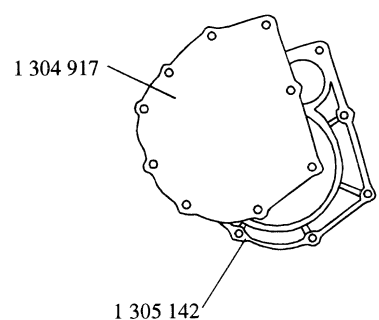
In this case, block the opening in the gearbox with the cover 1 304 917 and gasket 1 305 142. The gasket must be fitted with silicone.

Detach the oil hoses from the retarder. Use two plastic plugs<sup>1</sup> with inside diameter 39 mm to block the ends of the hoses.

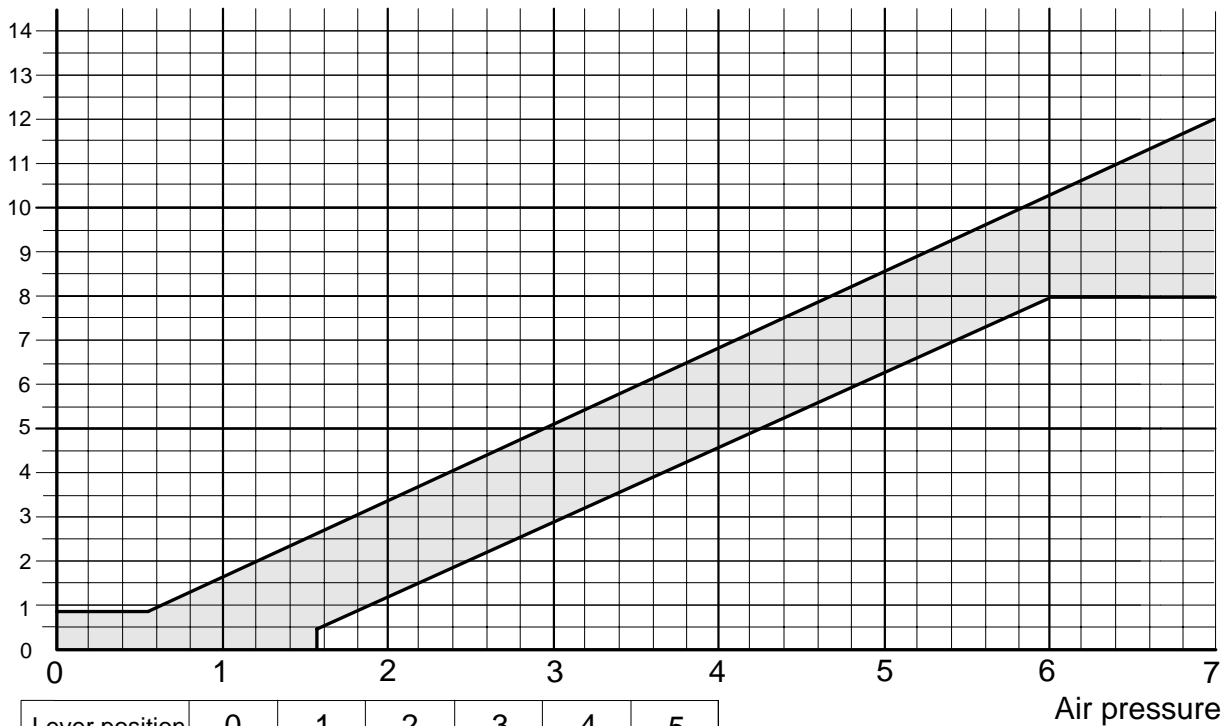
116 027

## Test report for test of hydraulic pressure

Lever position	0	1	2	3	4	5
Air pressure						
Oil pressure

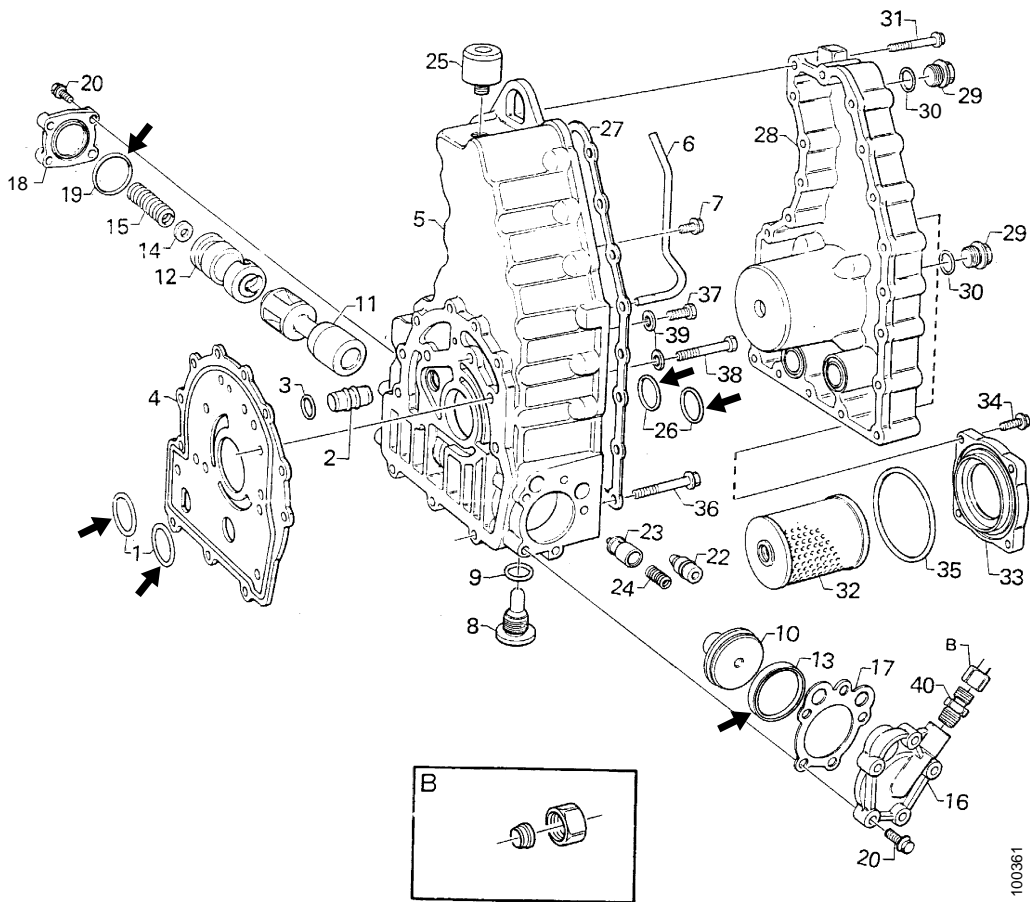
100361

- 1 O-ring
- 2 Spacing sleeve
- 3 O-ring
- 4 Gasket plate
- 5 Valve housing
- 6 Drain pipe
- 7 Flange screw
- 8 Drain plug
- 9 O-ring
- 10 Valve plunger
- 11 Piston
- 12 Piston
- 13 Ring
- 14 Shim
- 15 Compression spring
- 16 Valve housing cover
- 17 Gasket
- 18 Valve housing cover
- 19 O-ring
- 20 Flange screw
- 22 Safety valve
- 23 Valve plunger
- 24 Compression spring
- 25 Air filter
- 26 O-ring
- 27 Gasket
- 28 Oil sump cover
- 29 Plug
- 30 O-ring
- 31 Flange screw
- 32 Oil filter
- 33 Filter cover
- 34 Flange screw
- 35 O-ring
- 36 Flange screw
- 37 Bolt
- 38 Bolt
- 39 Washer
- 40 Union
- B Union nut with cone

Valve housing

*Components indicated with arrows must be in perfect condition or the retarder braking capacity will be reduced.*

- Ring 13
- O-ring 19
- O-rings 1
- O-rings 26
- Safety valve 22

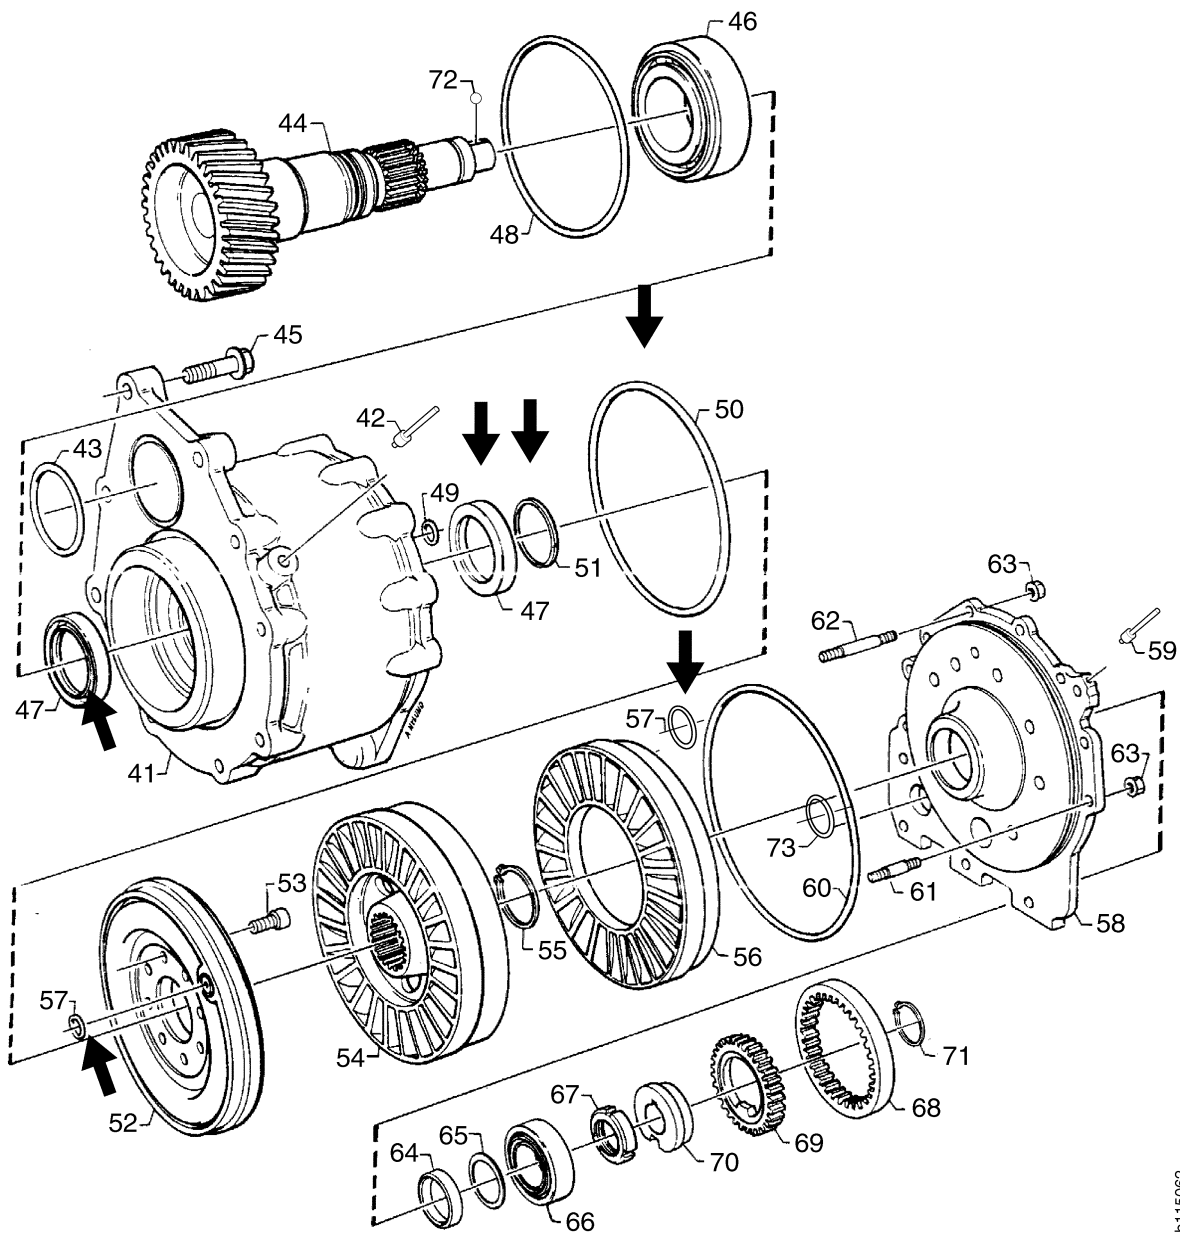
b115062

- 41 Retarder housing
- 42 Plug
- 43 O-ring
- 44 Shaft
- 45 Flange screw
- 46 Roller bearing
- 47 Sealing ring
- 48 O-ring
- 49 O-ring
- 50 O-ring
- 51 Sealing ring of piston ring type
- 52 Stator, inner
- 53 Hexagon socket screw
- 54 Rotor
- 55 Retaining ring
- 56 Stator, outer
- 57 O-ring
- 58 Retarder end closure
- 59 Plug
- 60 O-ring
- 61 Stud
- 62 Stud
- 63 Flange nut
- 64 Spacing ring 6.00 or 6.05 mm
- 65 Shim 0.3 / 0.4 / 0.5 mm
- 66 Roller bearing
- 67 Lock nut
- 68 Oil pump impeller, outer
- 69 Oil pump impeller, inner
- 70 Driver
- 71 Retaining ring
- 72 Ball
- 73 O-ring

Retarder housing

*Components indicated with arrows must be in perfect condition or the retarder braking capacity will be reduced.*
